# **2021 Annual Fishway Status Report for Bonneville Project**

# Becca Cates, Andrew Derugin, and Jeanette Wendler

U. S. Army Corps of Engineers Bonneville Lock & Dam Cascade Locks, OR 97014 (541) 374-4598

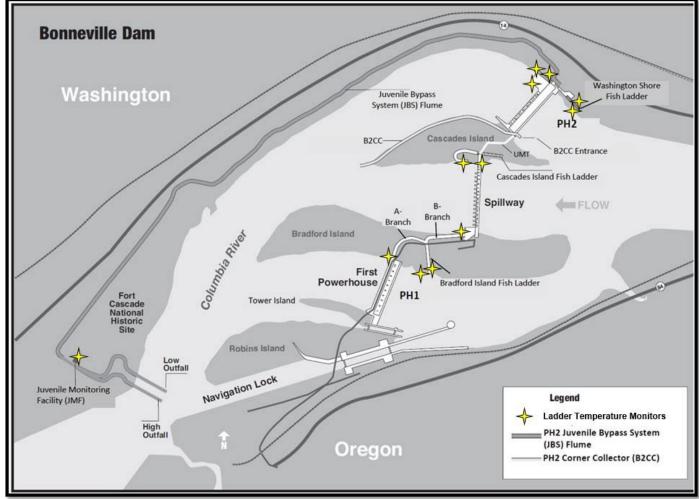
Figure 1. Bonneville Lock and Dam. Image obtained from FPP (2021).

The Project includes two powerhouses, a spillway, and one operating navigation lock. There are four adult fish ladders, located at each powerhouse and the north and south ends of the spillway for upstream migration. There are three Juvenile Bypass Systems (JBS) for downstream migration: an Ice and Trash Sluiceway (ITS) at Powerhouse 1 (PH1), a downstream migration transportation channel (DSM) at Powerhouse Two (PH2), and the corner collector at PH2 (B2CC) (**Figure 1**).

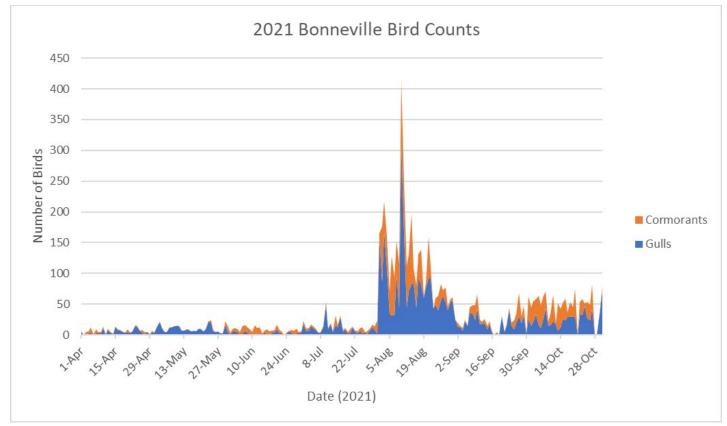
#### Figure 2. 2021 Bonneville Avian Counts.

Bonneville Project Fisheries recorded daily bird counts between 01 April through 31 October 2021 (**Figure 2**). These counts consist of the total numbers of gulls, cormorants, pelicans, grebes, and Caspian terns that were observed in the tailraces of Powerhouse 1, Powerhouse 2, Spillway tailrace, B2 Corner Collector outfall, and the Juvenile Bypass outfalls.

Please note that pelicans, grebes, and terns are not included in this figure due to the extremely low observations (<5 for total monitoring period). However, data can be provided upon request.

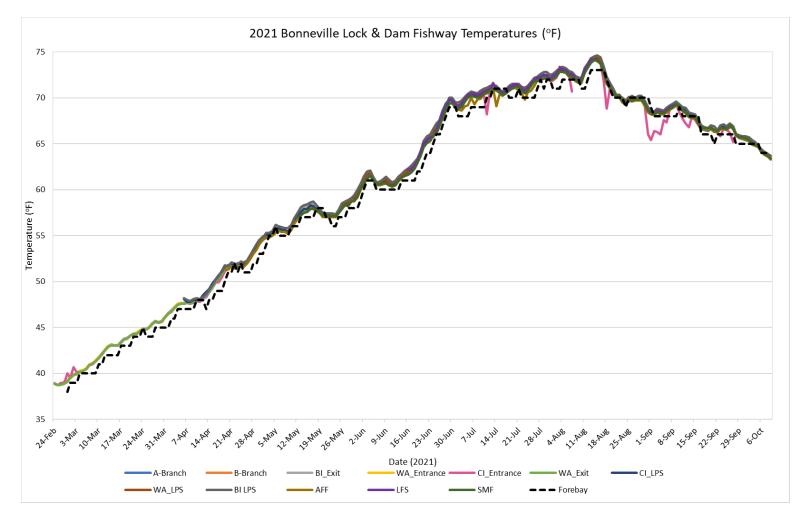
#### Figure 3. 2021 Temperatures at Bonneville.

Project biologists monitor fishway temperatures throughout the fish passage season, from 24 February through 09 October (**Figure 3**). Temperature probes are installed at the following locations: A-Branch Entrance, B-Branch Entrance, Bradford Island Exit, Washington Shore Entrance (NDE), Washington Shore Exit (near FV6-9), AFF, SMF, BI LPS, CI LPS, WA LPS, and the LFS. Additionally, the Technical Management Team (TMT) tracks BON forebay temperature on their <u>website</u>. The TMT temperature is publicly accessible in real-time, and is the standard utilized per the FPP to determine when high-temperature fish sampling restrictions are operative in BON facilities. In 2021, these temperatures were available from 28 February through 22 September. Detailed daily temperatures can be found in the weekly reports and are available upon request.

Please note the following temperature probe issues: WA\_LPS temperature probe failed to log temperatures after 28 August 2021. B-Branch temperature probe broke off inside the stilling well pipe and failed to log temperatures after 21 August 2021. CI\_Entrance temperature probe failed to log consistent temperatures at tailwater levels below 10 feet.
