MEMORANDUM FOR Biologist, Operations Division (CENWP-OD)

SUBJECT: Bonneville Project, Fishway and Fish Activities for **Week 46** of 2019, which covers the period from **10– 16 November**.

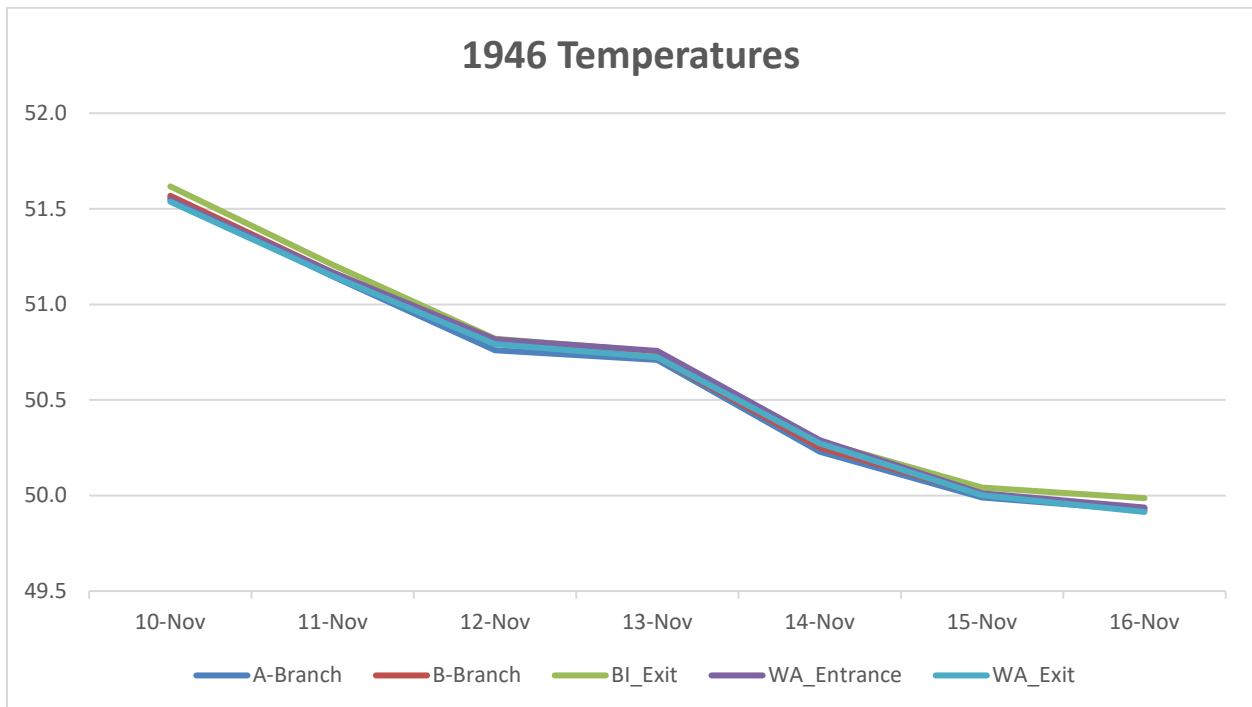
a. Fishway Temperatures. Temperatures are taken from 01 March - 30 November.

Date	A-Branch	B-Branch	BI_Exit	WA_Entrance	WA_Exit
10-Nov	51.6	51.6	51.6	51.5	51.5
11-Nov	51.1	51.2	51.2	51.2	51.1
12-Nov	50.8	50.8	50.8	50.8	50.8
13-Nov	50.7	50.7	50.8	50.8	50.7
14-Nov	50.2	50.3	50.3	50.3	50.3
15-Nov	50.0	50.0	50.0	50.0	50.0
16-Nov	49.9	49.9	50.0	49.9	49.9
