MEMORANDUM FOR Biologist, Operations Division (CENWP-OD)

SUBJECT: Bonneville Project, Fishway and Fish Activities for Week 12 of 2020, which covers the period from 15 - 21 March.

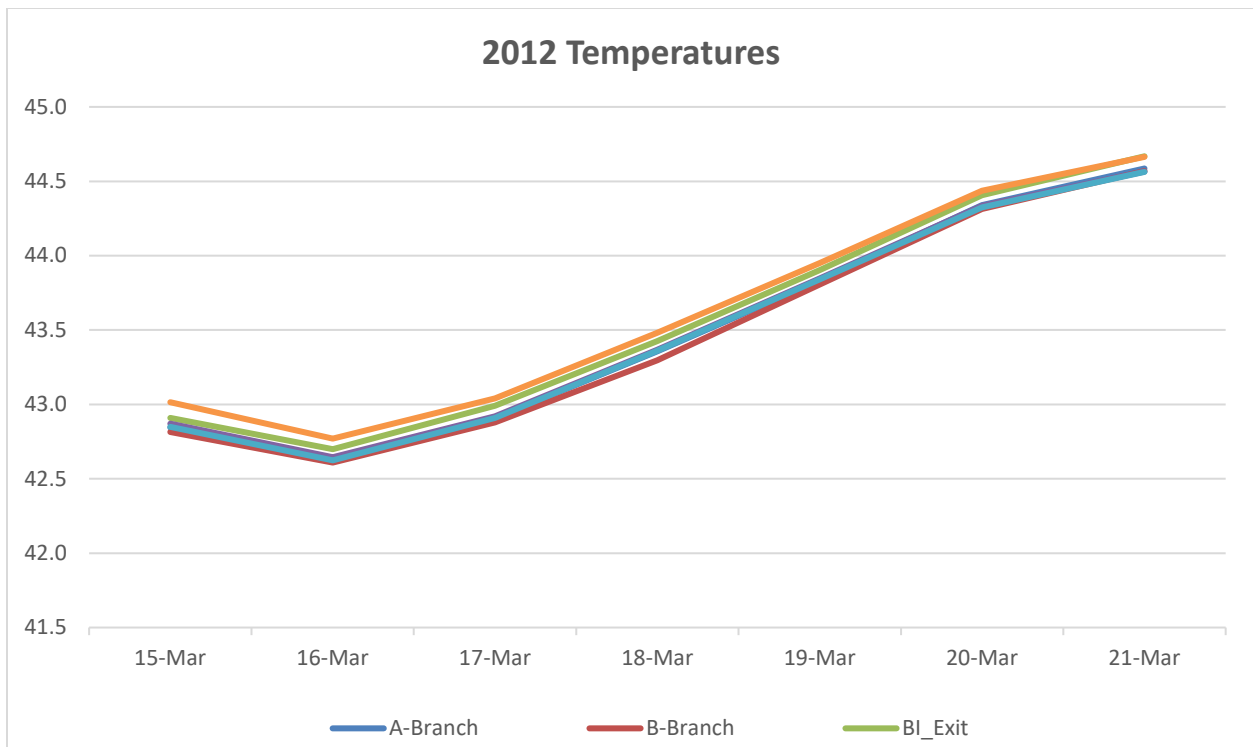
a. Fishway Temperatures. Temperatures are taken from 01 March - 30 November.

Date	A-Branch	B-Branch	BI_Exit	WA_Entrance	WA_Exit	SMF
15-Mar	42.8	42.8	42.9	42.9	42.9	43.0
16-Mar	42.6	42.6	42.7	42.6	42.6	42.8
17-Mar	42.9	42.9	43.0	42.9	42.9	43.0
18-Mar	43.4	43.3	43.4	43.4	43.4	43.5
19-Mar	43.8	43.8	43.9	43.8	43.8	44.0
20-Mar	44.3	44.3	44.4	44.3	44.3	44.4
21-Mar	44.6	44.6	44.7	44.6	44.6	44.7
