MEMORANDUM FOR Biologist, Operations Division (CENWP-OD)

SUBJECT: Bonneville Project, Fishway and Fish Activities for Week 13 of 2020, which covers the period from 22 - 28 March.

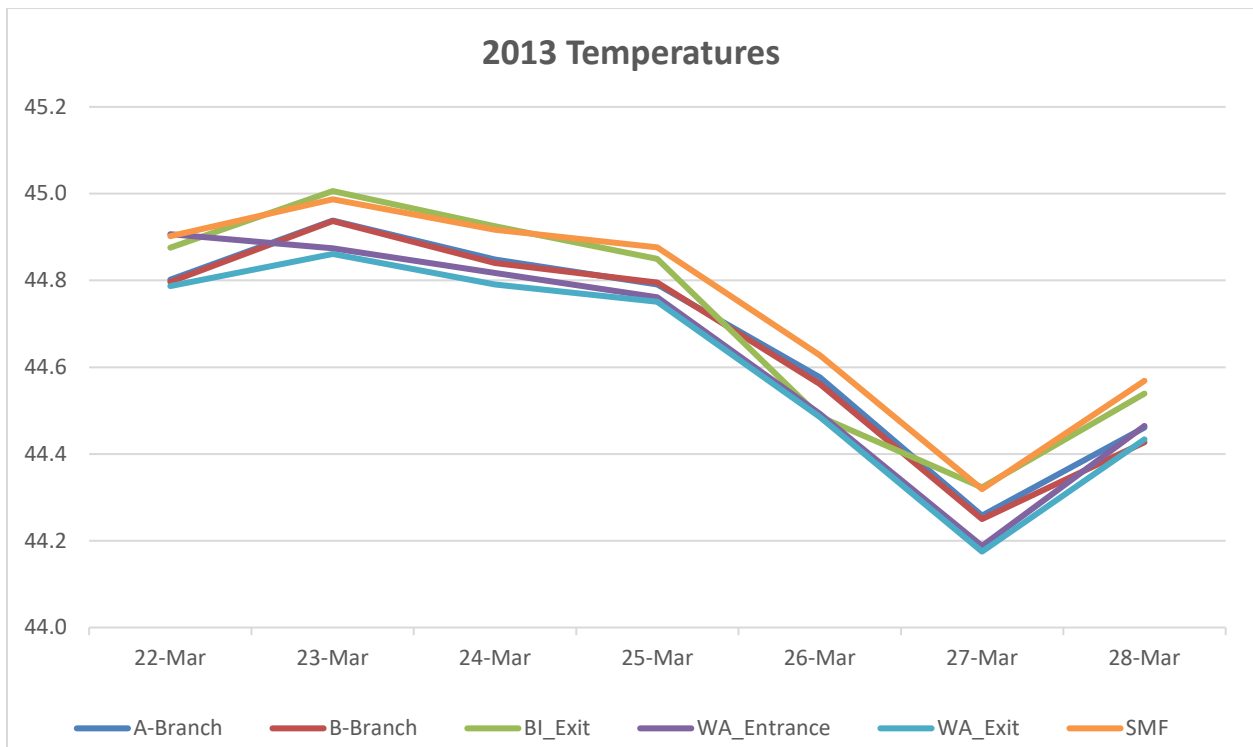
a. Fishway Temperatures. Temperatures are taken from 01 March - 30 November.

Date	A-Branch	B-Branch	BI_Exit	WA_Entrance	WA_Exit	SMF
22-Mar	44.8	44.8	44.9	44.9	44.8	44.9
23-Mar	44.9	44.9	45.0	44.9	44.9	45.0
24-Mar	44.8	44.8	44.9	44.8	44.8	44.9
25-Mar	44.8	44.8	44.9	44.8	44.8	44.9
26-Mar	44.6	44.6	44.5	44.5	44.5	44.6
27-Mar	44.3	44.3	44.3	44.2	44.2	44.3
28-Mar	44.5	44.4	44.5	44.5	44.4	44.6
