# The Dalles Dam Fishway Status Report

3/9/2015

Inspection Period: 3/1/2015 to 3/7/2015

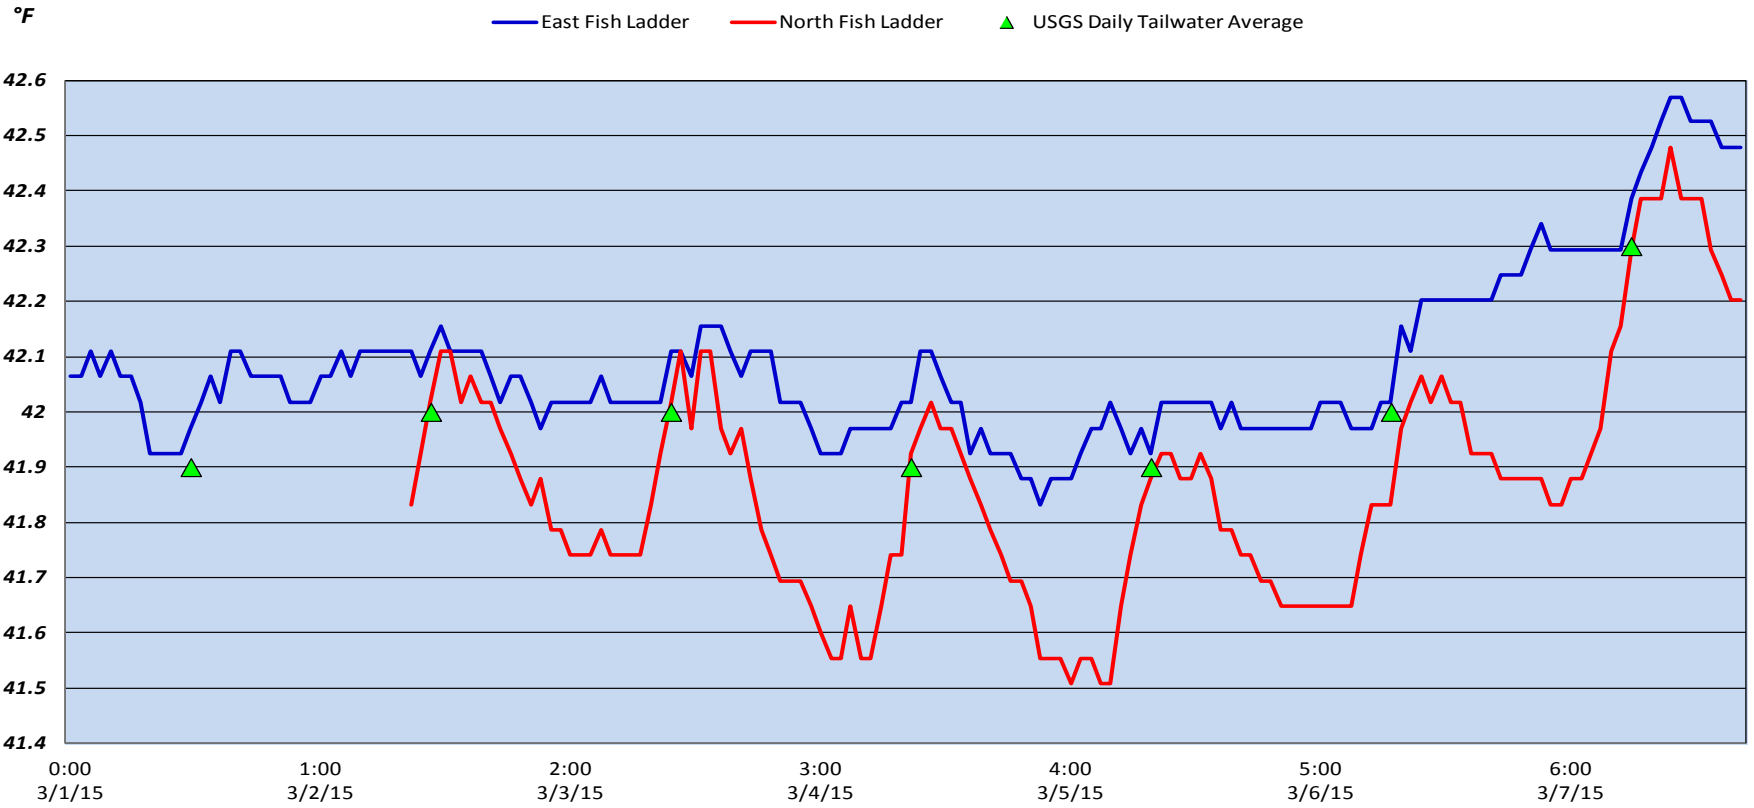
### The Dalles Dam Adult Fish Ladder River/Water Temperatures

41.9
42.0
42.0
41.9
41.9
42.0
42.3
AVG: 42.0

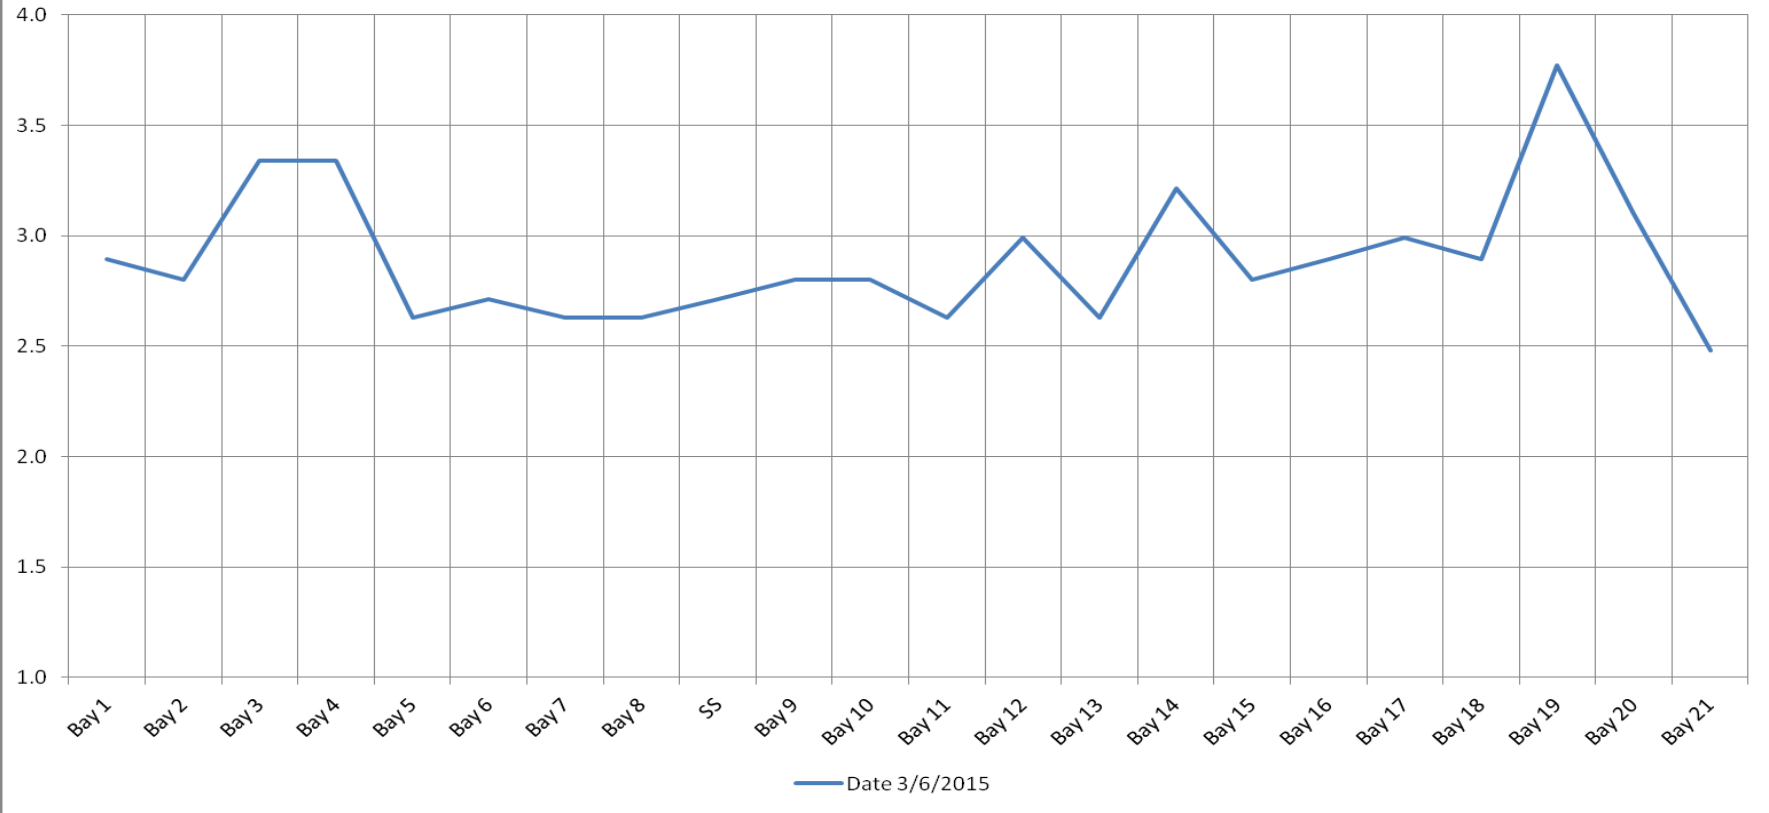
The Dalles Dam Collection Channel Velocites (In criteria 1.5 - 4.0 fps)
