The Dalles Dam Fishway Status Report

12/6/2015

Inspection Period: 11/29/2015 - 12/05/2015

US Army Corps
of Engineers
Portland District

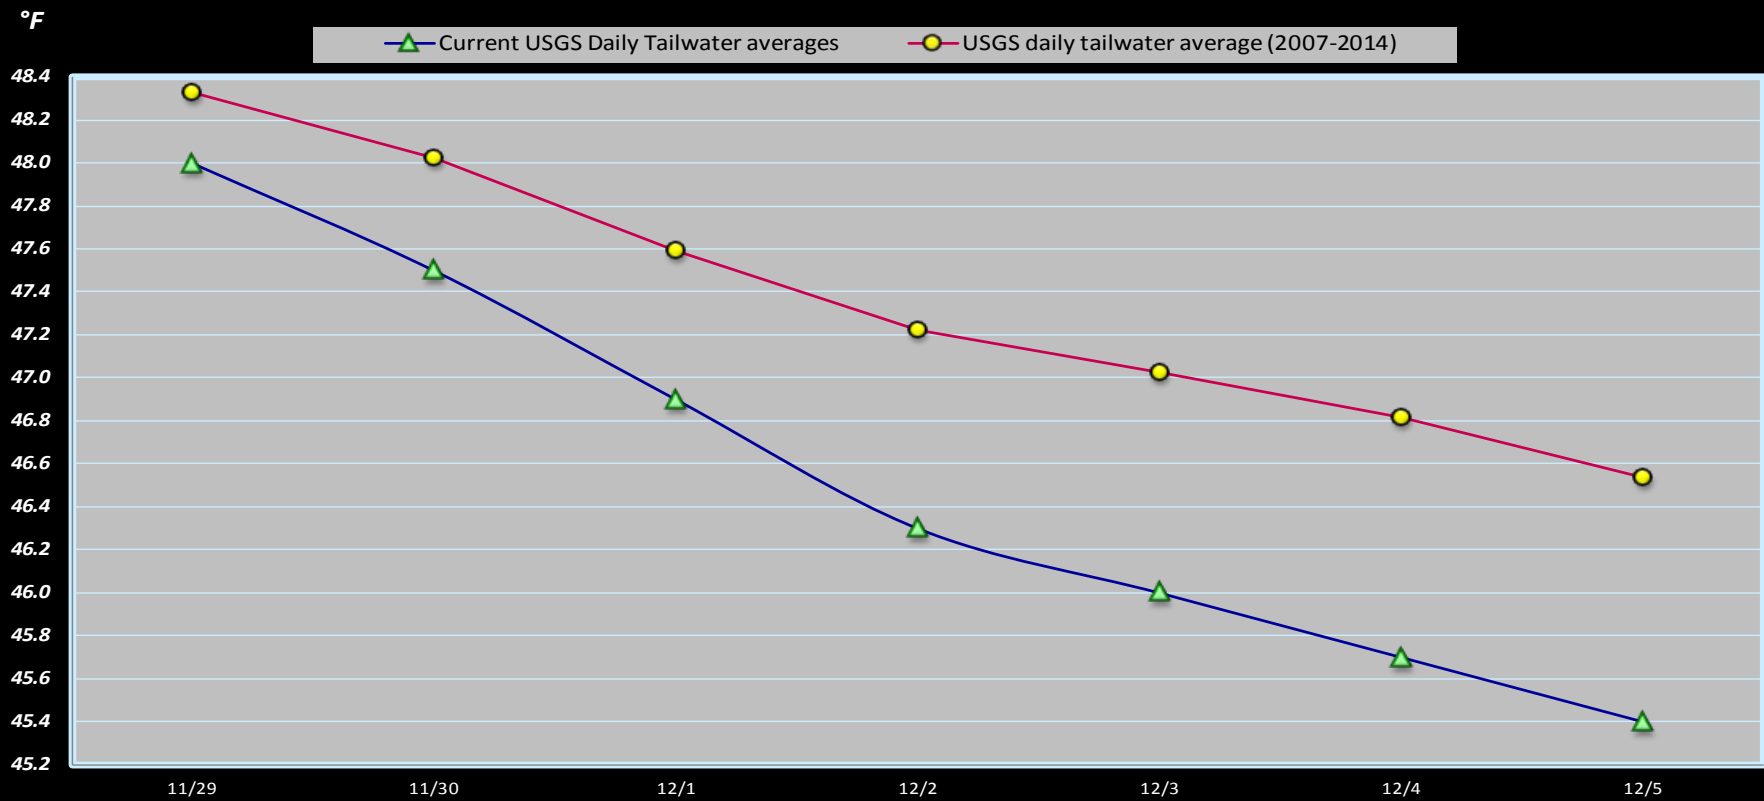
The Dalles Dam Tailwater River Temperatures

Secchi:		Temperatures
5.0	Sun	48.0
5.0	Mon	47.5
5.0	Tue	46.9
5.0	Wed	46.3
5.0	Thurs	46.0
5.0	Fri	45.7
5.0	Sat	45.4
5.0	AVG	46.5
