Annual Juvenile Fish Passage Report

McNary Lock and Dam

2013

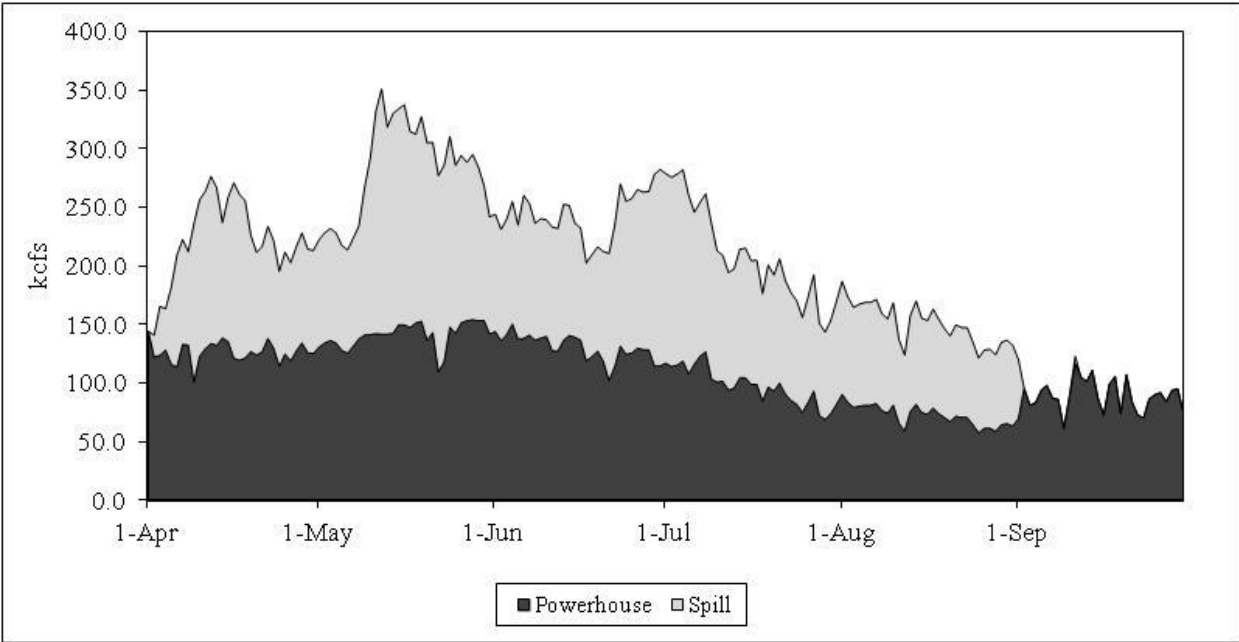
Figure 1. Average daily powerhouse discharge and spill at McNary Dam, 2013.

River flows in 2013 were slightly higher in April and May but, slightly lower for the rest of the season than the 2009-2012 average (Table 16). A peak hourly flow of 357.9 kcfs was recorded on May 12th while a minimum hourly flow of 54.2 kcfs occurred on September 23rd. The highest average flow day during the 2012 fish passage season was May 12th with an hourly average of 356.7 kcfs. The minimum average daily flow of 66.9 kcfs was recorded September 9th (Figure 1). The court ordered summer spill implementation plan began at midnight on April 10 with 40% of the flow going through spill bays to improve fish passage. June 17 through August 31, 50% of the flow was passed through the spill bays. The peak hourly spill of 209.8 kcfs was reported multiple times on May 11th and May 12th. Maximum average daily spill occurred on May 12th with an hourly average spill of 209.2 kcfs.
