**ADULT AND JUVENILE FISH FACILITIES MONITORING REPORT
LITTLE GOOSE DAM – 2014**

Little Goose Dam
U.S. Army Corps of Engineers
April 2015

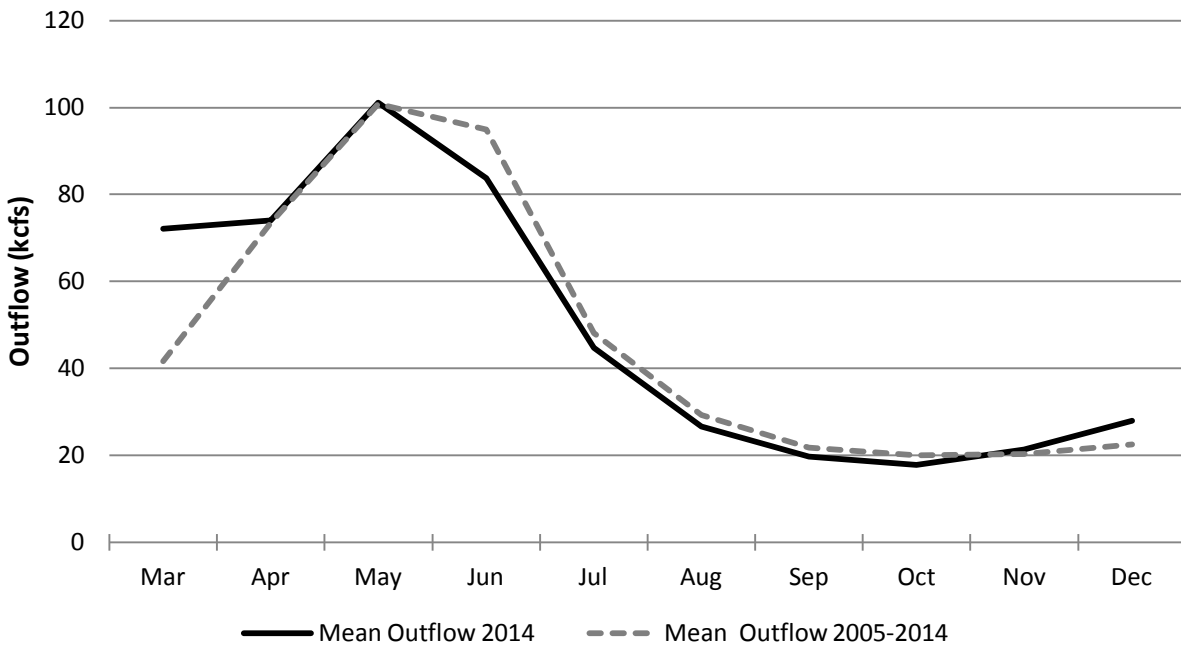
Figure 1. Little Goose Lock and Dam monthly outflow.

Below average winter and spring precipitation preceded a hot and dry summer. The average daily flow past LGS was 47.6 kcfs. The maximum average daily flow of 140.0 kcfs occurred on May 26 and the minimum average daily flow of 12.5 kcfs occurred on September 25. Monthly average flows compared to the 10 year average are illustrated in Figure 1.
