2014 Juvenile Fish Collection and Bypass Report
McNary Dam Juvenile Fish Facility

Carl Dugger
U.S. Army Corps of Engineers
Supervisory Fisheries Biologist

February 2015

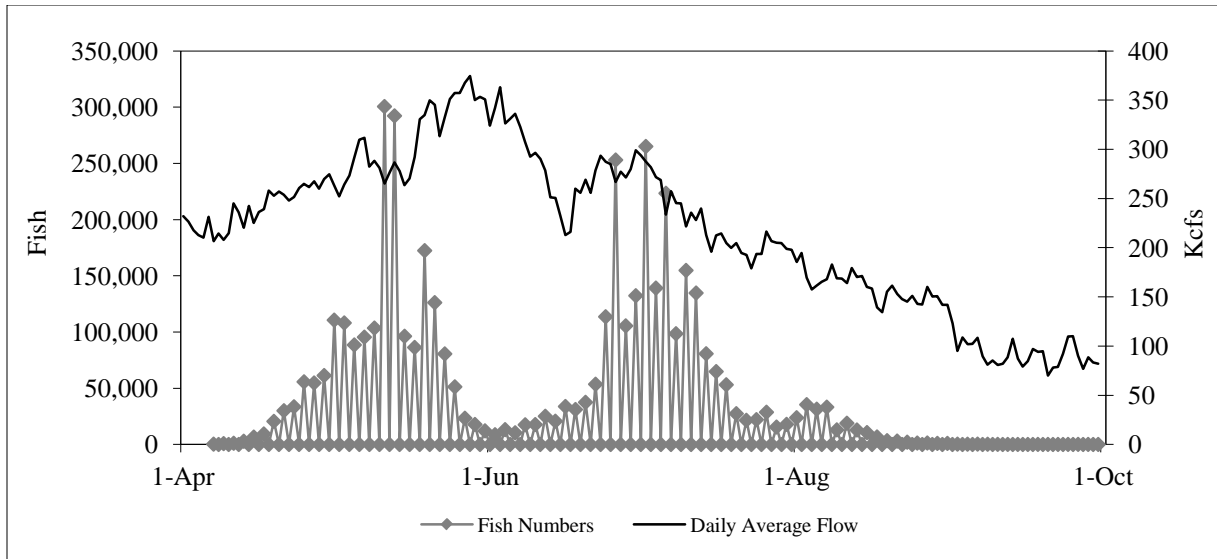
Figure 2. Daily juvenile salmonid passage all species vs. daily average flow at McNary Dam, 2014.

An estimated 4,464,404 juvenile salmonids were collected at McNary Dam this season (Table 2). Composition by species in 2014: 1,004,596 yearling Chinook, 2,407,283 subyearling Chinook, 230,095 clipped Steelhead, 66,411 unclipped Steelhead, 3,350 clipped Sockeye, 683,687 unclipped Sockeye and 68,982 Coho. Collection totals do not include fish passing during emergency or primary bypass operations. Daily fish passage and river flow information is provided in Figure 2.

Peak collection occurred on May 11th with a daily total passage of 300,558. Peak collection dates and daily passage totals by species group were: May 11th yearling Chinook (194,300), July 2nd subyearling Chinook (264,064), May 1st clipped Steelhead (36,600), May 11th unclipped Steelhead (7,800), May 23rd clipped Sockeye/Kokanee (2,200), May 19th unclipped Sockeye/Kokanee (110,059), and May 21st Coho (9,204) (Table 3).
