SUBJECT: Submission of 2017 Adult and Juvenile Fish Facility Monitoring Report, Ice Harbor Dam.

2017 ADULT AND JUVENILE FISH FACILITY MONITORING REPORT

ICE HARBOR DAM

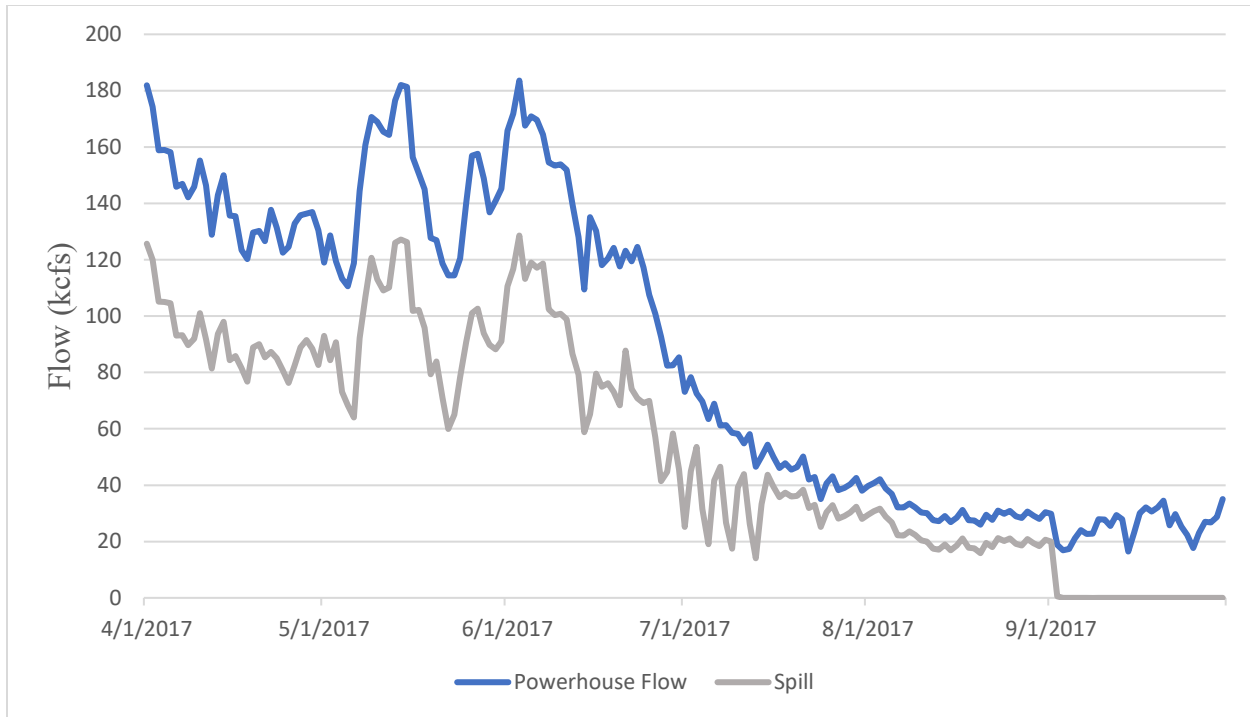
Figure 1. Comparison of daily project outflow and spill at Ice Harbor Dam, 2017.

The highest daily outflow for the season was 214.0 kilo cubic feet per second (kcfs) on March 18. The lowest daily outflow for the season occurred October 23 with an outflow of 12.0 kcfs. The average flow for the season was 54.6 kcfs, (Figure 1).

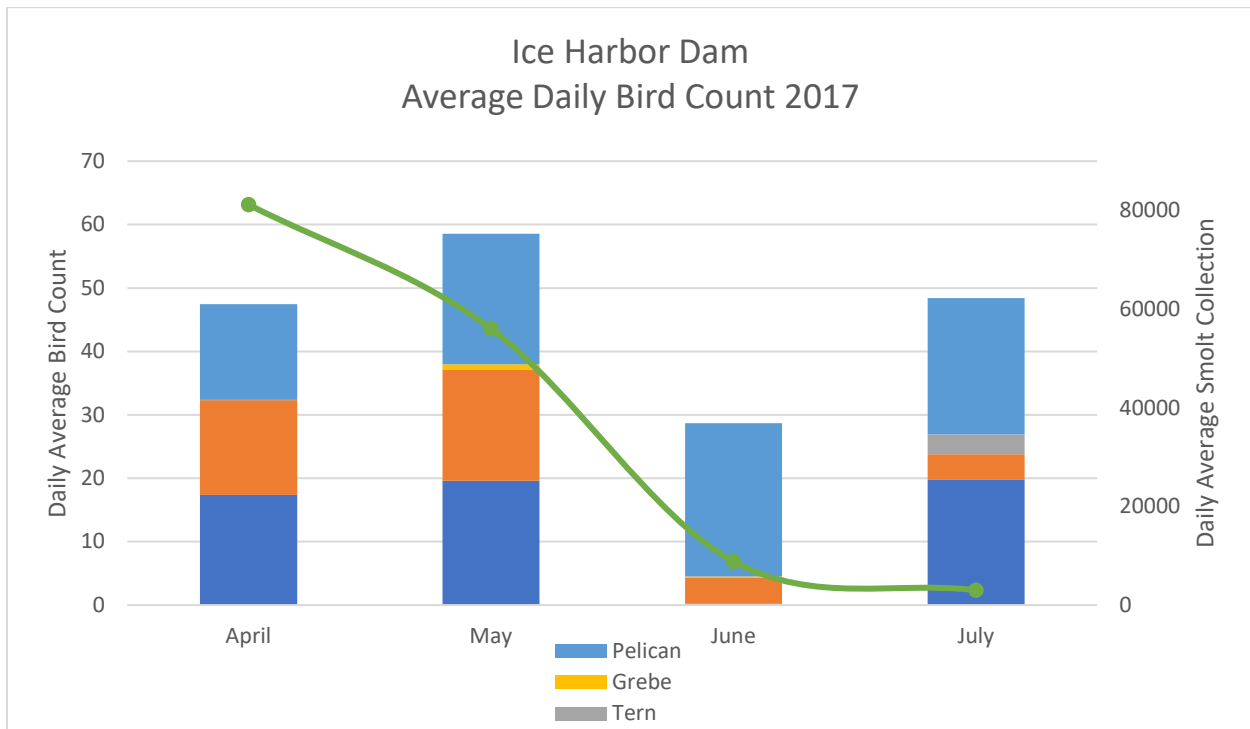
Figure 2. Daily average count at Ice Harbor Dam, 2013-2017.

Bird monitoring occurred from April 1 to July 31. A bar graph below illustrates the daily average bird count, (Figure 1). Gulls, cormorants, Caspian Terns, Western Grebes and American white pelicans were counted once per day, 6 or 7 days a week from April 1 to June 30 and 4 days (Monday to Thursday) from July 1 to July 31. Areas of avian predation monitoring included: forebay, powerhouse tailrace (two areas), spillway tailrace (three areas), Eagle Island and JFF bypass outfall. Deterrent measures include bird deterrent hydro cannon, bird wires and hazing (April 1 to June 30) under the animal control contract with United States Department of Agriculture-Wildlife Services (USDA-WS). Three of the avian deterrent wires, which broke off during high flows earlier in the year, were replaced by APHIS Wildlife Services on September 13.

The highest number of birds observed from April 1 to the end of July were gulls totaling 1,390. The highest average daily count of gulls observed for a month in 2017 was in July totaling 19.7. June came very close to July averaging 19.6. However, the highest amount observed in one day was 93 on May 8 (Figure 2).
