SUBJECT: Submission of 2018 Adult and Juvenile Fish Facility Monitoring Report, Lower Monumental Dam.

ADULT AND JUVENILE FISH FACILITY MONITORING REPORT
LOWER MONUMENTAL DAM
2018

Charles A. Barnes Jr.
Supervisory Fish Biologist
and
Raymond A. A. Addis
Assistant Biologist
Lower Monumental Dam
U.S. Army Corps of Engineers

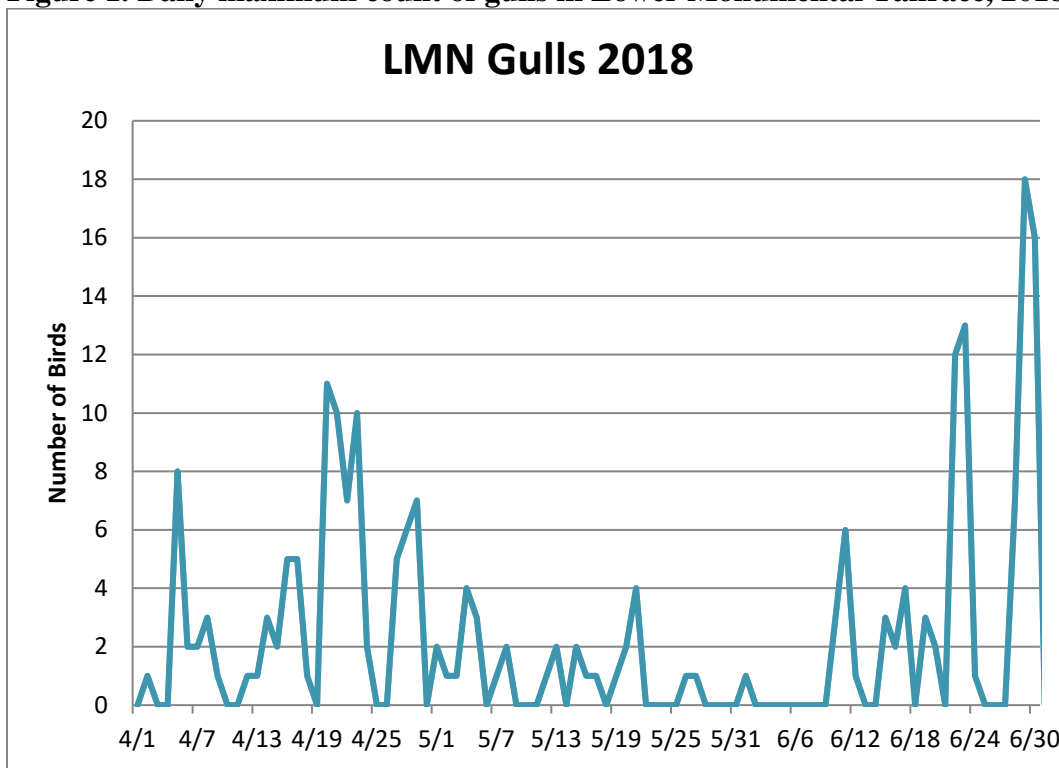
The maximum number of gulls was 18 (June 29) with a daily average of 2.36.

Figure 1. Daily maximum count of gulls in Lower Monumental Tailrace, 2018.
