SUBJECT: Submission of 2019 Adult and Juvenile Fish Facility Monitoring Report, Lower Monumental Dam.

ADULT AND JUVENILE FISH FACILITY MONITORING REPORT
LOWER MONUMENTAL DAM
2019

Charles A. Barnes Jr.
Supervisory Fish Biologist
and
Raymond A. A. Addis
Assistant Biologist
Lower Monumental Dam
U.S. Army Corps of Engineers

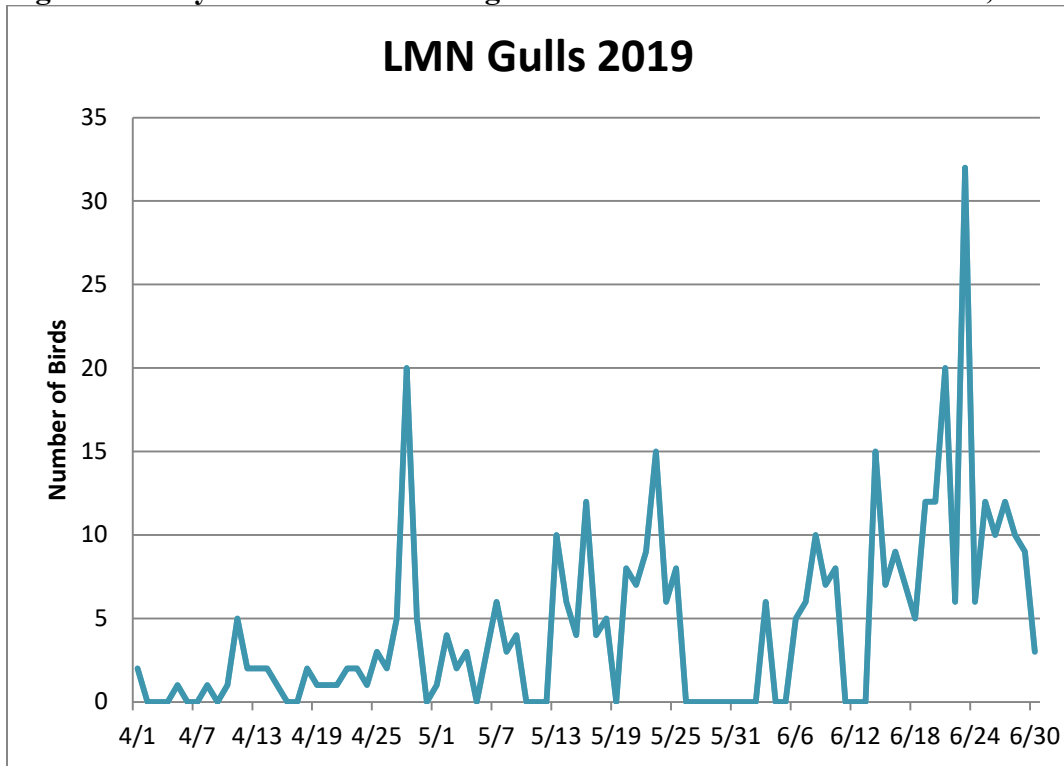
The maximum number of gulls was 32 (June 23) with a daily average of 4.52.

Figure 1. Daily maximum count of gulls in Lower Monumental Tailrace, 2019.

Figure 1. Daily maximum count of gulls in Lower Monumental Tailrace, 2019.....	15
Figure 2. Daily maximum count of cormorants in Lower Monumental Tailrace, 2019.....	16

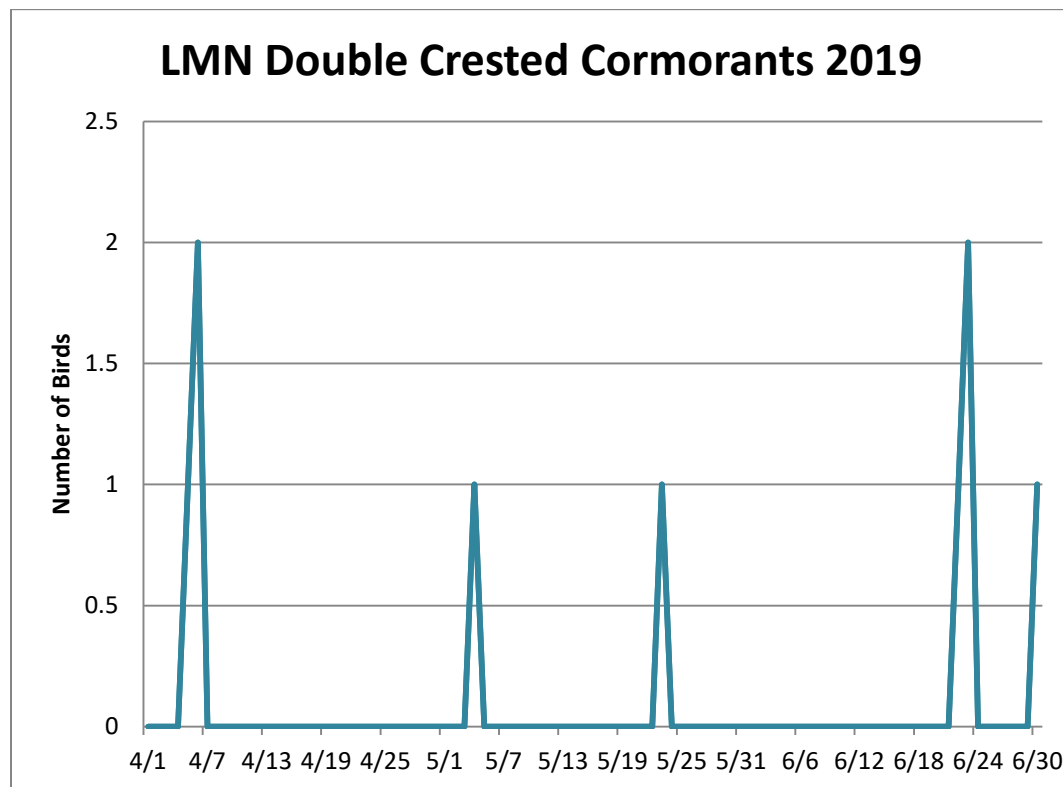
The maximum number of cormorants was 2 (April 6 and June 23) with a daily average of 0.10.

Figure 2. Daily maximum count of cormorants in Lower Monumental Tailrace, 2019.
