SUBJECT: Submission of 2020 Adult and Juvenile Fish Facility Monitoring Report, Lower Monumental Dam.

ADULT AND JUVENILE FISH FACILITY MONITORING REPORT
LOWER MONUMENTAL DAM
2020

Charles A. Barnes Jr.
Supervisory Fish Biologist
and
Raymond A. A. Addis
Assistant Biologist
Lower Monumental Dam
U.S. Army Corps of Engineers

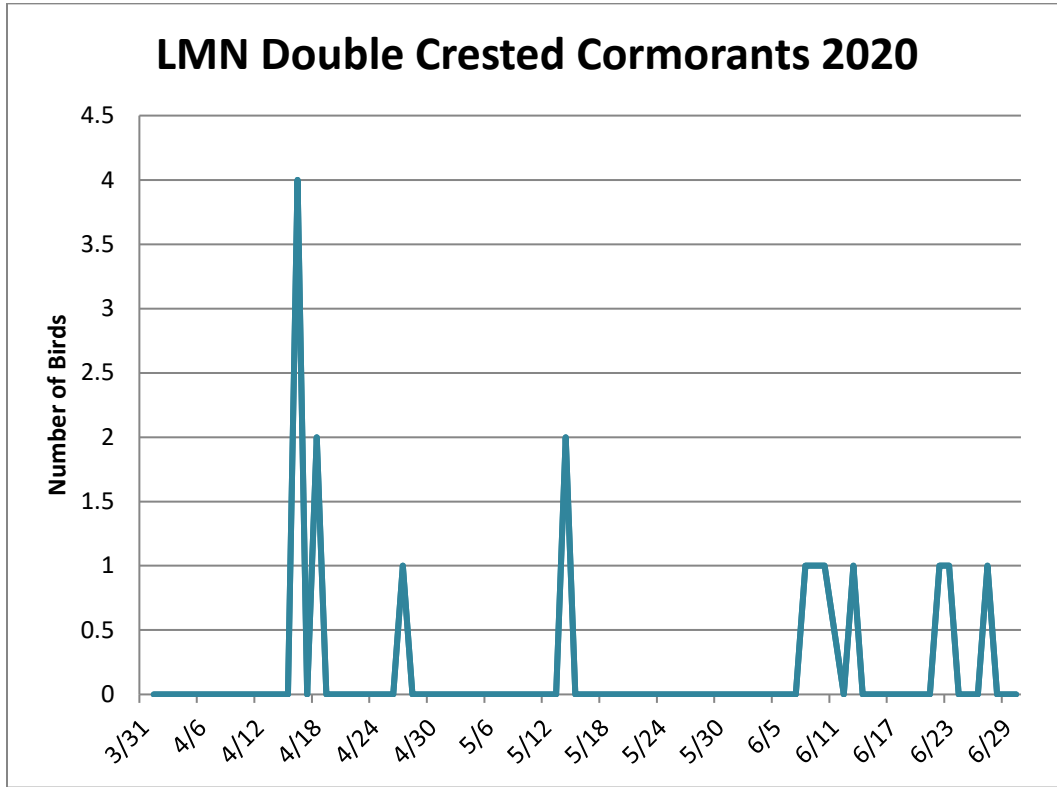
The maximum number of cormorants was 4 (April 16) with a daily average of 0.17.

Figure 2. Daily maximum count of cormorants in Lower Monumental Tailrace, 2020.

Single daily counts of gulls, cormorants and terns occurred between the hours of 1100 and 1300 each day from April 1 through June 30 as per the Avian Action Plan. Maximum counts with date of occurrence, average count through the April 1 to June 30 period, and a graph of the daily counts for each species throughout the period are as follows (Figures 1-2).

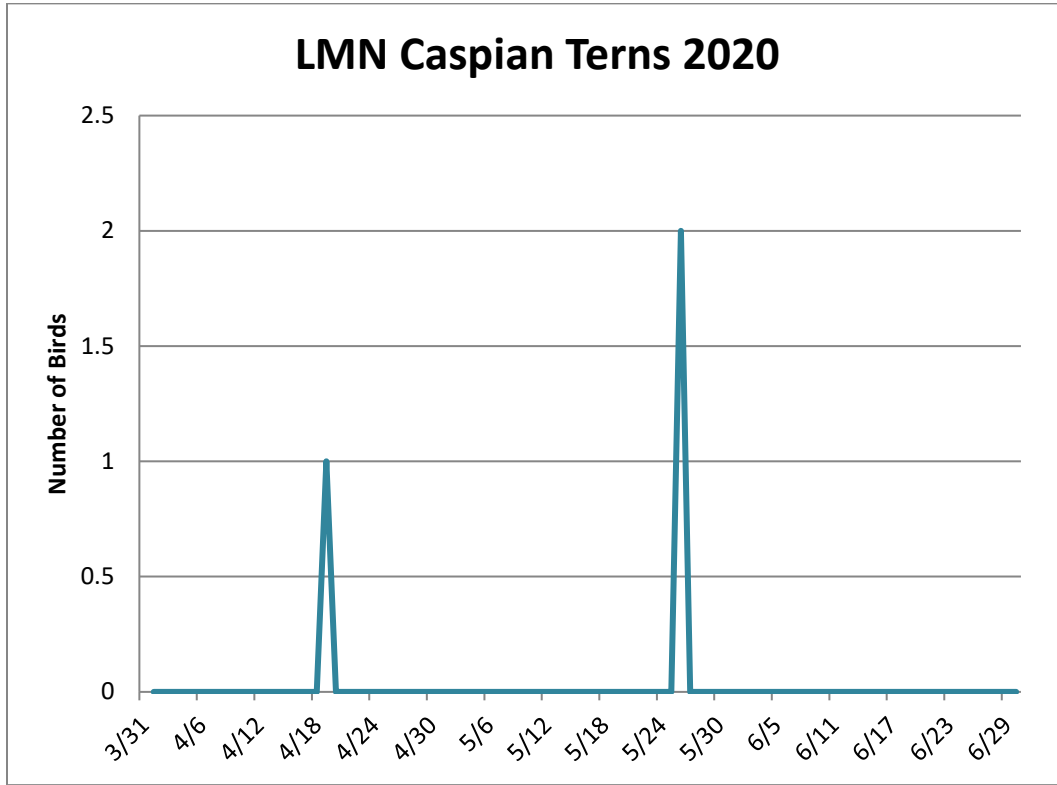
The maximum number of terns was 2 (May 26) with a daily average of 0.03.

Figure 3. Daily maximum count of terns in Lower Monumental Tailrace, 2020.
