**ADULT AND JUVENILE FISH FACILITIES MONITORING REPORT  
LITTLE GOOSE DAM – 2012**

Little Goose Dam  
U.S. Army Corps of Engineers  
April 2013

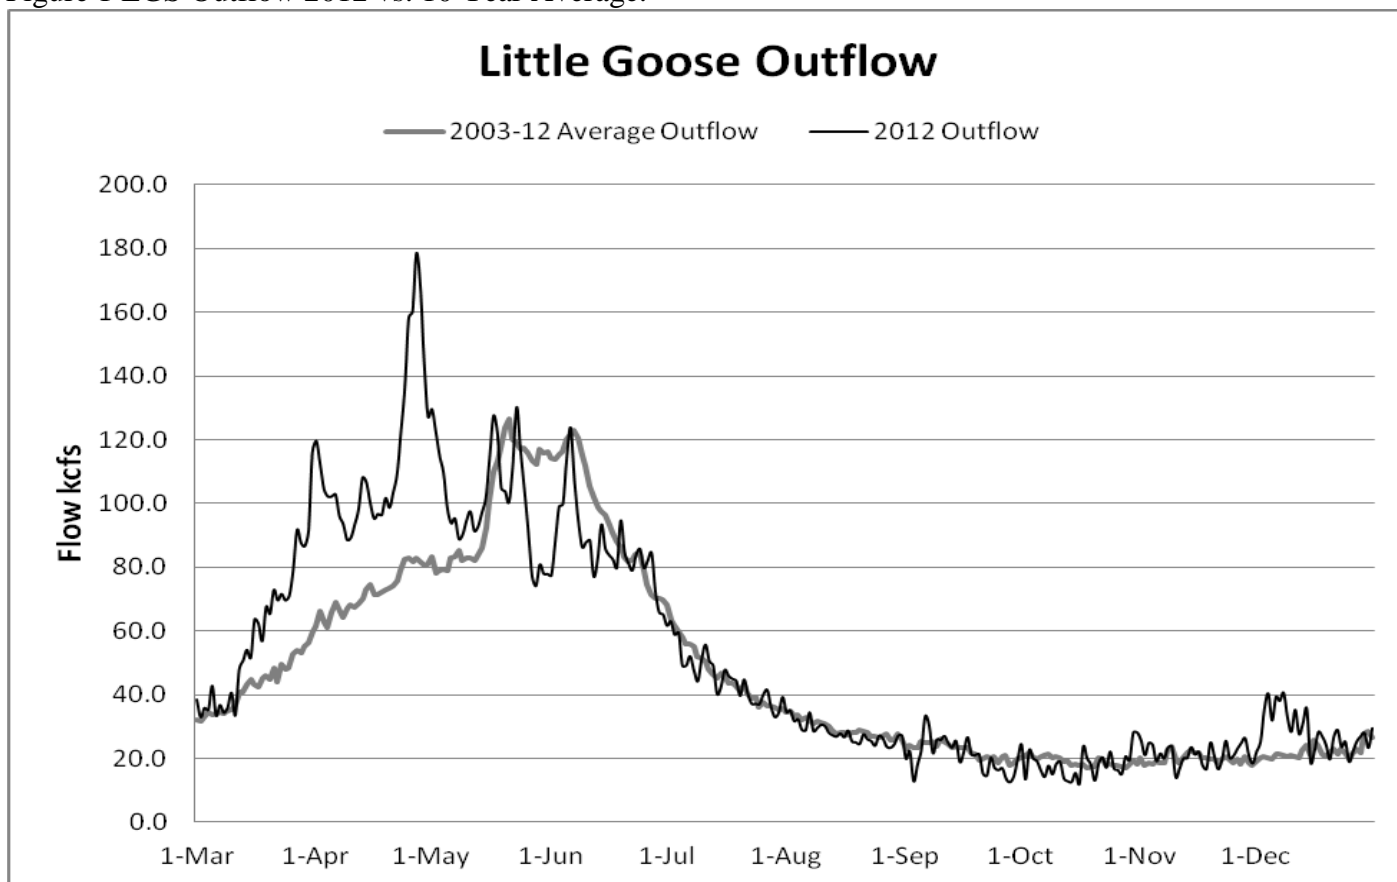
A wet spring produced above average river flows from mid March through early May followed by a dry summer that produced flows near average for the remainder of the year (Figure 1). The average daily flow past LGS was 52.3kcfs compared to the 2003-2012 ten year average of 47.0 kcfs. The peak daily flow of 178.4 kcfs occurred on April 27 and the minimum, 12.1 kcfs occurred on October 16.

Figure 1 LGS Outflow 2012 vs. 10 Year Average.
