**U.S. ARMY CORPS OF ENGINEERS
WALLA WALLA DISTRICT
FISH FACILITIES WEEKLY REPORT
#20-2022**

Project: McNary

Dates: July 15 – July 21, 2022

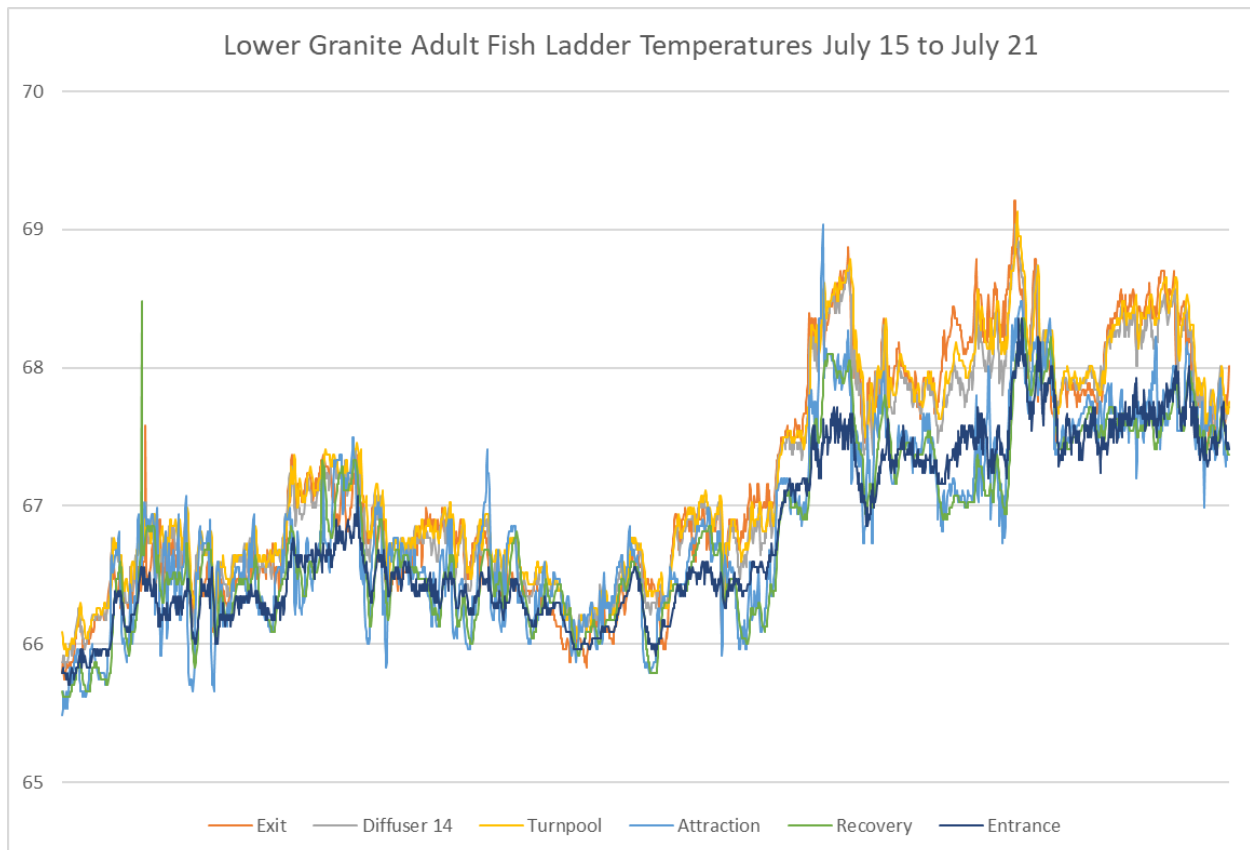
Figure 1. Lower Granite Dam adult fish ladder temperatures July 15 to July 21, 2022.

Comments: The fish ladder cooling water pumps are in operation. The fish ladder temperature probes and system were upgraded over the winter outage season. NWW and NWD continues working on the issue with only some sensor readings available online. HOBO ladder temperature data for the week is included at the end of this report (Figure 1).
