**U.S. ARMY CORPS OF ENGINEERS
WALLA WALLA DISTRICT
FISH FACILITIES WEEKLY REPORT
#22-2022**

Project: McNary

Dates: July 29 – August 4, 2022

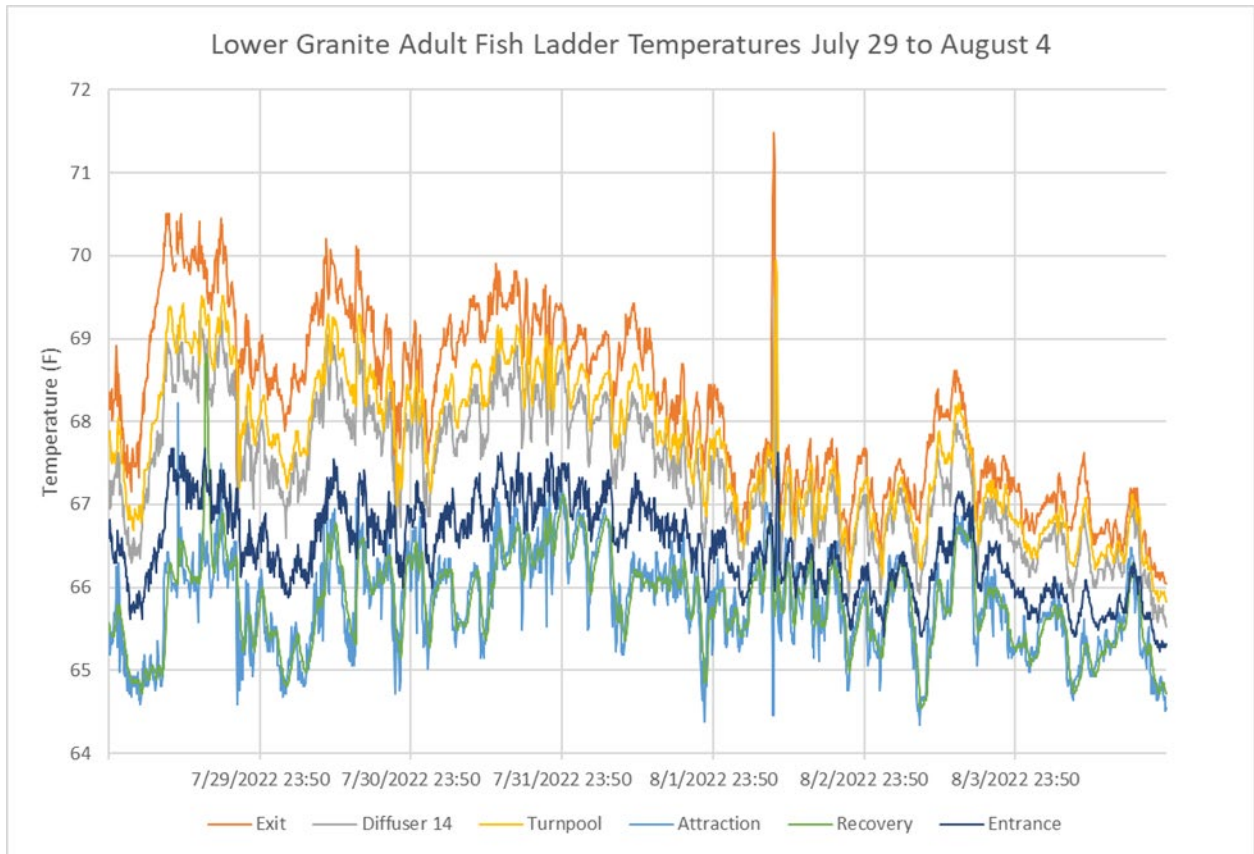
Figure 1. Lower Granite Dam adult fish ladder temperatures July 29 to August 4, 2022.

Comments: The fish ladder cooling water pumps are in operation. Pump supply configuration was modified to provide water directly into the ladder exit channel from pump 1. The fish ladder temperature probes and system were upgraded over the winter outage season. NWW and NWD continues working on the issue with only some sensor readings available online. Fish ladder temperature data is provided in (Figure 1).

Adult Fish Trap Operations: The adult trap is operating Monday through Friday at a 20% (18%/week) sample rate. HOBO data indicates a temperature between the main ladder and the adult trap (Figure 1). The adult trap was flushed with the screen cleaned July 29.
