1. McNary

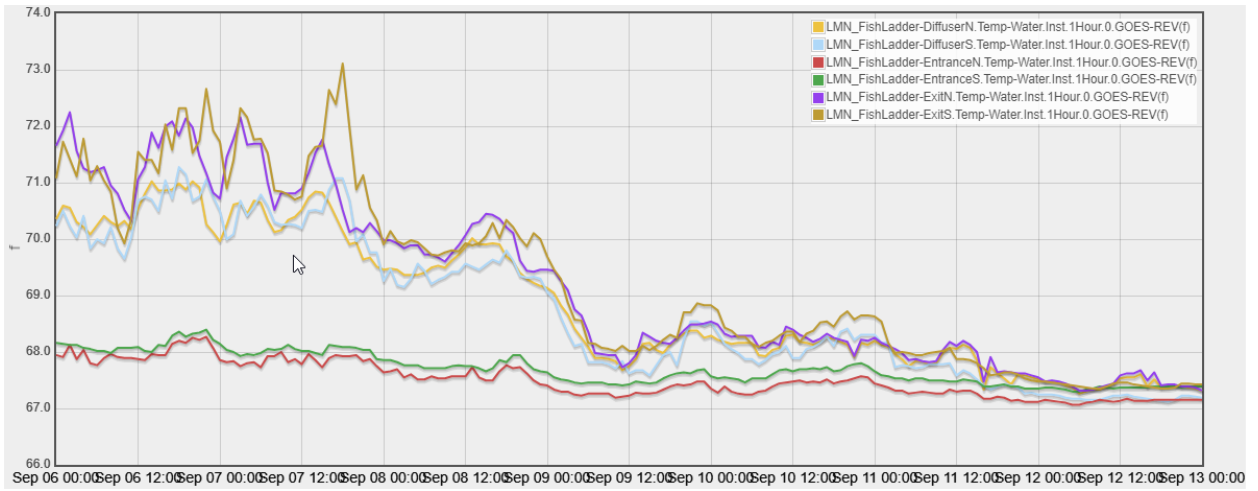
Temperature Probes: The adult passage temperature probes operated correctly during this reporting period. The graph below shows the temperatures per recording point for the reporting period.
