**1. McNary**

**Project: Little Goose Dam**

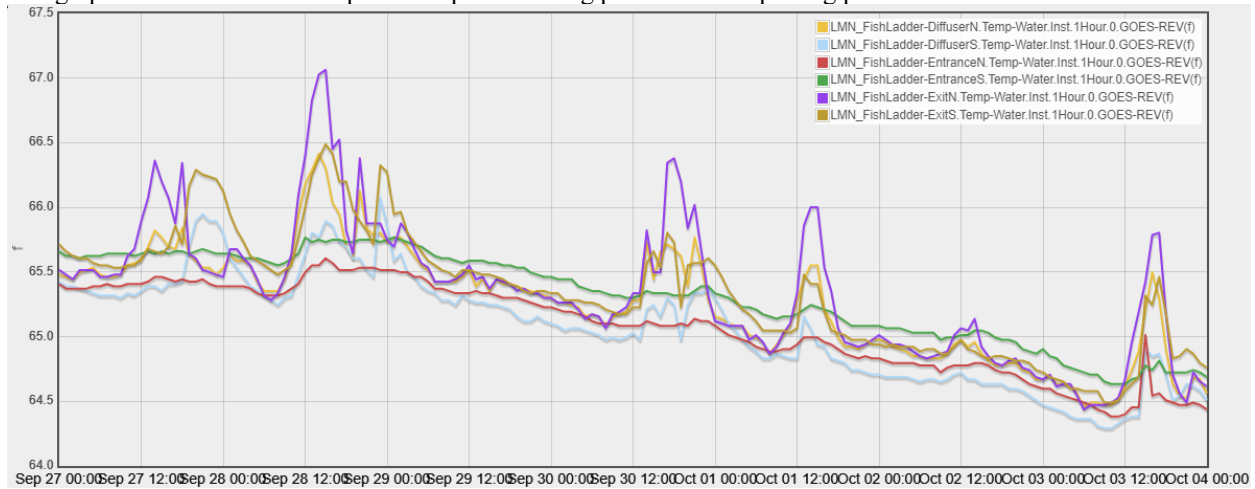
**Temperature Probes:** The adult passage temperature probes operated correctly during this reporting period.

The graph below shows the temperatures per recording point for the reporting period.
