**1. McNary**

**2. Ice Harbor**

**3. Lower Monumental**

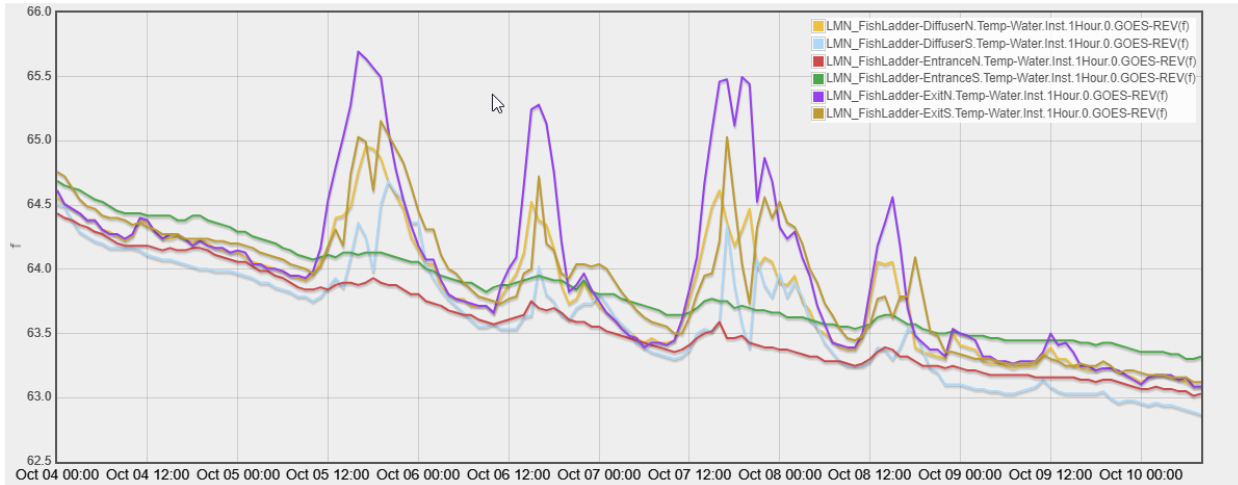
Temperature Probes: The adult passage temperature probes operated correctly during this reporting period.

The graph below shows the temperatures per recording point for the reporting period.
