**U.S. ARMY CORPS OF ENGINEERS
WALLA WALLA DISTRICT
FISH FACILITIES WEEKLY REPORT
#38-2024**

Project: McNary

Dates: November 15-21, 2024

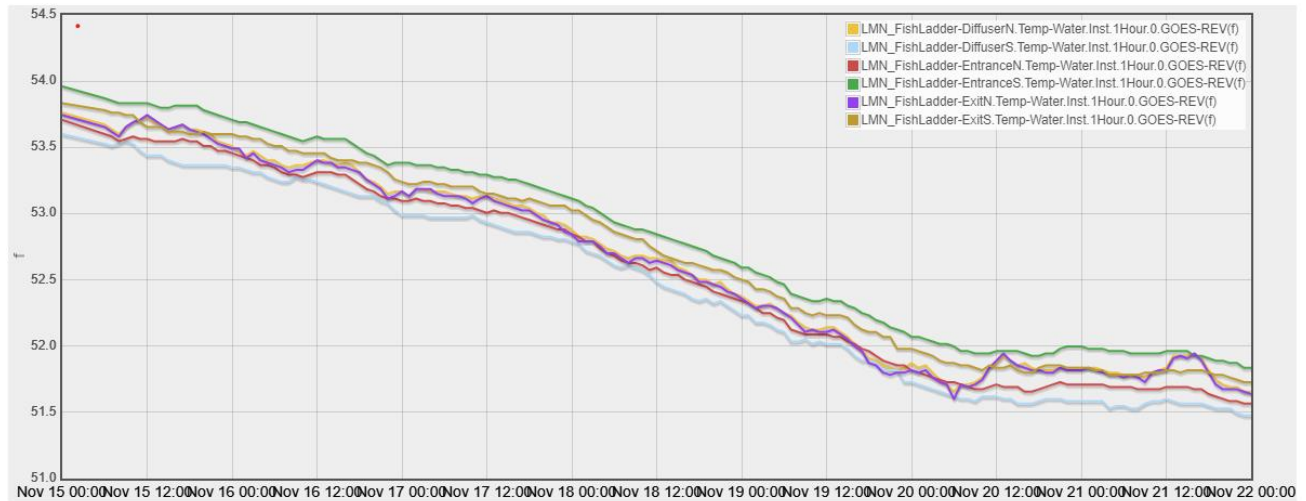
Temperature Probes: The adult passage temperature probes operated correctly during this reporting period.

The graph below shows the temperatures per recording point for the reporting period.
