MEMORANDUM FOR THE RECORD - 17 IHR 10

SUBJECT: 1 Adult and 2 juvenile fish mortalities due to plugged orifices on June 26, 2017.

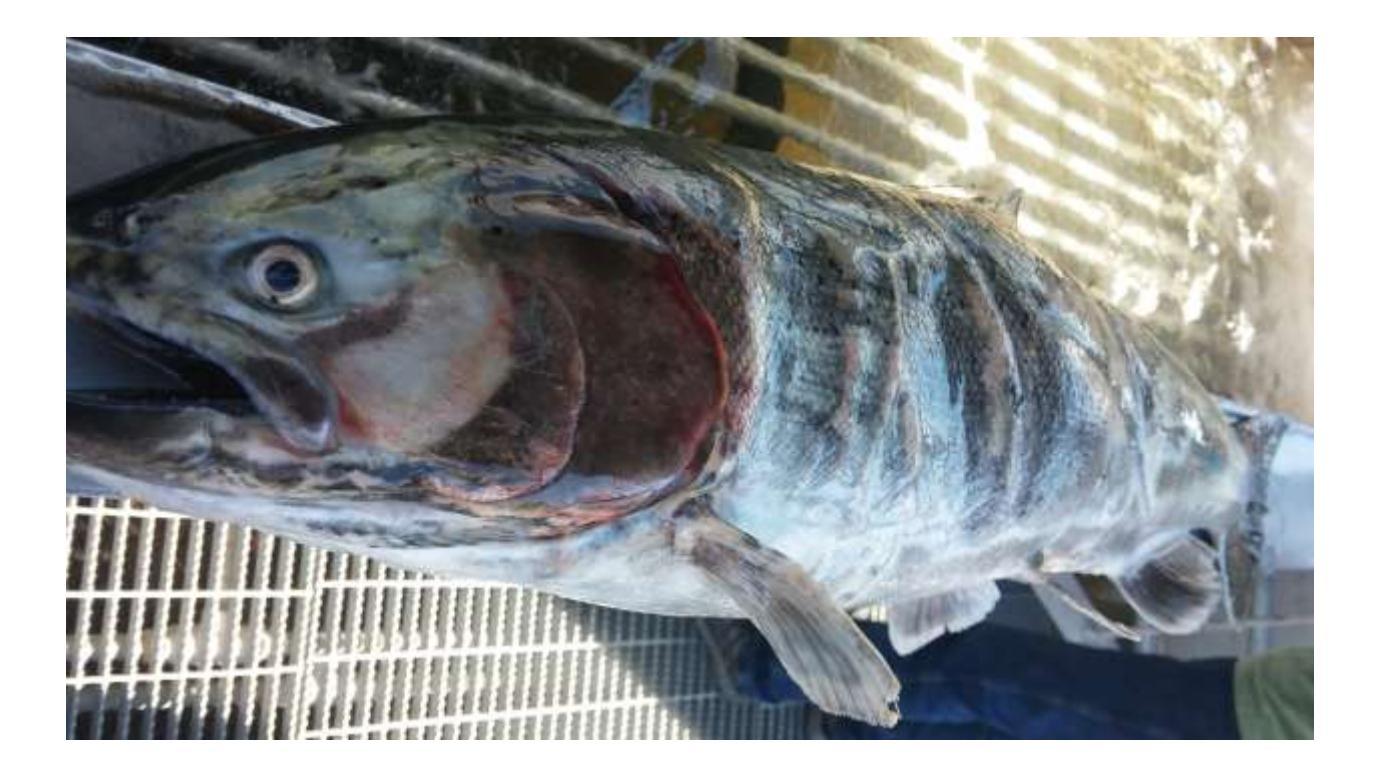
- E. Marks and injuries found on carcass The adult chinook had linear indentations on one side of its body (see photo below), probably from being pressed against sticks that were plugging a gatewell orifice.

- G. Cause and time of death On June 26, at 0830 hours, fish facility personnel went to the juvenile fish channel to cycle and backflush orifices. Three orifices were found to be totally obstructed with debris and two other orifices were partially plugged. As the plugged orifices were being cleared of debris, large amounts (about three 32-gallon buckets, see photo below) of woody debris came into the separator. The adult chinook came into the separator about an hour after orifices were backflushed. The 3 fish probably died from being impinged on debris stuck across orifices. The fish were descaled and were showing early signs of boating, so they were probably dead for at least a day.

- H. Future and preventative measures The project biologist's requested frequency of orifice cycling and backflushing has been four time a day (every 6 hours) this spring. This is being increased to six times a day (every 4 hours). There will be a logbook for personnel to record each time they backflush orifices, to better track when it is being done.
