# **Appendix A**

**2022 Total Dissolved Gas**

**Fixed Monitoring Stations**

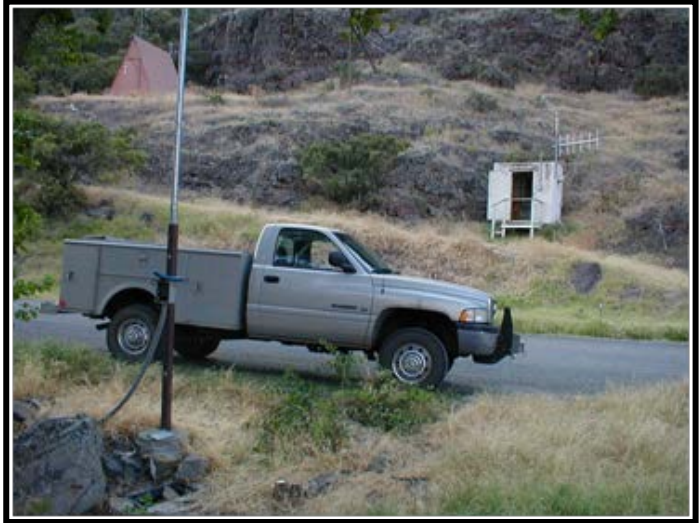
### 3. Anatone TDG Monitoring Station on the Snake River (ANQW)

**Location:** This gauge is located on the Washington shoreline of the Snake River approximately 1.3 miles downstream of the Grande Ronde River confluence. It is co-located with the USGS Anatone Stream gauge (ANAW).

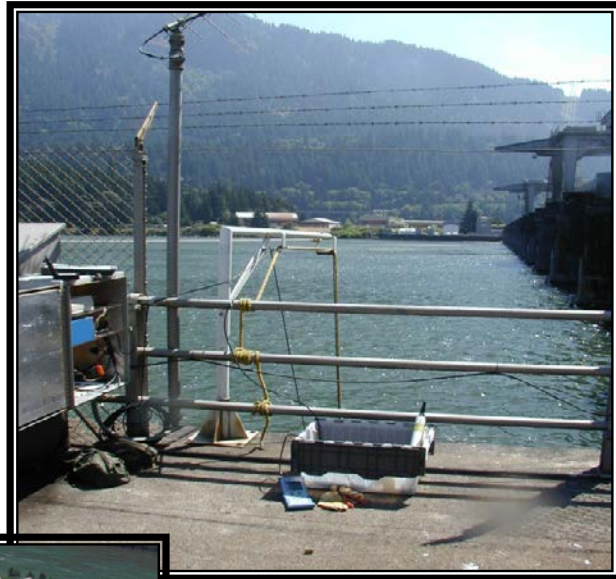
#### 4. Bonneville Forebay TDG Monitoring Station (BON)

**Location:** On the northern side of the spillway channel on Cascade Island just upstream of Spillbay #1.

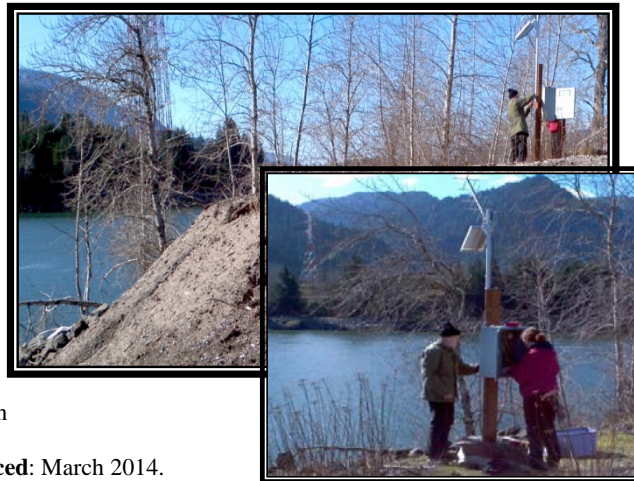
## 6. Cascades Island TDG Monitoring Station (CCIW)

**Location:** Within the Bonneville Dam spillway channel on Cascade Island.

**Reason for replacement:** Old gage destroyed due to high velocity flows.

**Comments:** Became the spill management gauge as of 2004. Location of station moved to higher elevation.

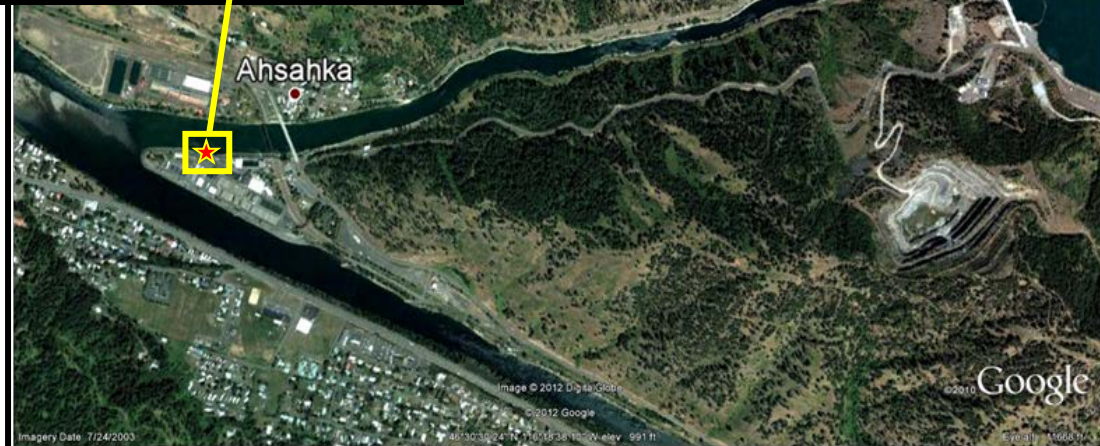
## 9. Dworshak TDG Monitoring Station (DWQI)

**Location:** On the southern bank of the North Fork, Clearwater River between the bridge and the U.S. Fish and Wildlife Service Fish Hatchery outflow pipe.

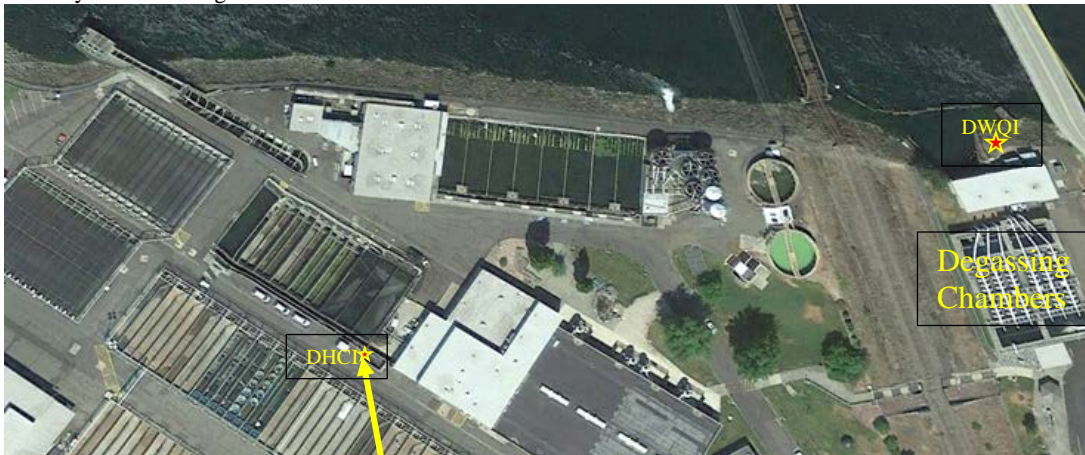
## **10. Dworshak Hatchery Collection Channel TDG Monitoring Station (DHCI)**

**Location:** Gauge is located in a collection channel of the U.S. Fish and Wildlife Service Dworshak National Fish Hatchery.

**Comments:** This gauge is used to assess the TDG levels at Dworshak National Fish Hatchery during Dworshak Dam spill. The water being measured has been treated by the hatchery's vacuum degassers.

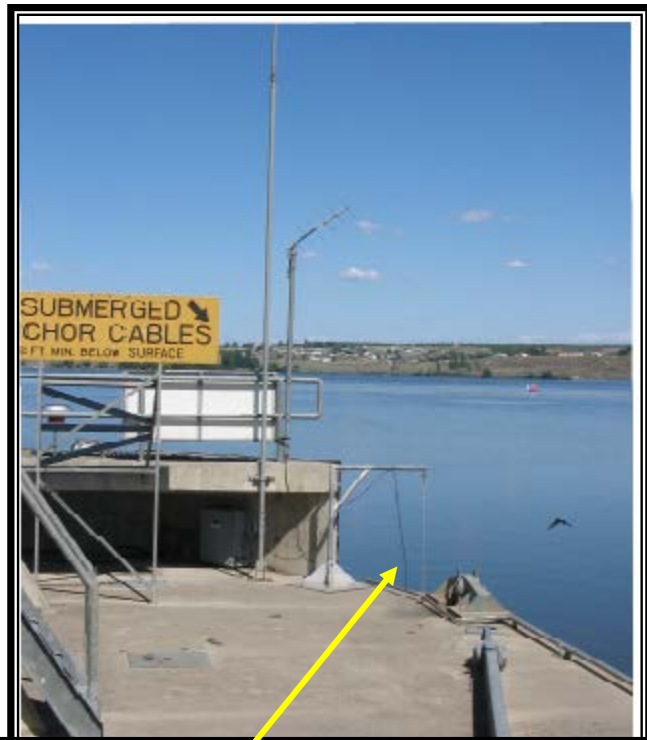
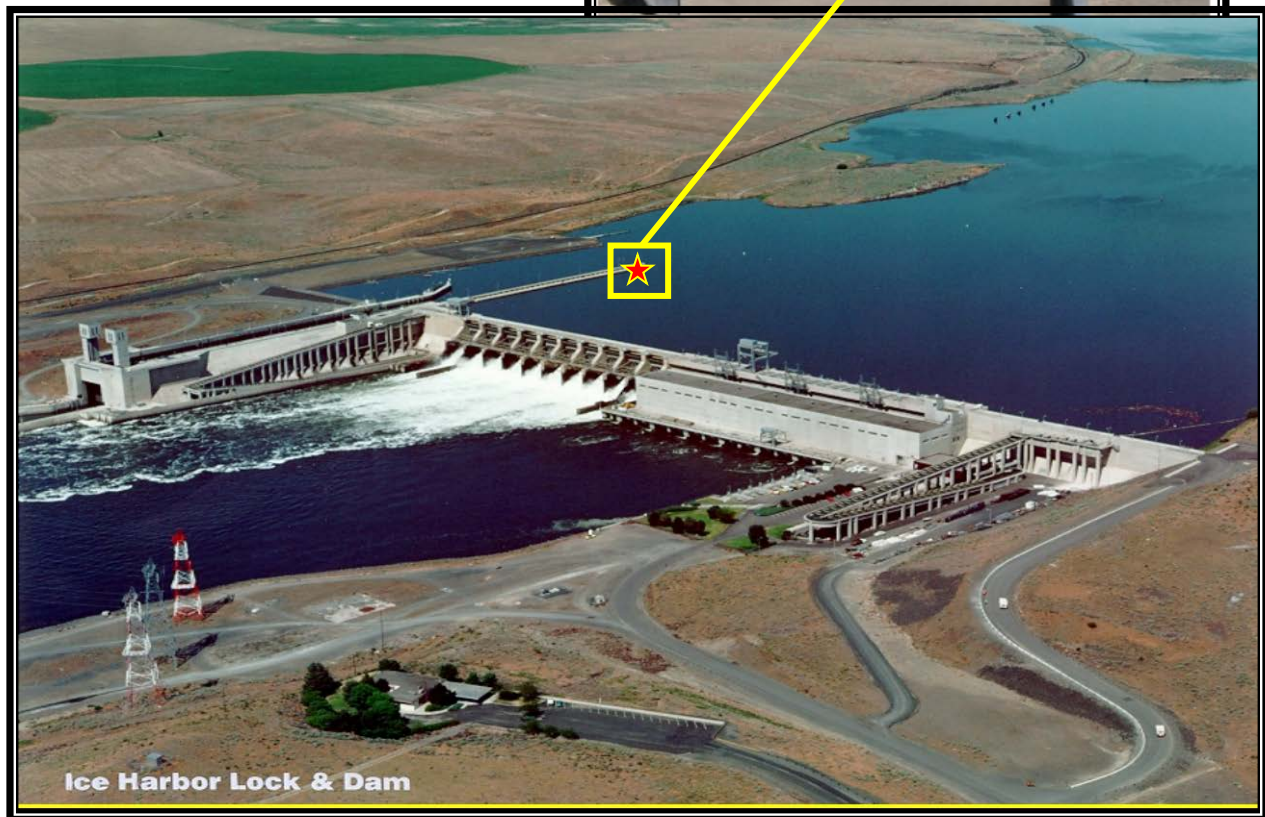
## 11. Ice Harbor Forebay TDG Monitoring Station (IHRA)

**Location:** At the upstream end of the navigation lock guidewall.

**Reason for replacement:** Moved due to thermal influences and lowered from 15 ft to 45 ft.

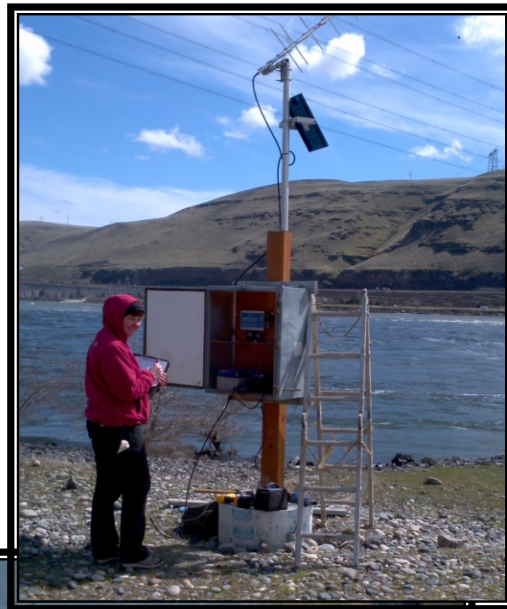
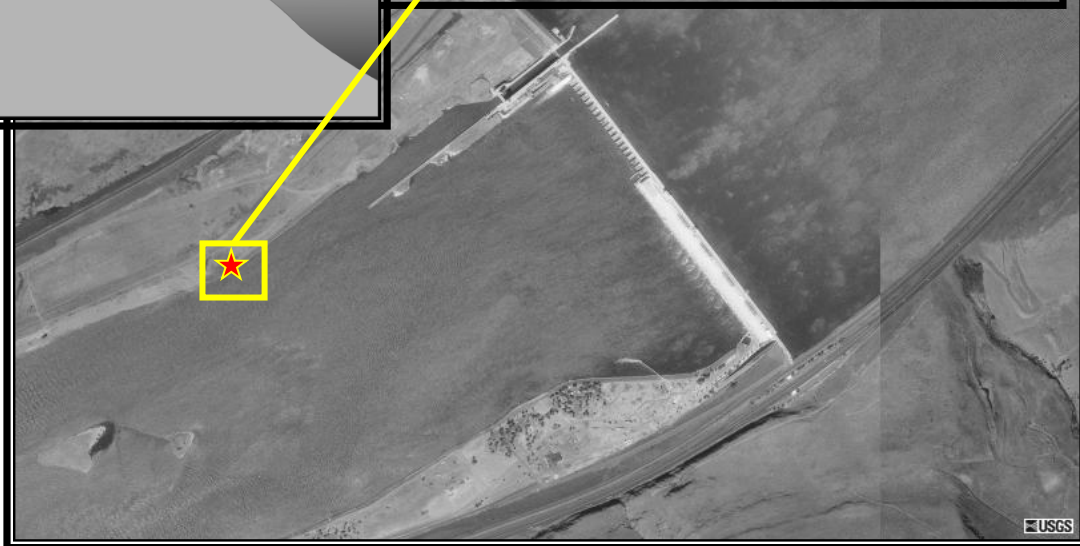
#### 14. John Day Tailwater TDG Monitoring Station (JHAW)

**Location:** Other Washington shore.

**Comments:** Location of station moved about 12 feet higher elevation from shore, further up the hill.

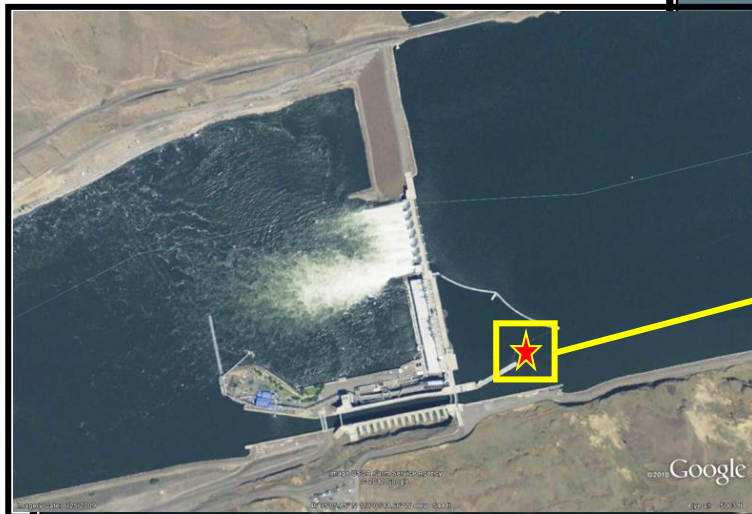
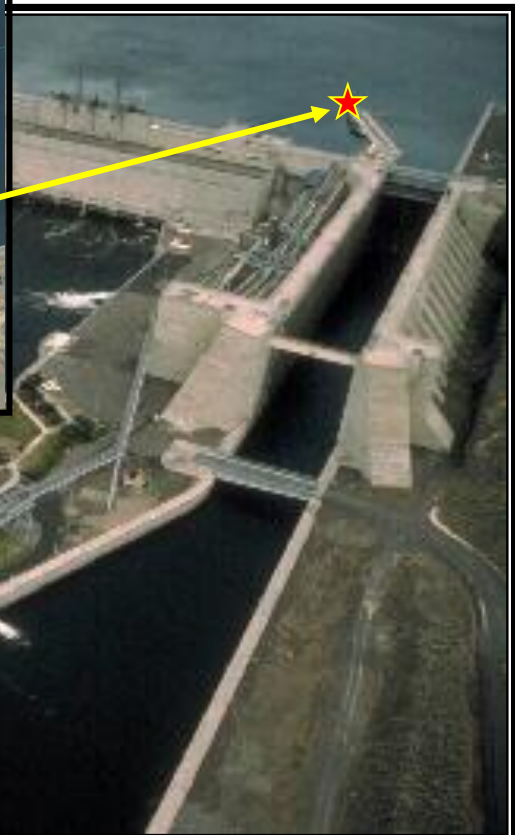
## 16. Little Goose Forebay TDG Monitoring Station (LGSA)

**Location:** At the upstream end of the navigation lock guidewall.

**Reason for replacement:** Move due to thermal influences and lowered from 15 ft to 45 ft.

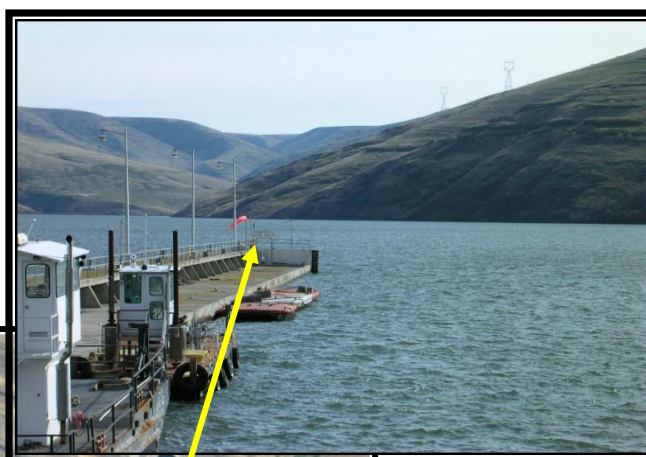
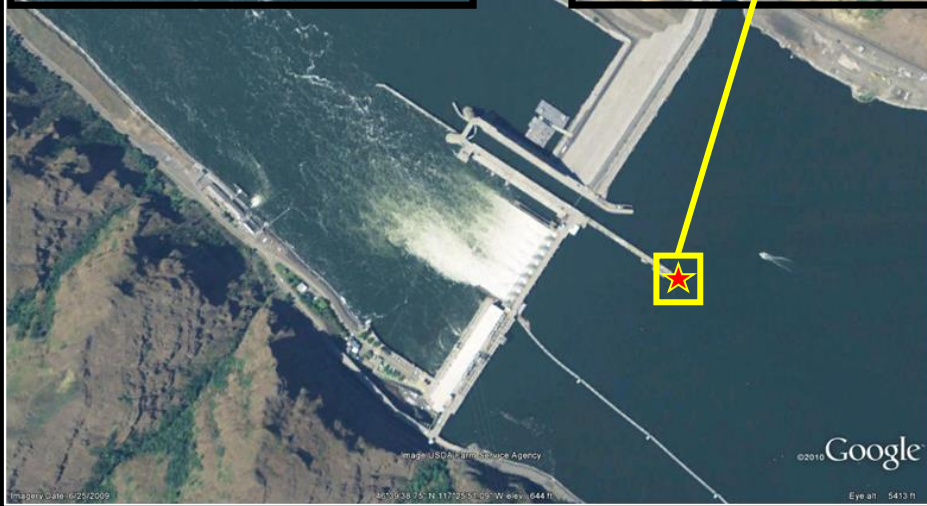
## 18. Lower Granite Forebay TDG Monitoring Station (LWG)

**Location:** At the upstream end of the navigation lock guidewall.

**Reason for replacement:** In March, 2005, this gauge was moved from a depth of 15 ft to 45 ft to avoid thermal influences. The geographic location of the gauge was not changed.
