Appendix A

2023 Total Dissolved Gas

Fixed Monitoring Stations

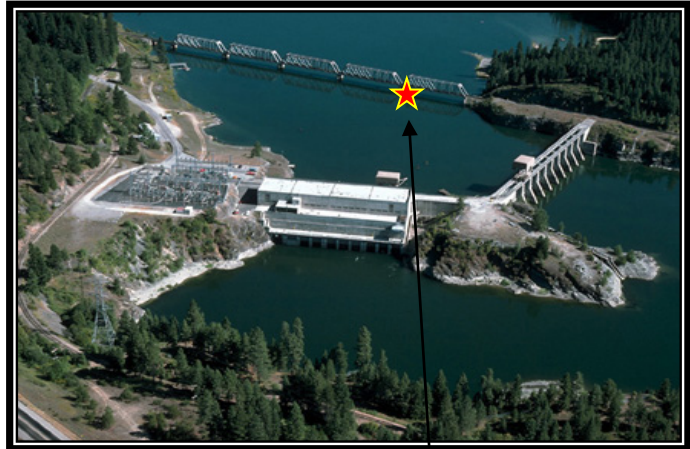
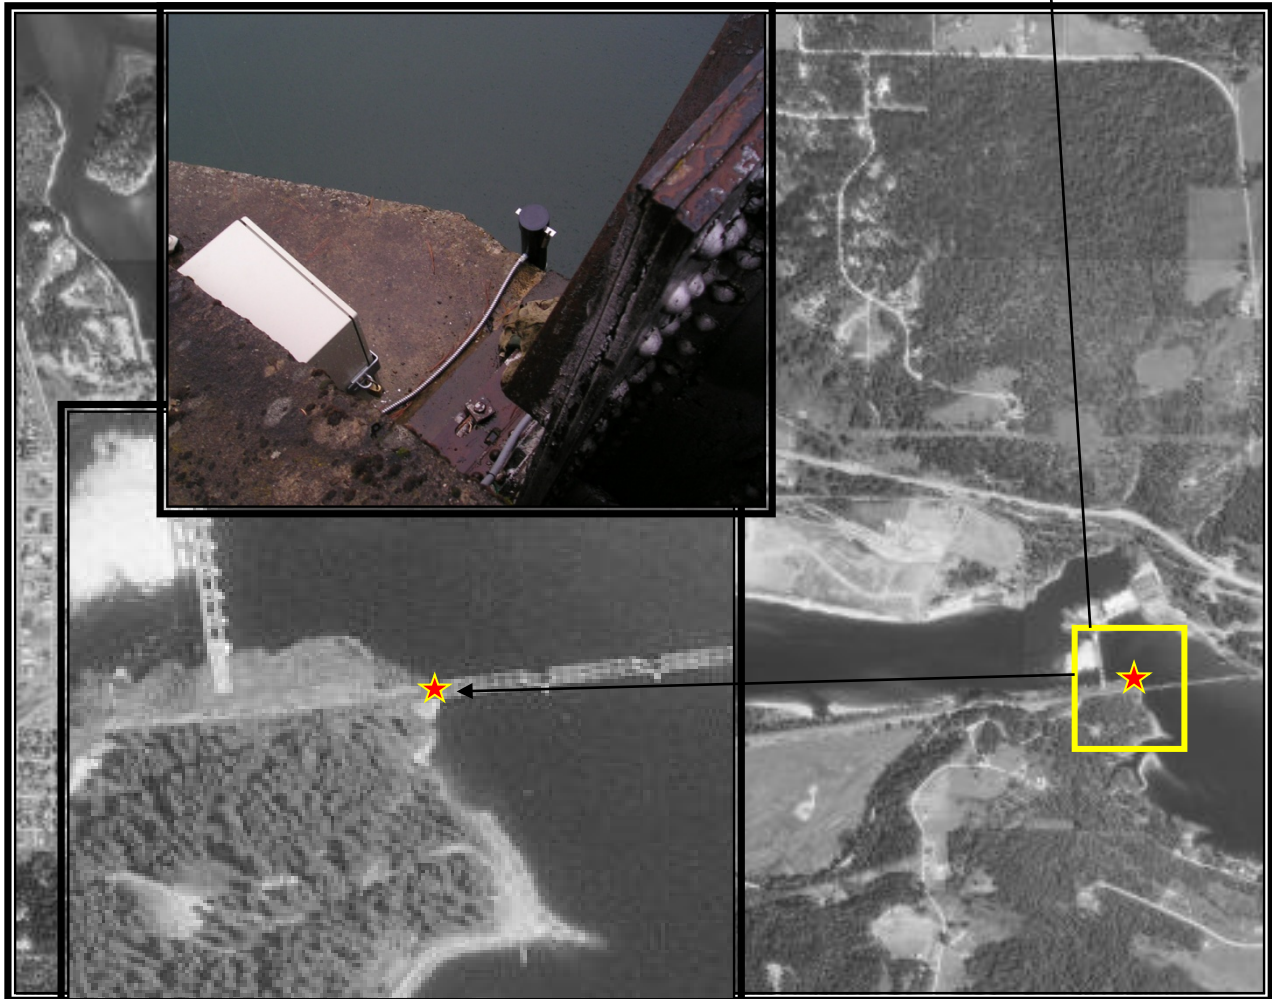
1. Albeni Falls Forebay TDG Monitoring Station (ALFI)

Gauge Type: Hydrosonde

Location: Attached to the railroad bridge pier on the southern shoreline of the Pend Oreille River

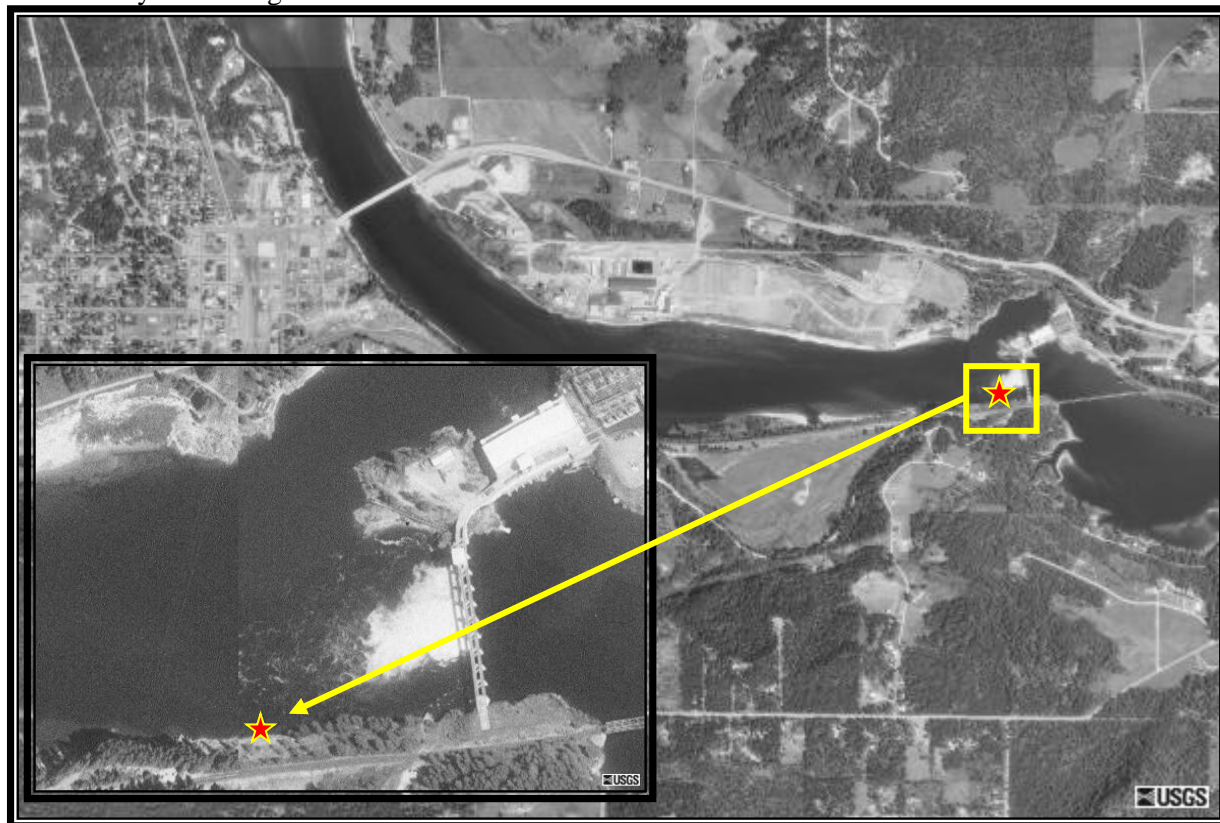
2. Albeni Falls Tailwater TDG Monitoring Station (ALQI)

Location: On the southern shoreline of the Pend Oreille River.

Reasons for replacement: This gauge was initiated at this site on July 28, 2005 due to sediment burying the previous site several times. This newer location is immediately below the spillway aerated zone in deeper water which should minimize sedimentation problems.

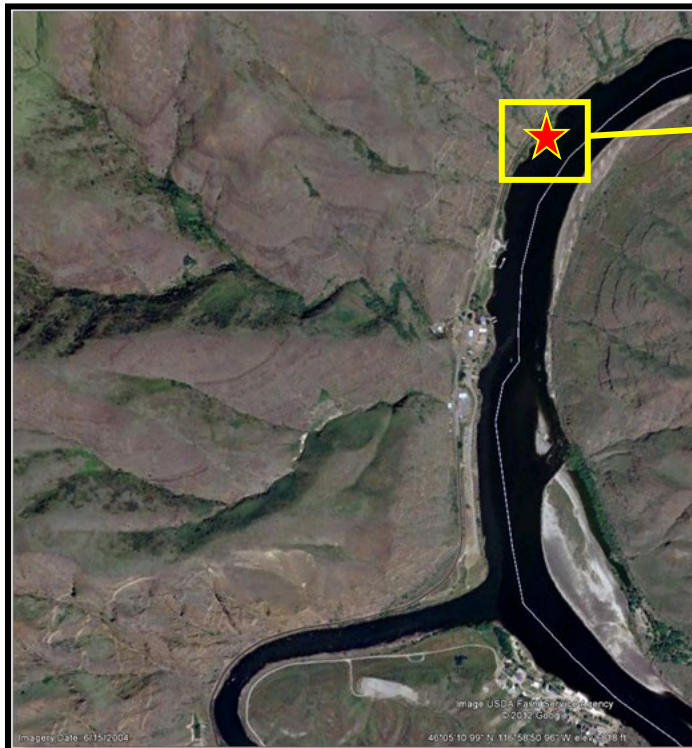
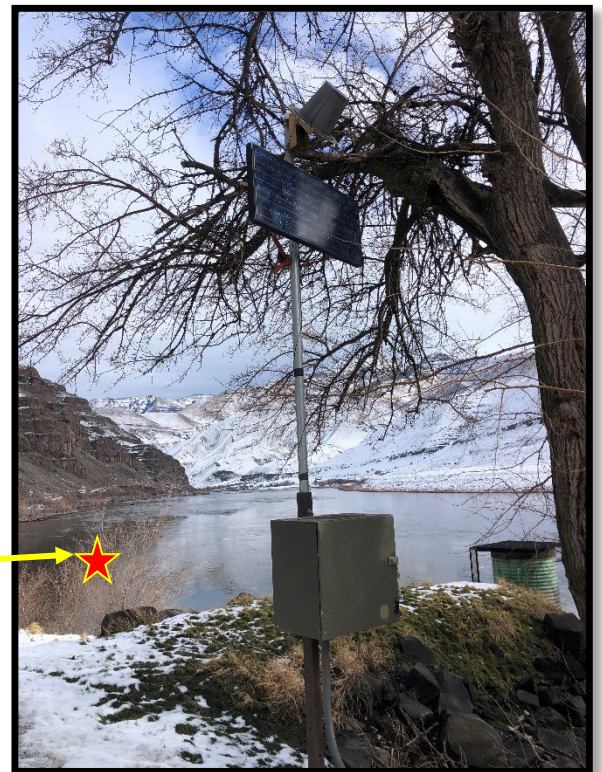
3. Anatone TDG Monitoring Station on the Snake River (ANQW)

Location: This gauge is located on the Washington shoreline of the Snake River approximately 1.3 miles downstream of the Grande Ronde River confluence. It is located 30-ft downstream of USGS Anatone Stream gauge (ANAW).

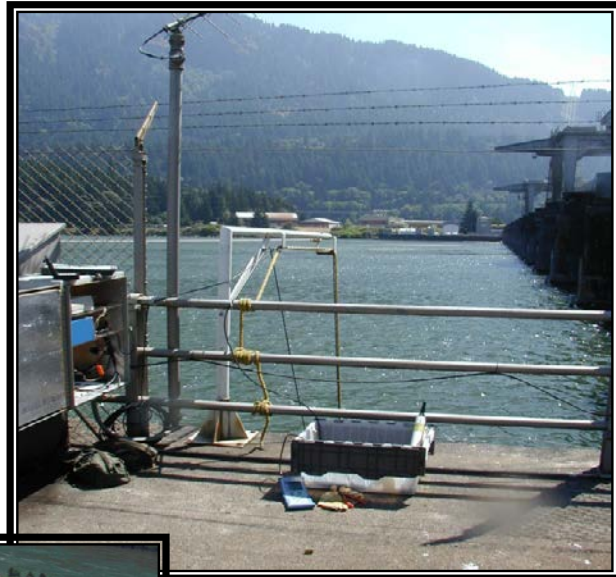
4. Bonneville Forebay TDG Monitoring Station (BON)

Location: On the northern side of the spillway channel on Cascade Island just upstream of Spillbay #1.

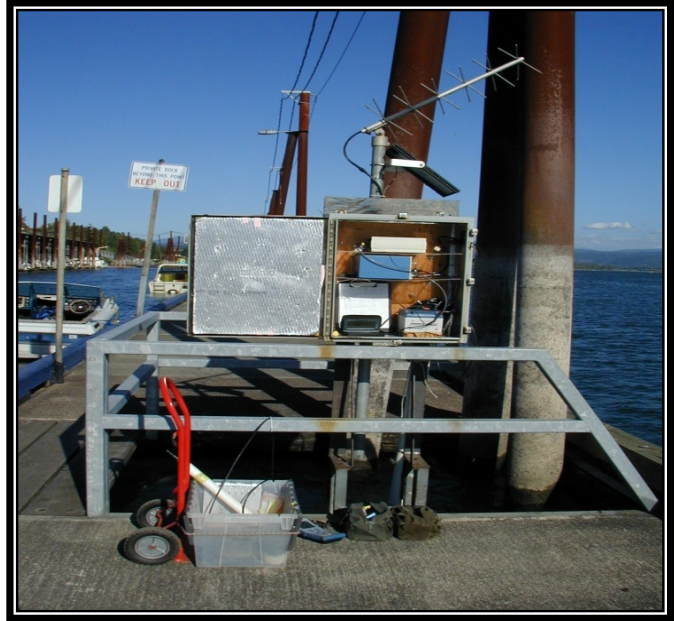
5. Camas-Washougal TDG Monitoring Station (CWMW)

Gage Elevation: Variable
Latitude: 45° 34' 38.42788" N
Longitude: 122° 22' 43.32961" W
Distance from Dam: 24 miles downstream from Bonneville
Datum: NAD83
River: Columbia
River Mile: 121.7
USGS-ID: 453439122223900
Owner: U.S. Army Corps of Engineers-NWP
Gauge Type: Hydrosonde
Data Transmission: GOES Satellite
Dates of Operation: April 1 – August 31*
Years of Operation: 1993 – 2020
Water Conditions: Mixed
Location: Attached to the boat dock at the outer edge of the harbor at the Port of Camas/Washougal, WA
This gage replaced: N/A
Reason for replacement: N/A
Comments: This gauge is currently being utilized as a surrogate forebay gauge for the management of spill at Bonneville Dam.

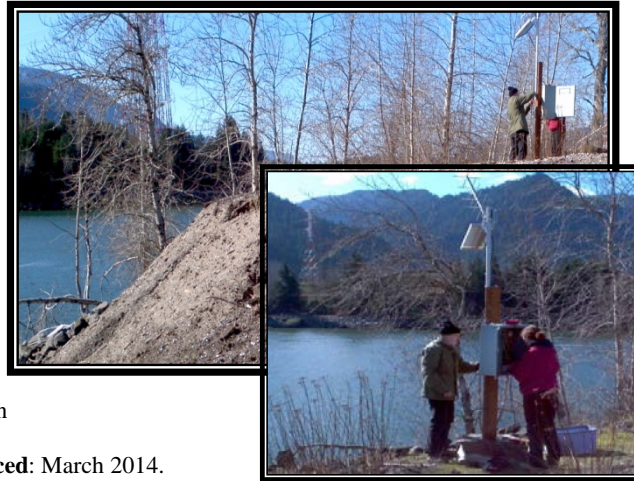
6. Cascades Island TDG Monitoring Station (CCIW)

Location: Within the Bonneville Dam spillway channel on Cascade Island.

Reason for replacement: Old gage destroyed due to high velocity flows.

Comments: Became the spill management gauge as of 2004. Location of station moved to higher elevation.

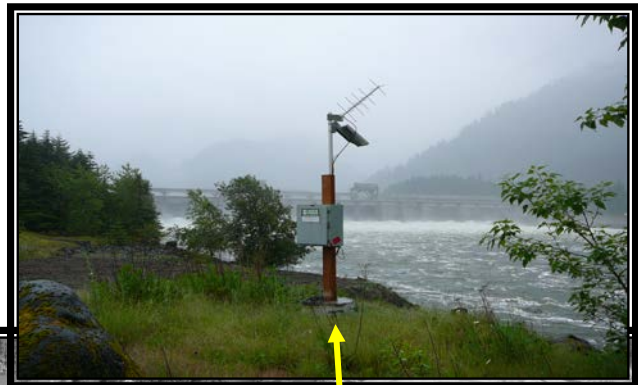
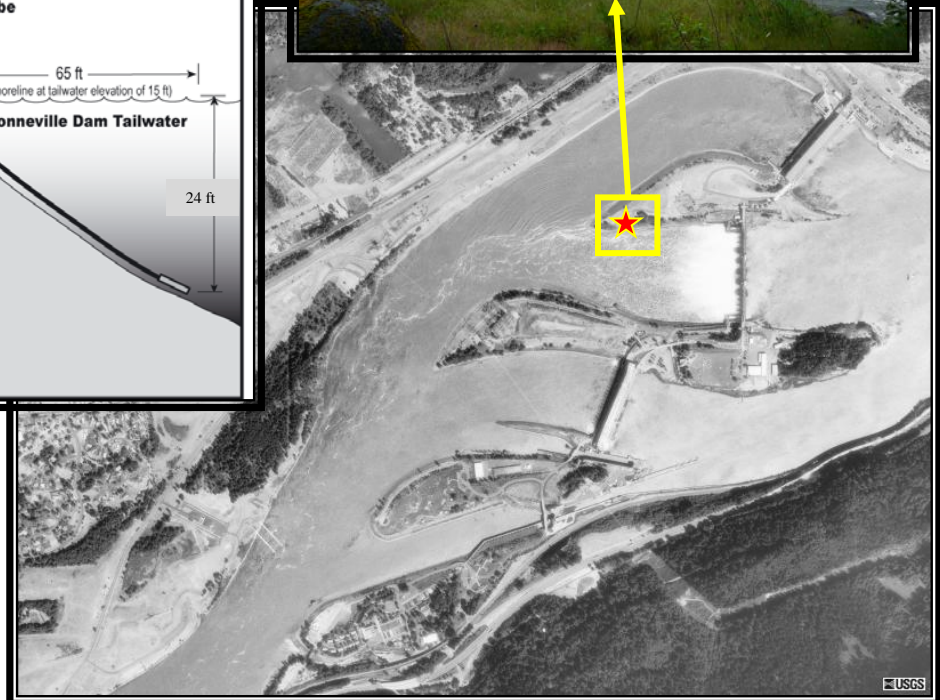
This gage replaced: September 2011; **Probe pipes replaced:** March 2014.

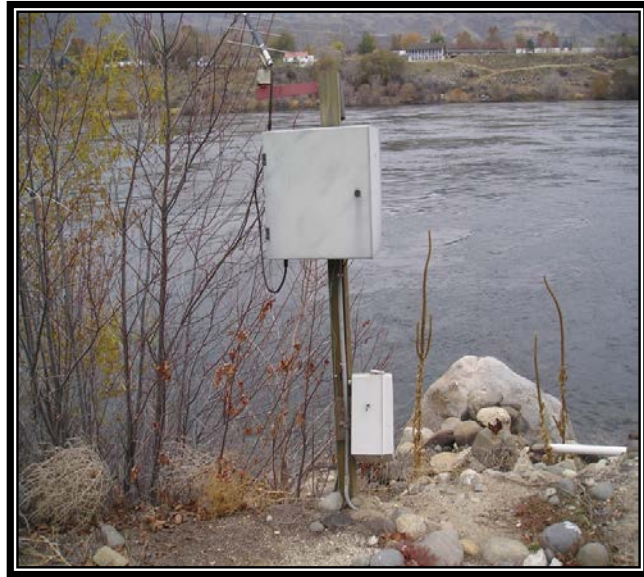
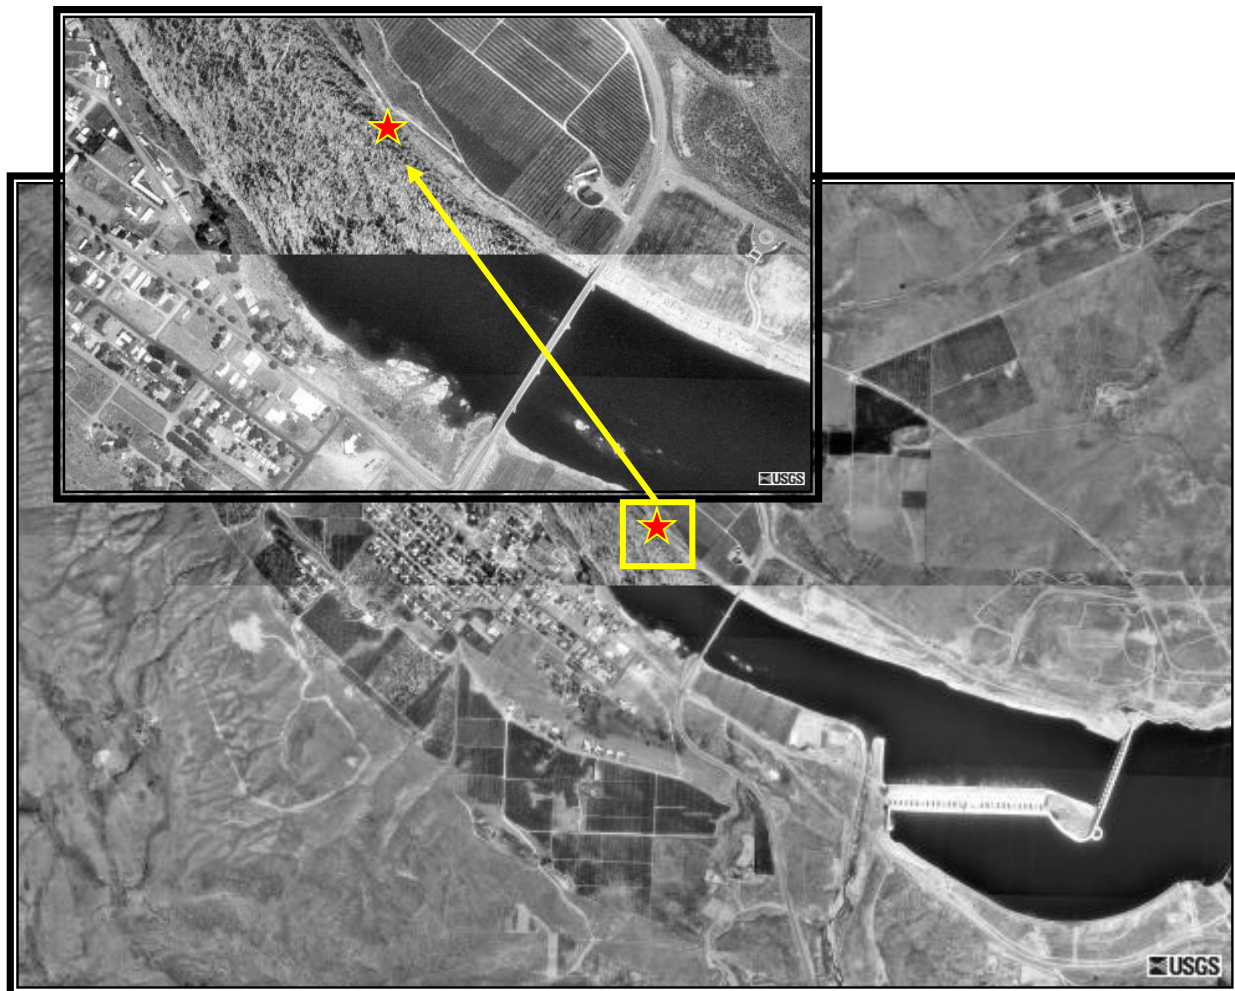
8. Chief Joseph Tailwater TDG Monitoring Station (CHQW)

Location: North bank of the river, just downstream of the Highway 17 Bridge.

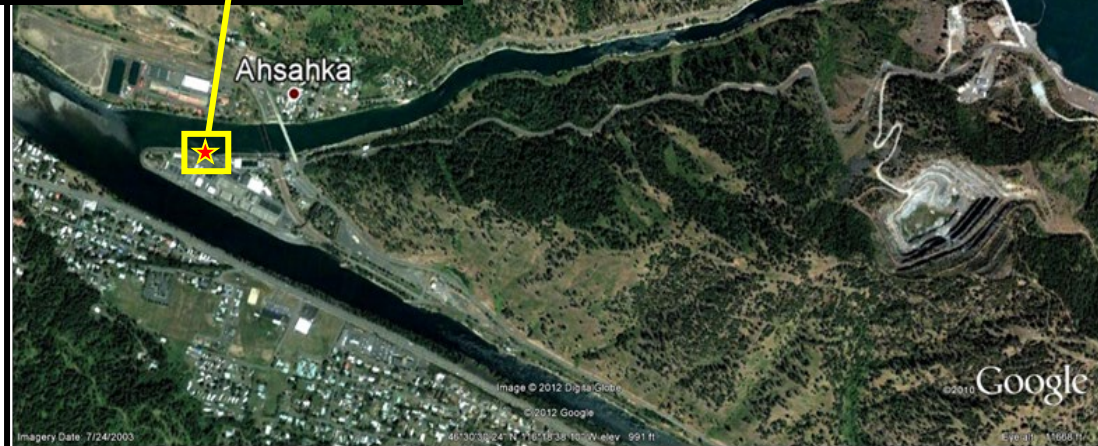
9. Dworshak TDG Monitoring Station (DWQI)

Location: On the southern bank of the North Fork, Clearwater River between the bridge and the Dworshak National Fish Hatchery outflow pipe.

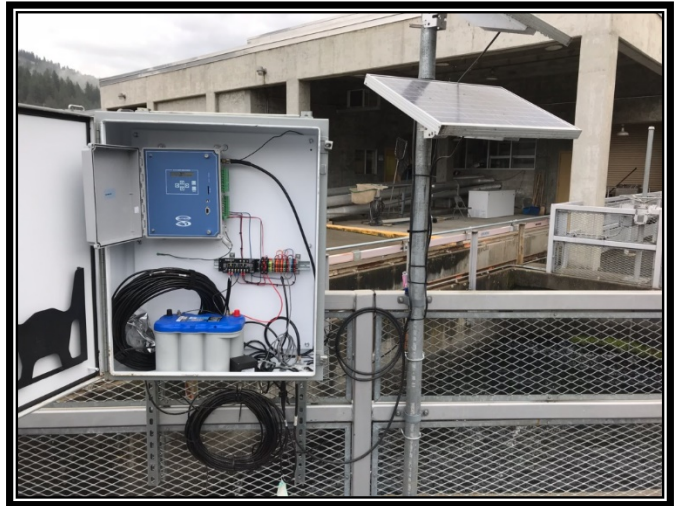
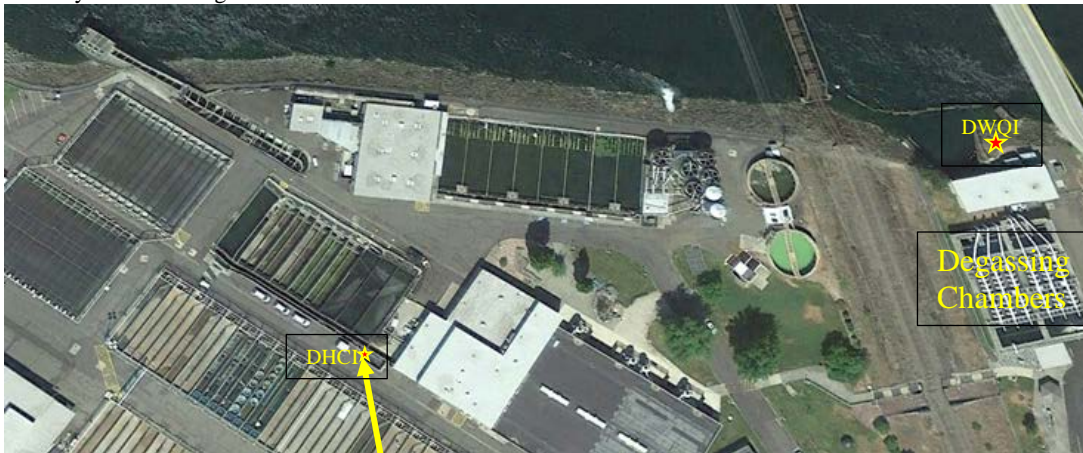
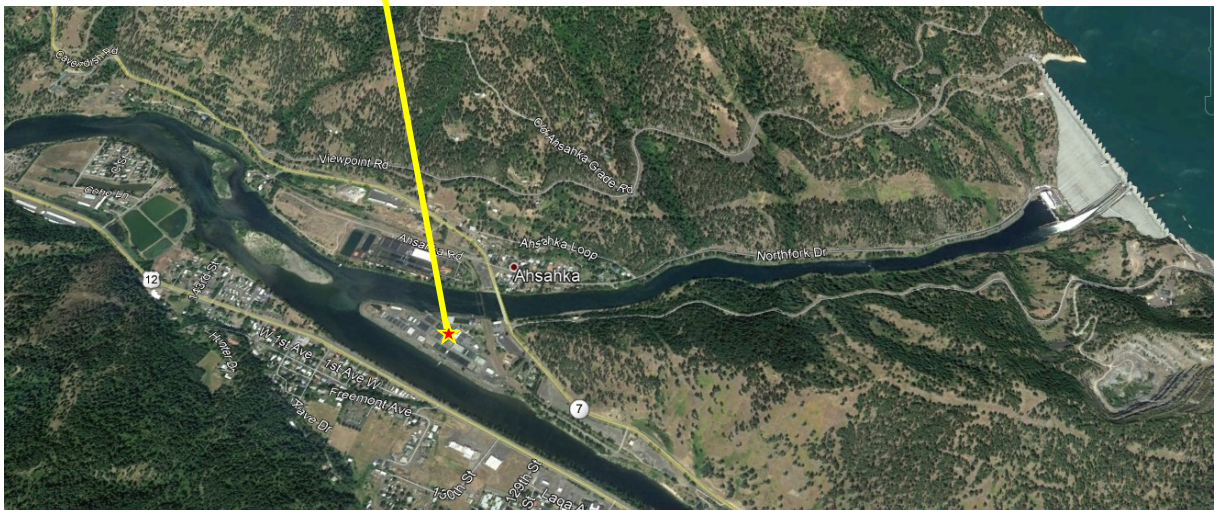
10. Dworshak Hatchery Collection Channel TDG Monitoring Station (DHCI)

Location: Gauge is located in a collection channel of the U.S. Fish and Wildlife Service Dworshak National Fish Hatchery.

Comments: This gauge is used to assess the TDG levels at Dworshak National Fish Hatchery during Dworshak Dam spill. The water being measured has been treated by the hatchery's vacuum degassers.

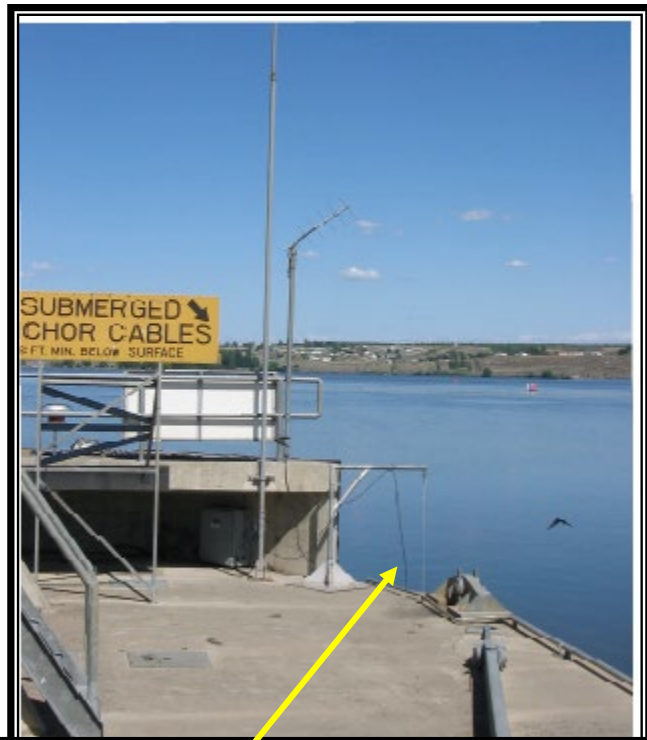
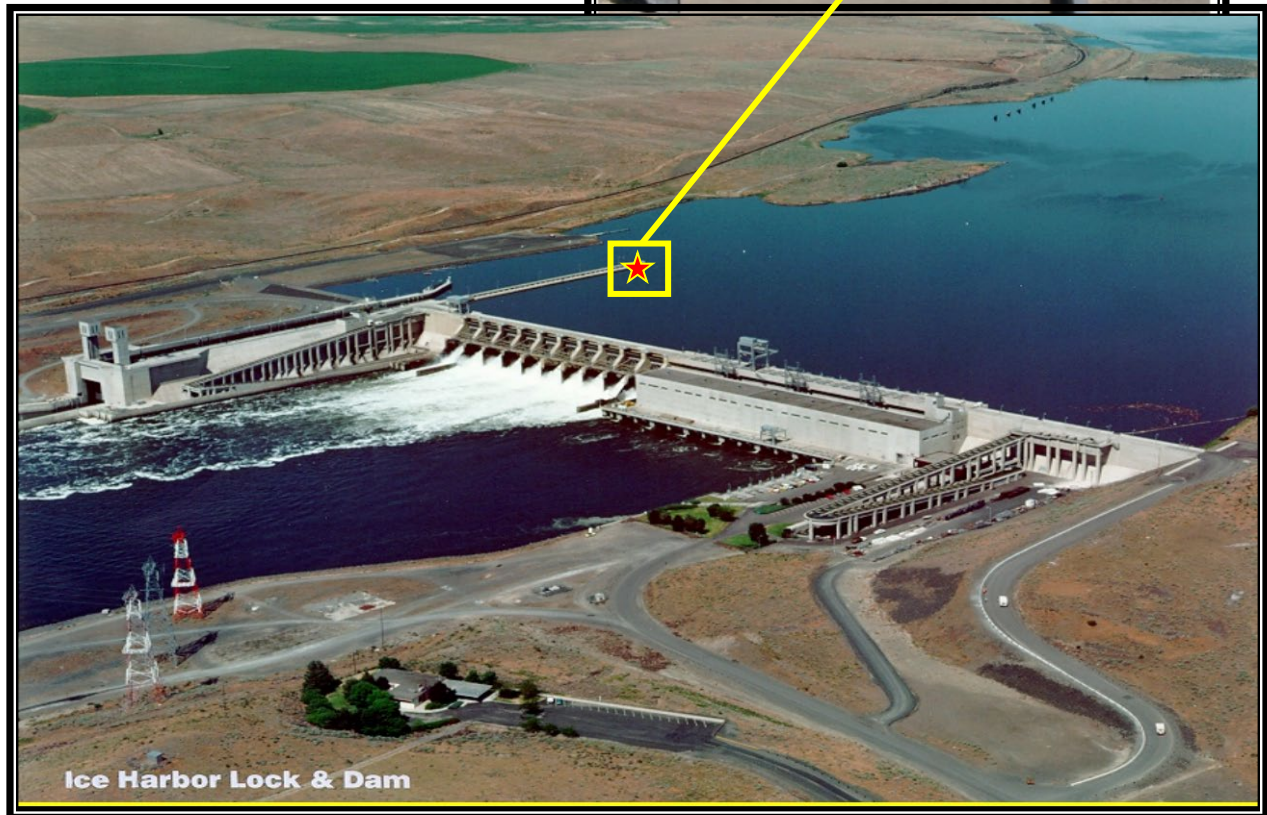
11. Ice Harbor Forebay TDG Monitoring Station (IHRA)

Location: At the upstream end of the navigation lock guidewall.

Reason for replacement: Moved due to thermal influences and lowered from 15 ft to 45 ft.

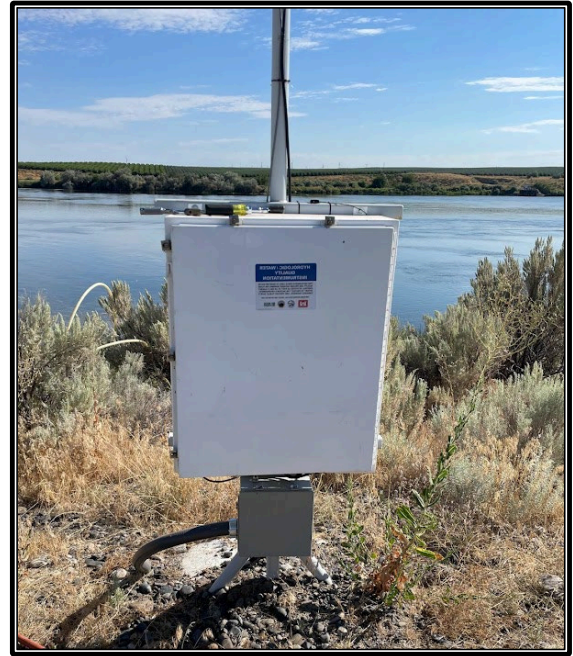
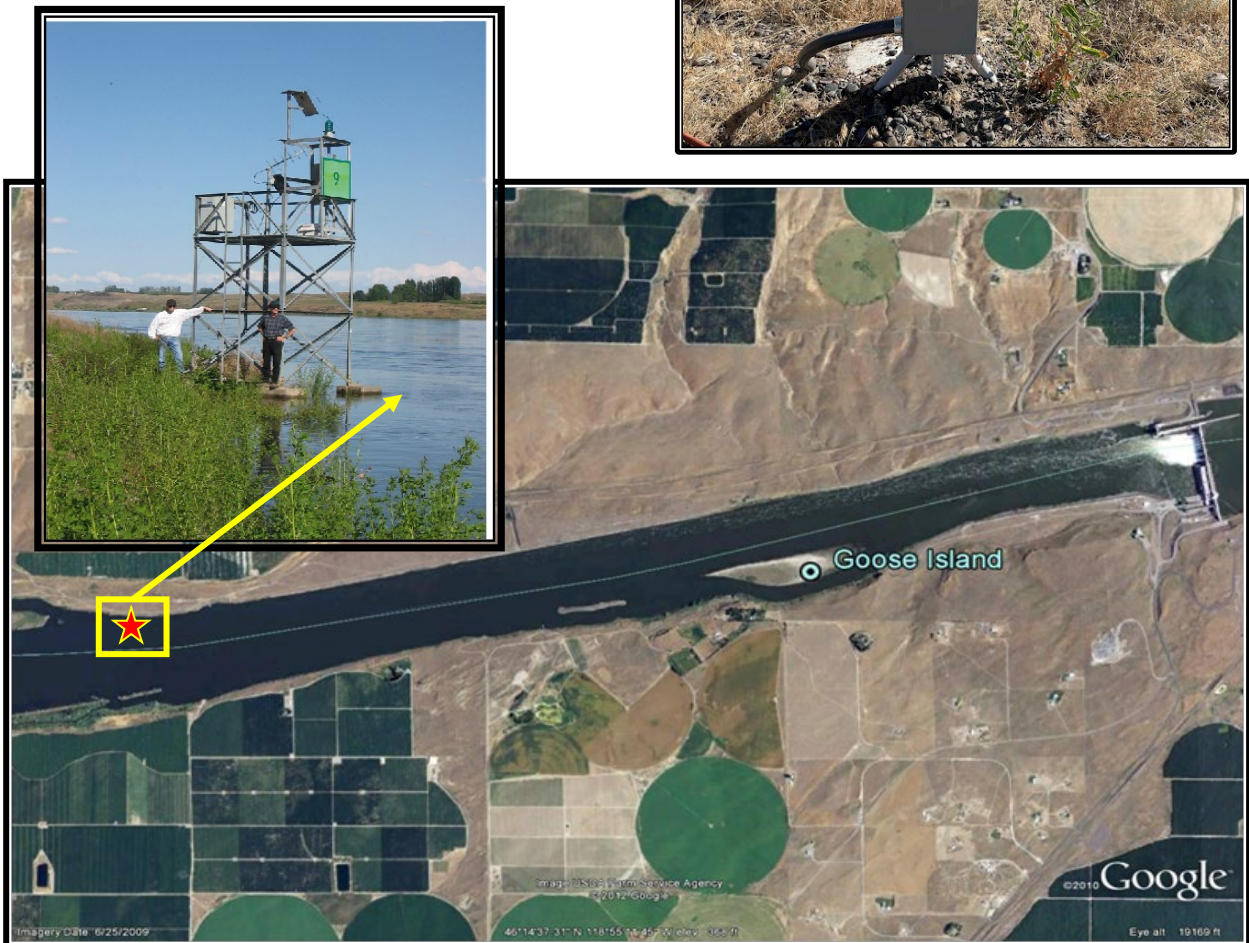
12. Ice Harbor Tailwater TDG Monitoring Station (IDSW)

Location: On the northern shore of the Snake River

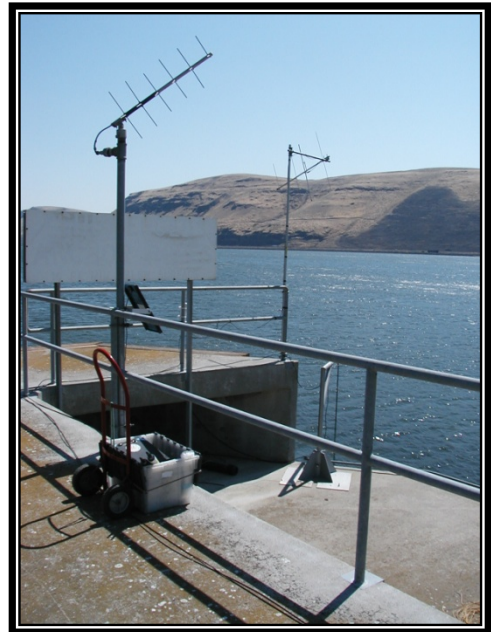
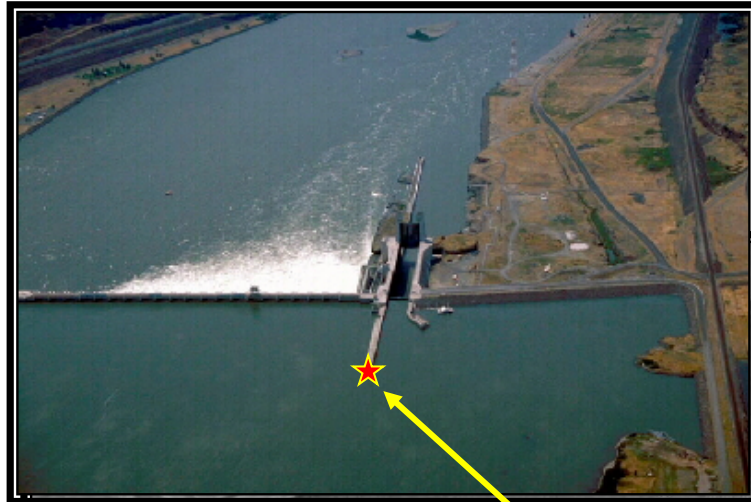
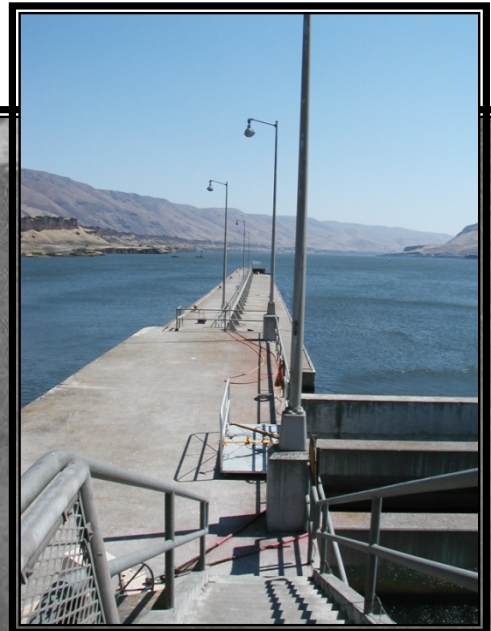
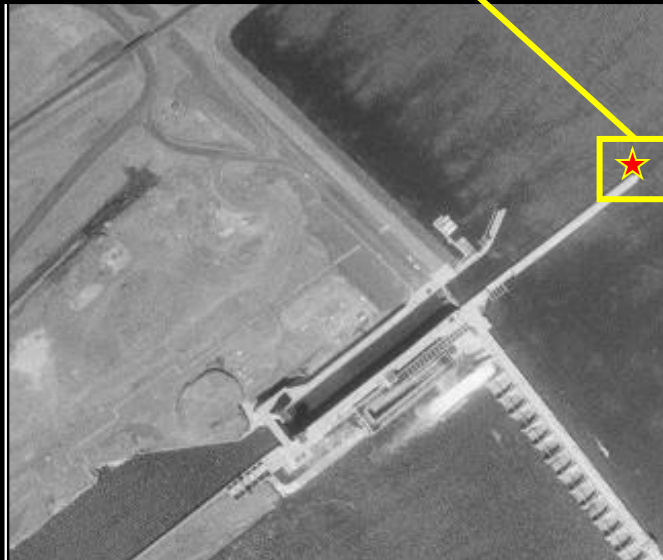
13. John Day Forebay TDG Monitoring Station (JDY)

Location: At upstream end of the navigation lock guidewall.

Reason for replacement: Moved due to thermal influences and lowered from 15 ft to 45 ft.

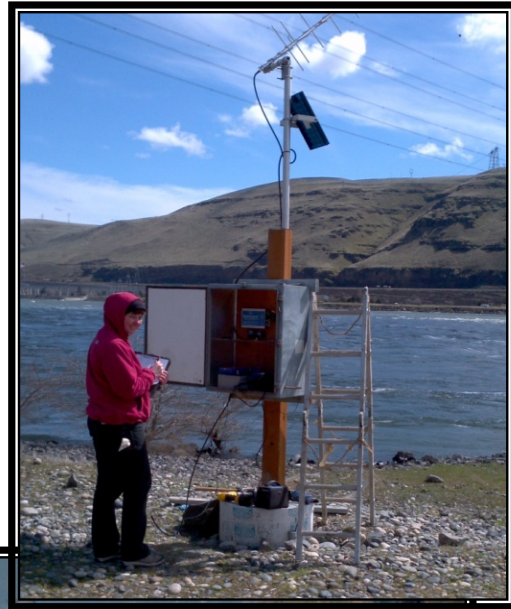
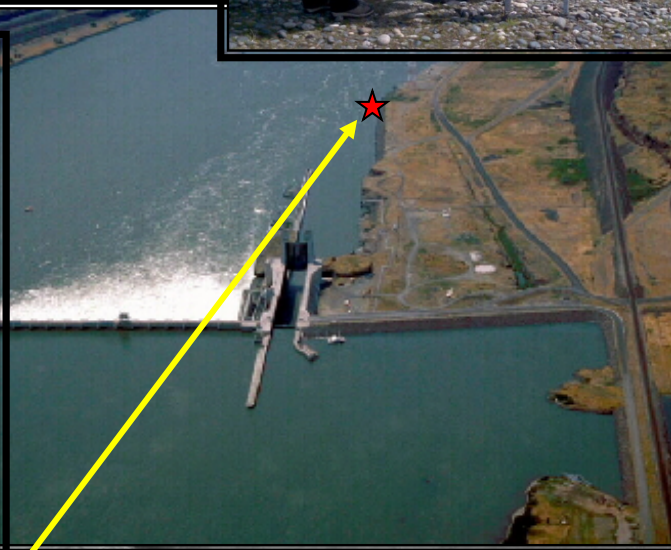
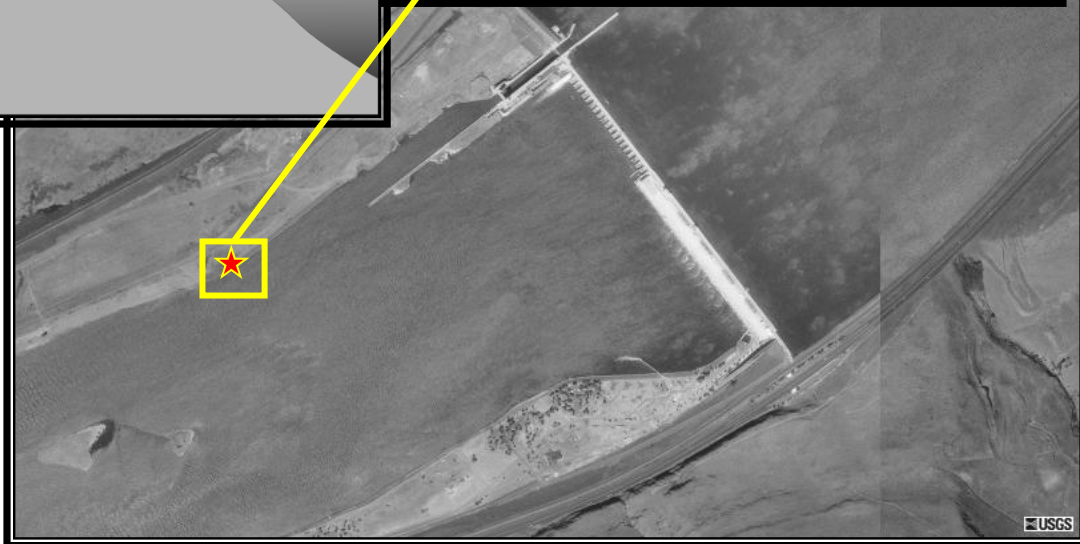
14. John Day Tailwater TDG Monitoring Station (JHAW)

Location: Other Washington shore.

Comments: Location of station moved about 12 feet higher elevation from shore, further up the hill.

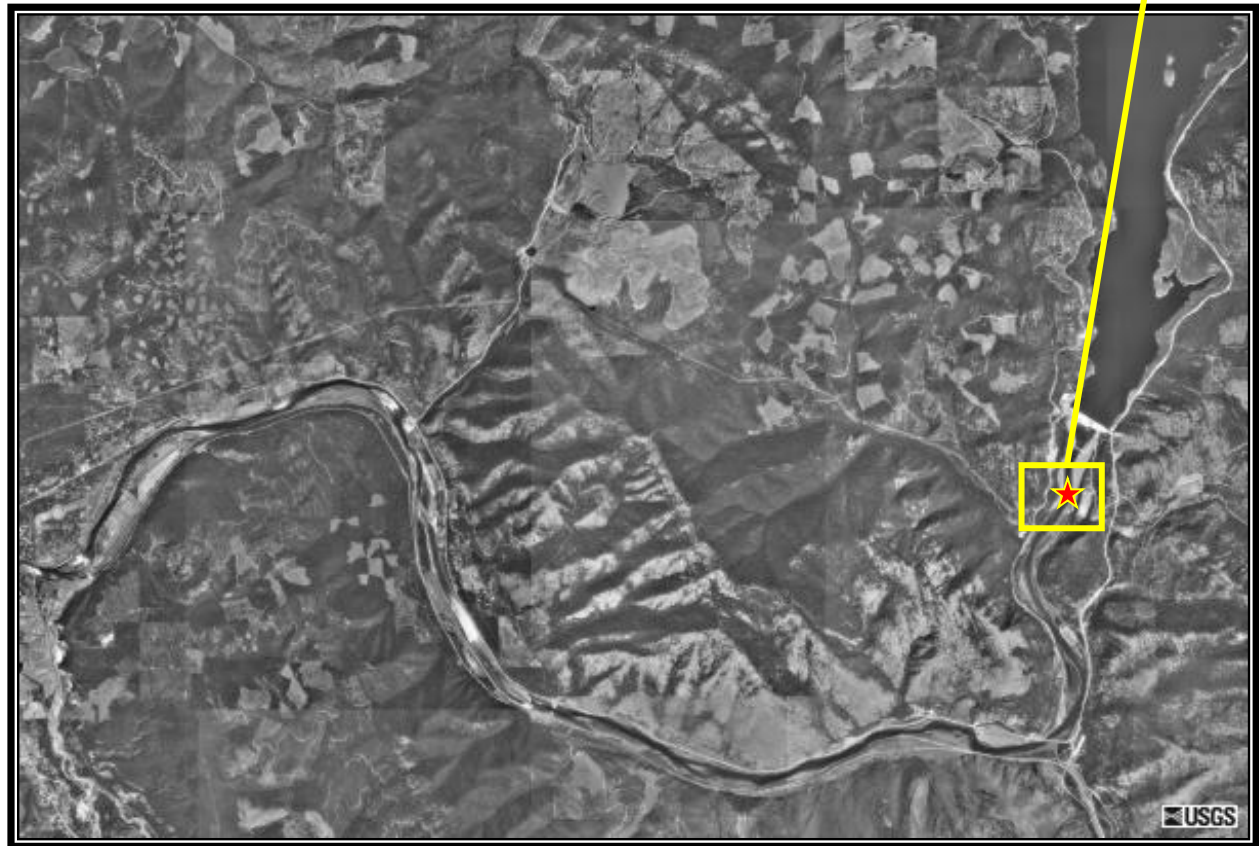
15. Libby Tailwater TDG Monitoring Station (LBQM)

Location: This gauge is located on the eastern shore of the Kootenai River approximately 750 feet downstream of the Libby Dam access road bridge.

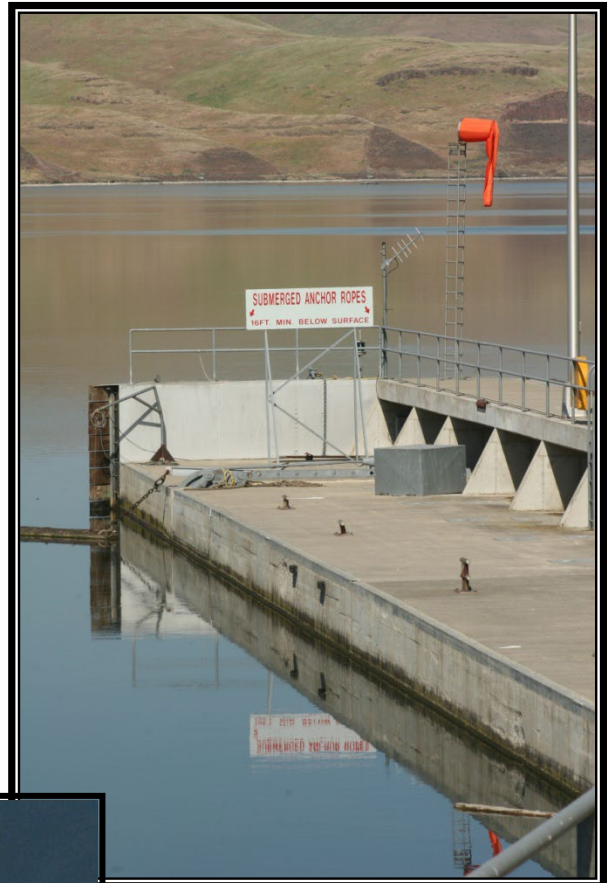
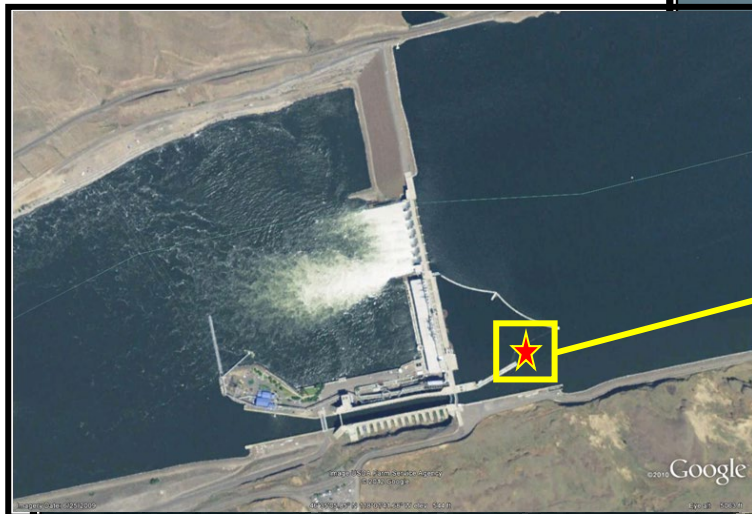
16. Little Goose Forebay TDG Monitoring Station (LGSA)

Location: At the upstream end of the navigation lock guidewall.

Reason for replacement: Moved due to thermal influences and lowered from 15 ft to 45 ft.

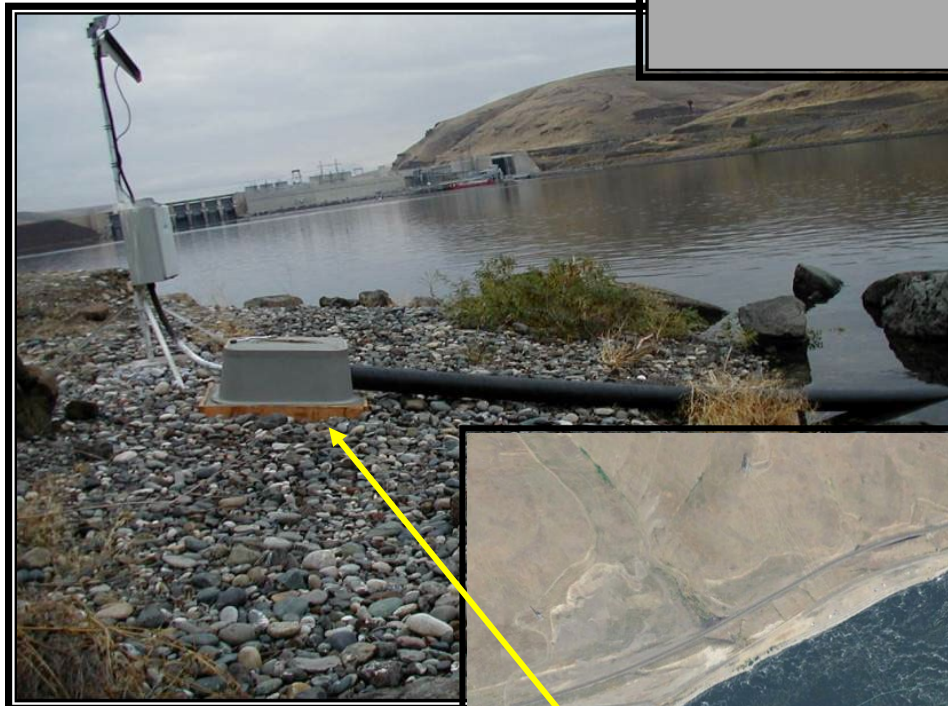
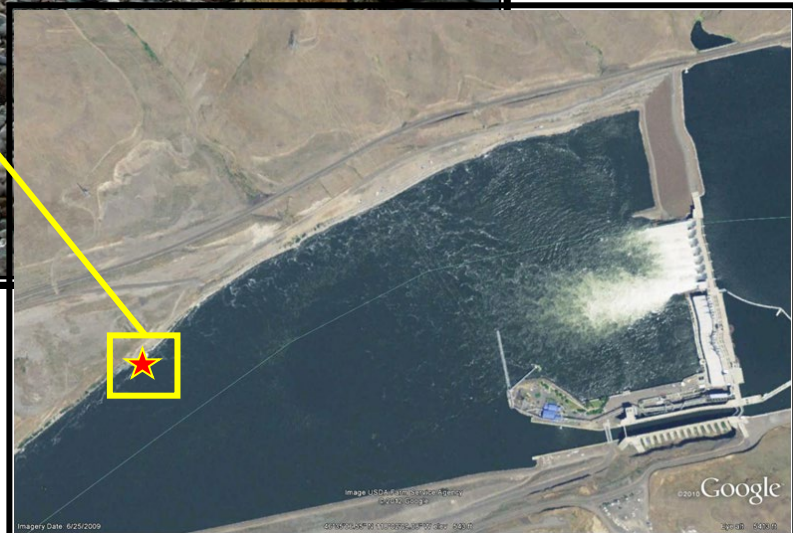
17. Little Goose Tailwater TDG Monitoring Station (LGSW)

Location: On the northern shore of the Snake River

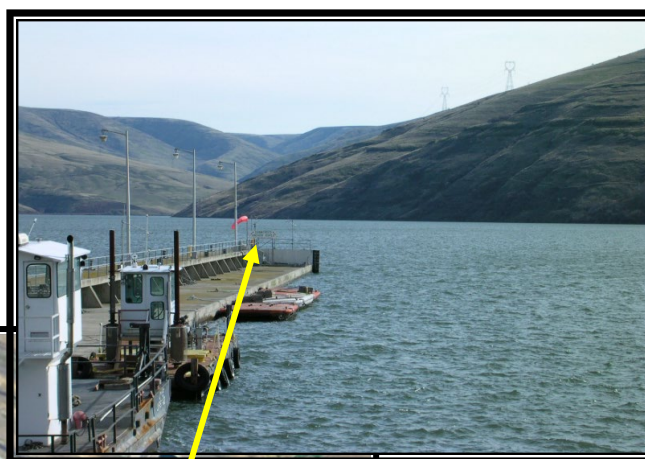
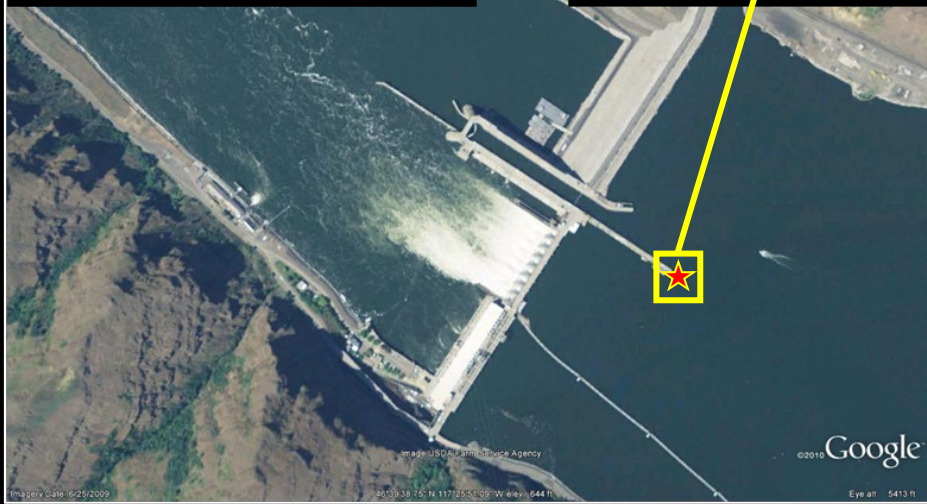
18. Lower Granite Forebay TDG Monitoring Station (LWG)

Location: At the upstream end of the navigation lock guidewall.

Reason for replacement: In March, 2005, this gauge was moved from a depth of 15 ft to 45 ft to avoid thermal influences. The geographic location of the gauge was not changed.

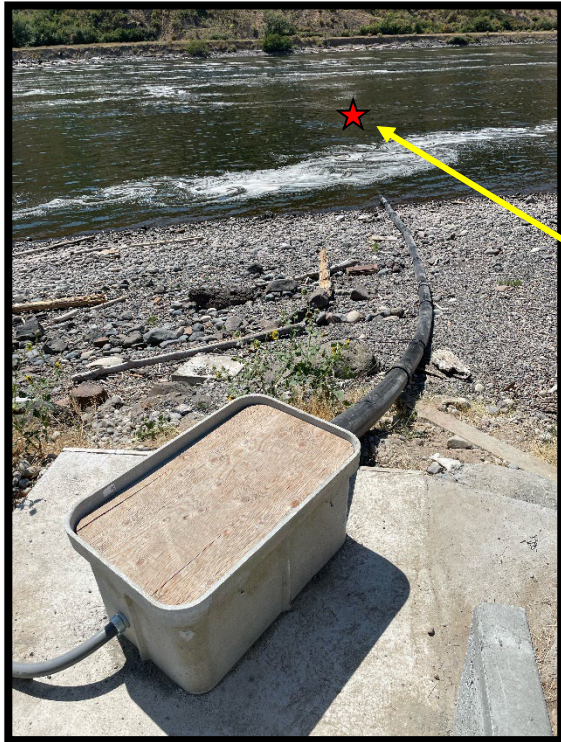
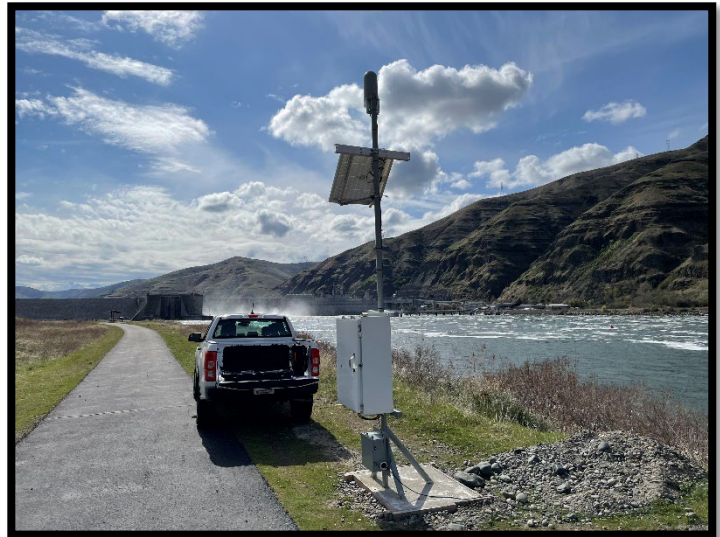
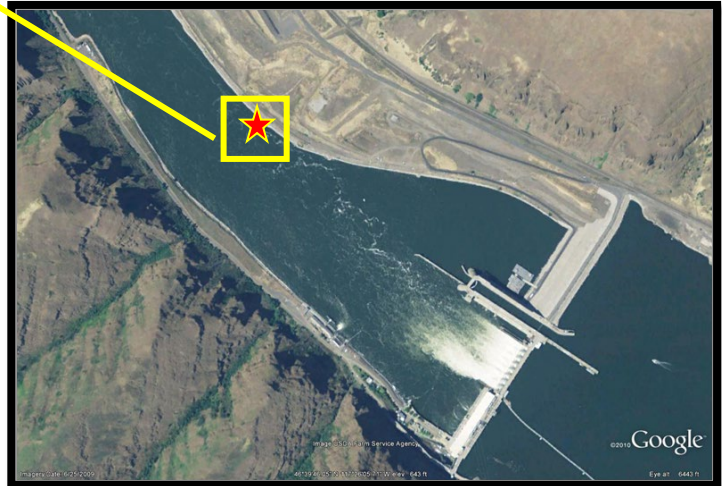
19. Lower Granite Tailwater TDG Monitoring Station (LGNW)

Location: On the northeastern shore of the Snake River.

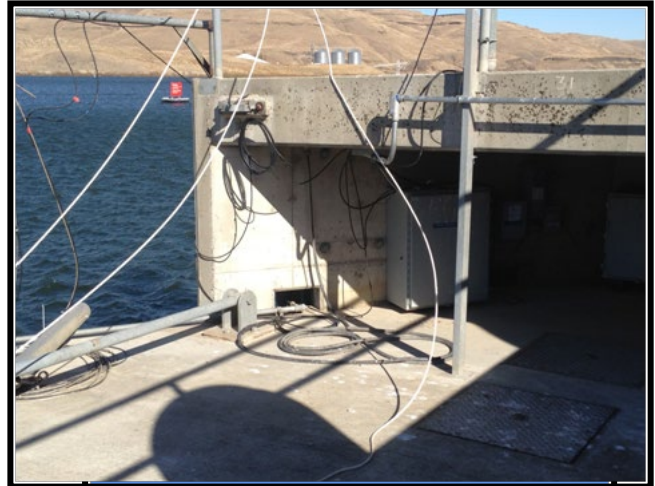
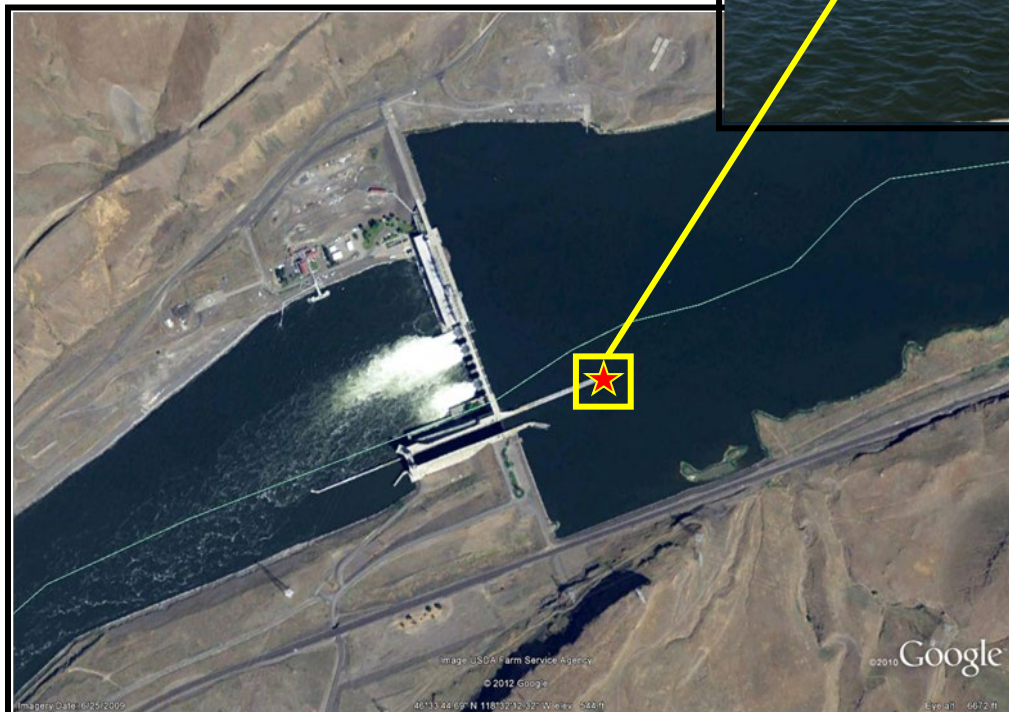
20. Lower Monumental Forebay TDG Monitoring Station (LMNA)

Location: At the upstream end of the navigation lock guidewall.

Reason for replacement: Moved due to thermal influences and lowered from 15 ft to 45 ft.

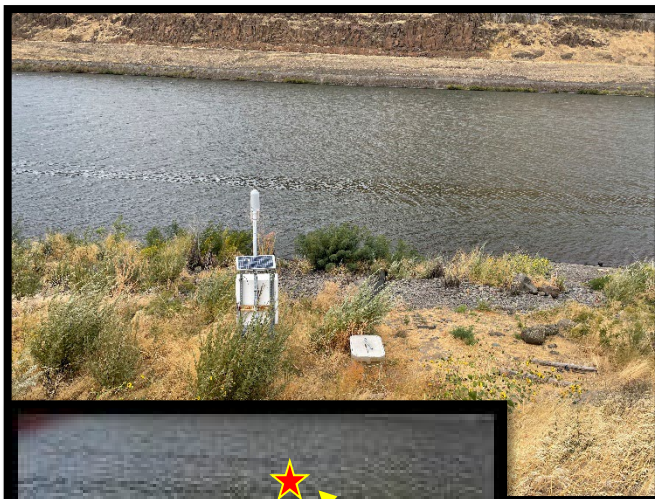
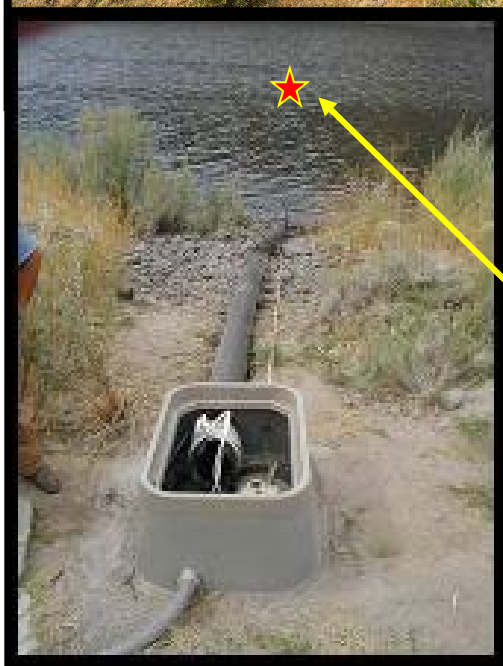
21. Lower Monumental Tailwater TDG Monitoring Station (LMNW)

Location: On the southeastern shore of the Snake River.

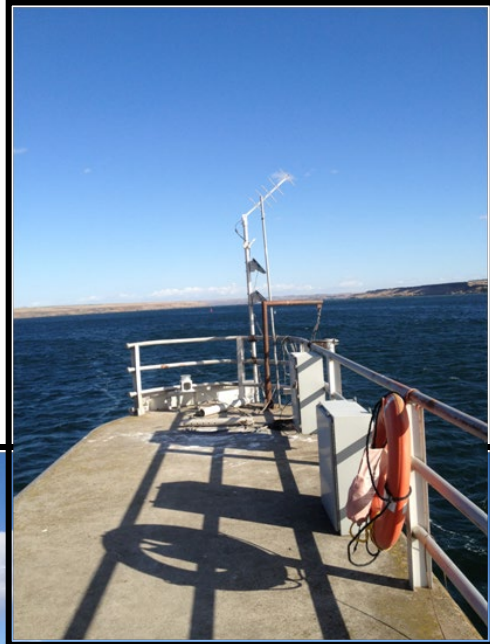
22. McNary Forebay TDG Monitoring Station (MCNA)

Reason for replacement: Moved due to thermal influences and lowered from 15 ft to 45 ft.
