Appendix A

2023 Total Dissolved Gas

Fixed Monitoring Stations

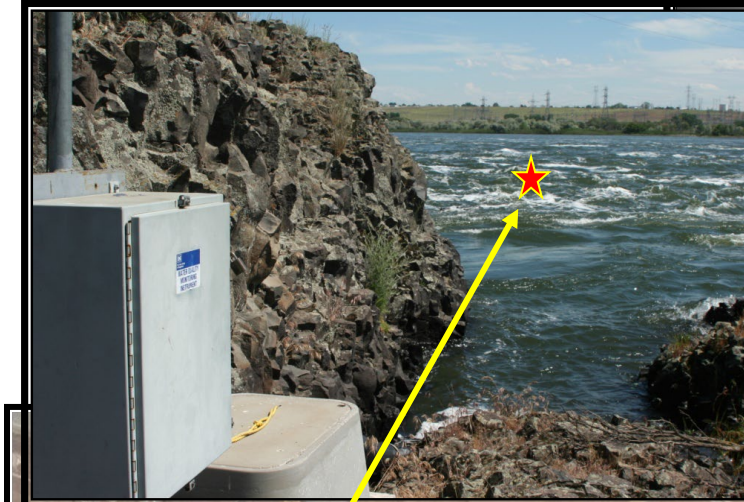
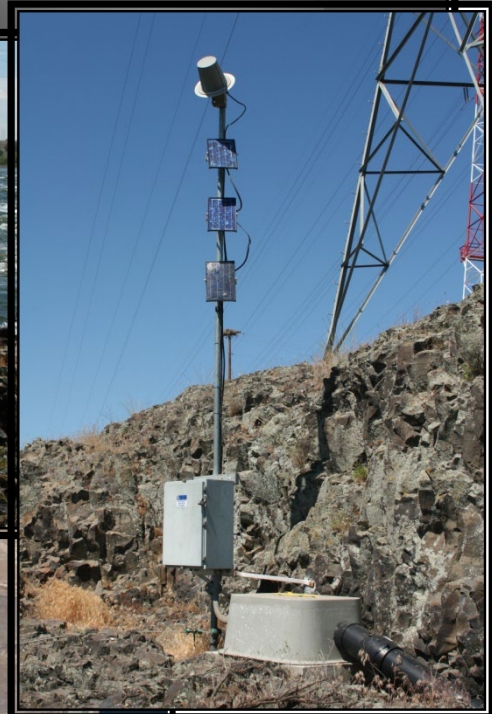
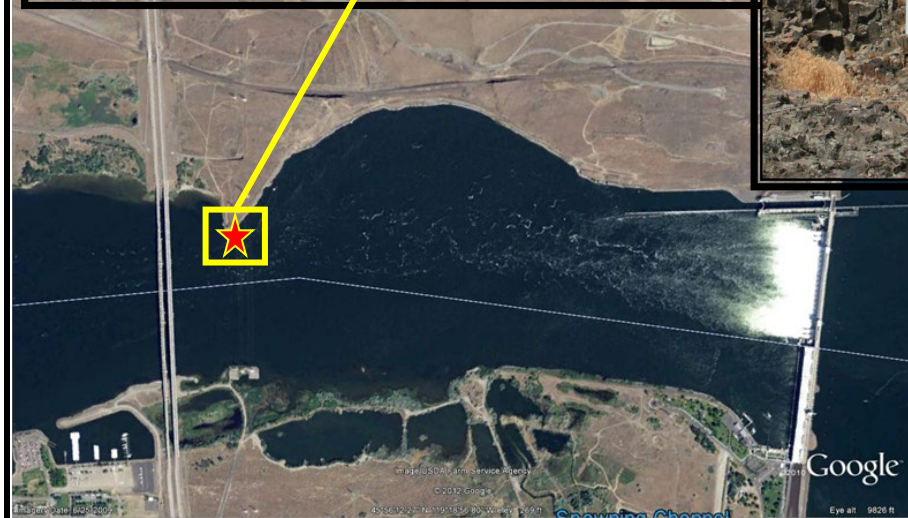
23. McNary Tailwater TDG Monitoring Station (MCPW)

Gage Elevation: Fixed
Latitude: 45° 56' 02.7775" N
Longitude: 119° 19' 35.4628" W
Distance from Dam: 1.3 miles
Datum: NAD83
River: Columbia
River Mile: 290.7
USGS-ID: None
Owner: U.S. Army Corps of Engineers-NWW
Gauge Type: Hydrosonde
Data Transmission: GOES Satellite
Dates of Operation: Year around
Years of Operation: 1995 - Present
Water Conditions: Spillway
Location: On a rocky outcrop on the Washington shore and just upstream of the Highway 395 Bridge.
This gage replaced: N/A
Reason for replacement: N/A
Comments: --

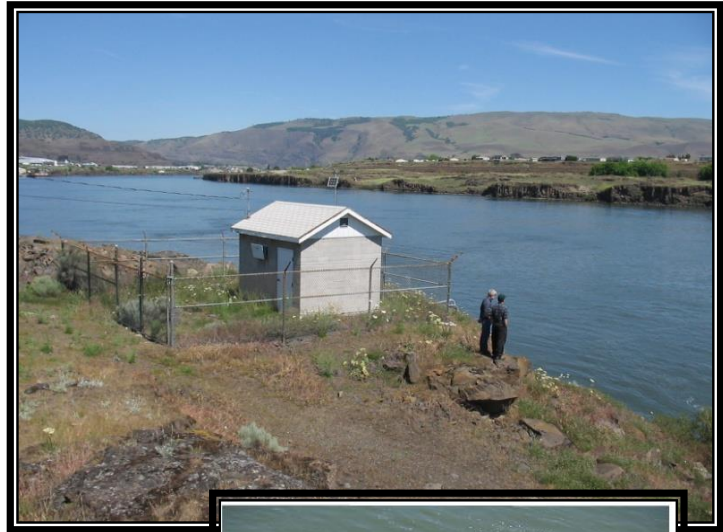
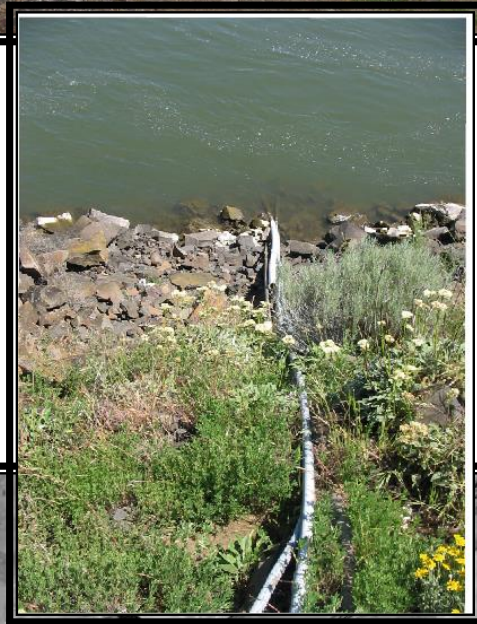
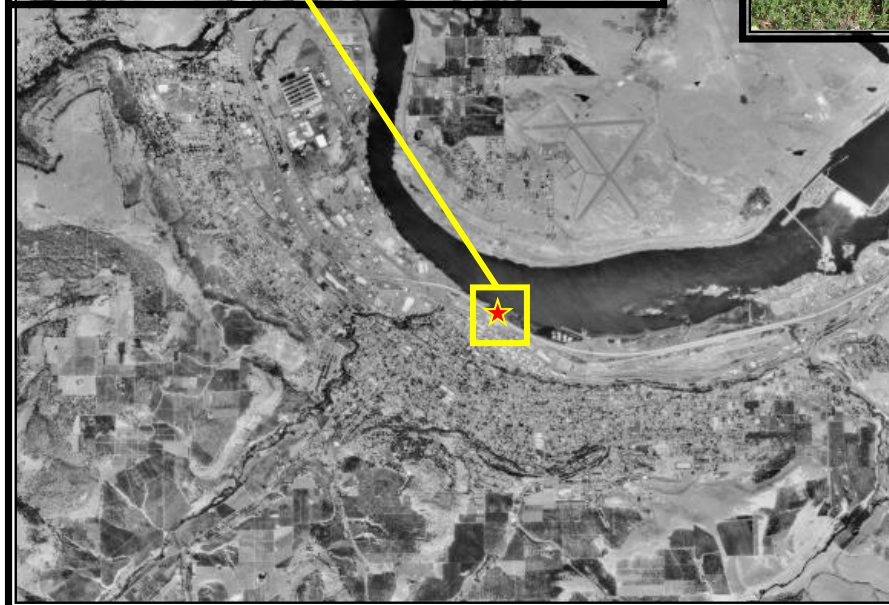
27. The Dalles Tailwater TDG Monitoring Station (TDDO)

Gage Elevation: Fixed (107.6 ft)
Latitude: 45° 36' 26.43330" N
Longitude: 121° 10' 24.25569" W
Distance from Dam: 2.5 miles
Datum: NAD83
River: Columbia
River Mile: 189.1
USGS-ID: 14105700
Owner: U.S. Army Corps of Engineers-NWP
Gauge Type: Hydrosone
Data Transmission: GOES Satellite
Dates of Operation: Was seasonal prior to 2006, now year around
Years of Operation: 1996 – Present
Water Conditions: Mixed
Location: Off Bargeway Road from Webber Street, near industrial complex.
This gage replaced: N/A
Reason for replacement: N/A
Comments: --

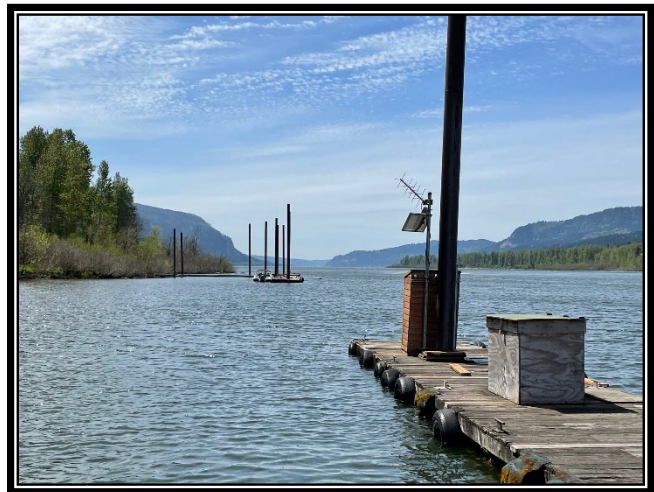
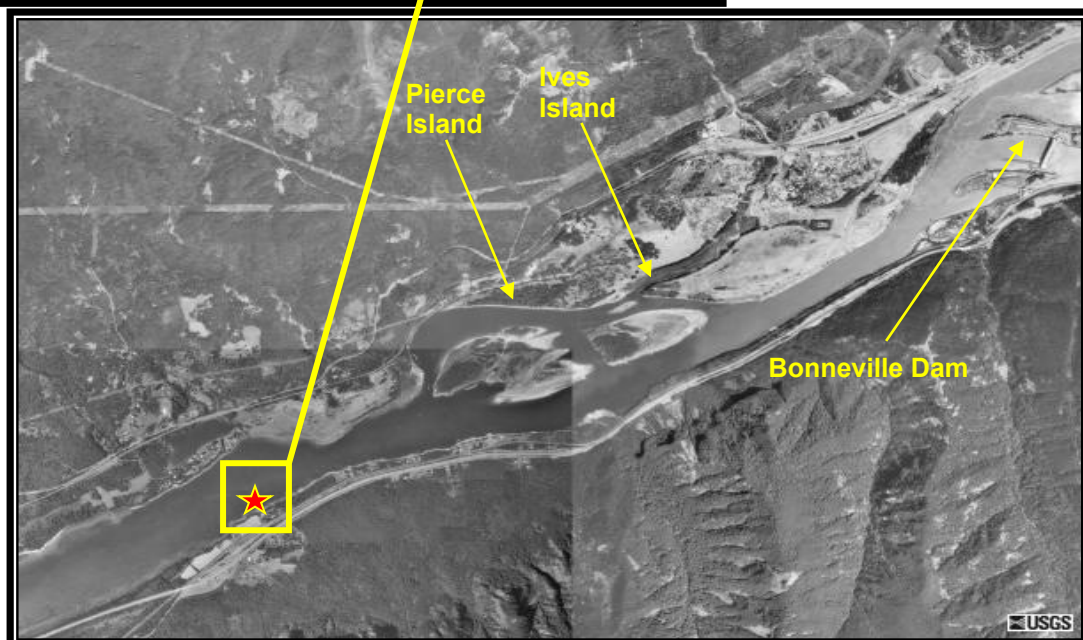
28. Warrendale TDG Monitoring Station (WRNO)

Comment: Up until the 2004 spill season, this gauge was used as the BON tailwater gauge for spill management and was operated year around. Currently, this gauge is being used as a fall, winter, and spring TDG monitor for Chum spawning. The gauge was moved to an upstream dock in 2022- the previous location is shown downstream in the photo.
