**OFFICIAL COORDINATION REQUEST FOR  
NON-ROUTINE OPERATIONS AND MAINTENANCE**

**COORDINATION TITLE:** 20 LMN 08 MOC-Floating Guide Wall Cable Emergency Repair

**PROJECT:** Lower Monumental Dam

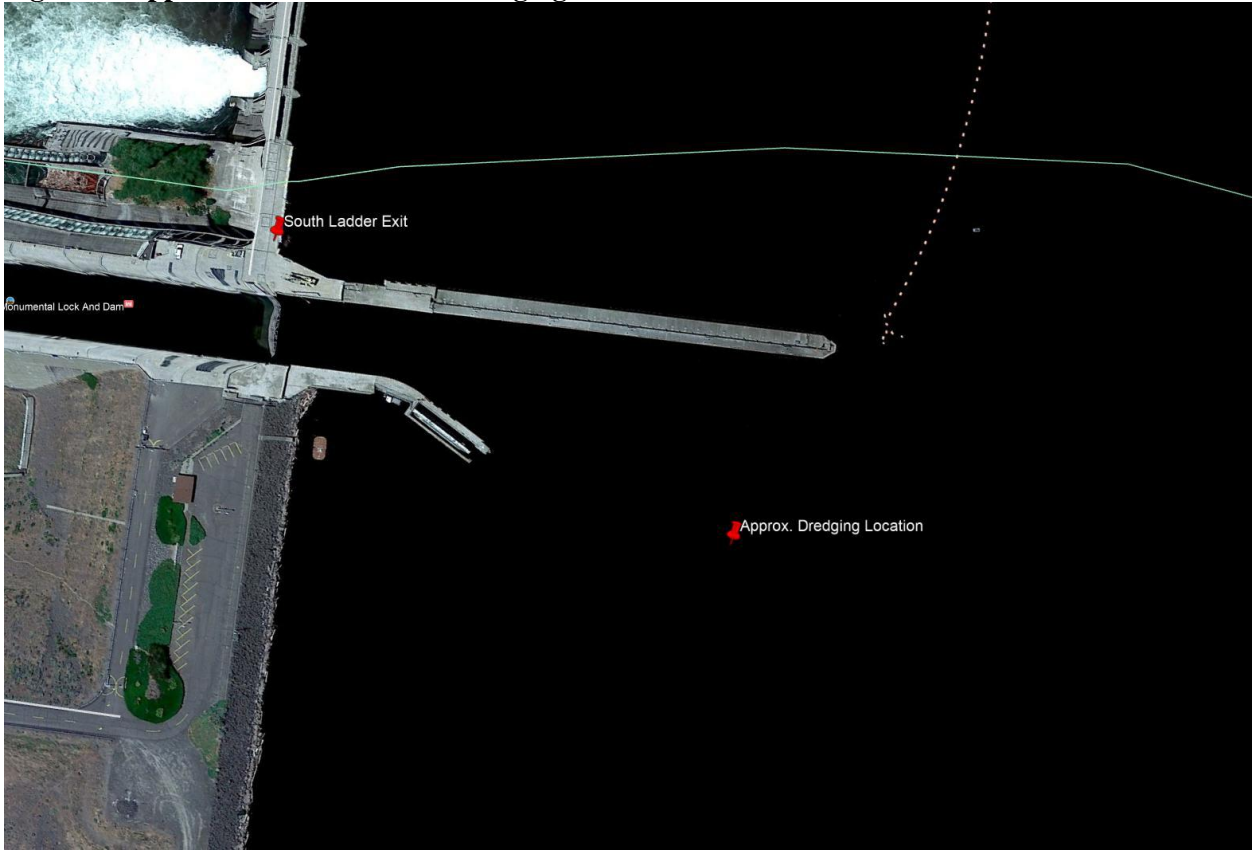
**Figure 1: Approximate Location of Dredging and south fish ladder exit location.**

The proposed activities would not affect salmon passage through Lower Monumental Dam because no changes in FPP operations would be needed. Dredging would occur 80 to 100 feet below the water surface where fish are not expected to be migrating. Figure 1, located at the end of this form, shows the approximated location the dredging will take place. The dredging area is approximately 750 feet from the south fish ladder exit.
