**MEMORANDUM FOR THE RECORD**

**SUBJECT: 22BON071 MFR AFF Walkway Lamprey Mortality**

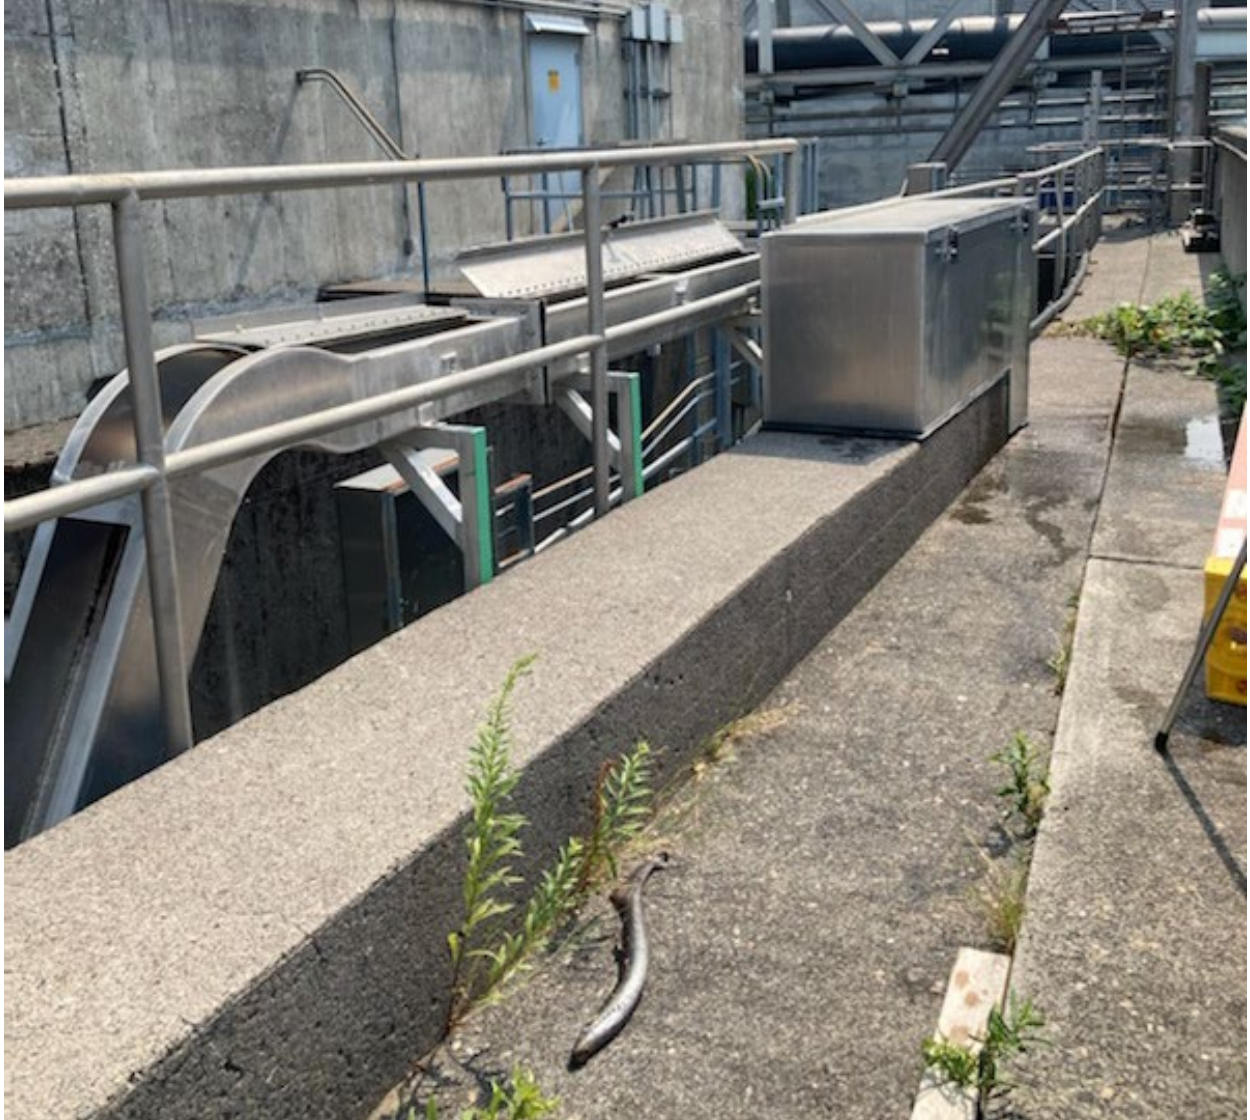
On 1 August, CRITFC lamprey translocation crew discovered one adult Pacific Lamprey mortality on the walkway near the Adult Fish Facility (AFF) lamprey trap. The CRITFC crew discovered that the flume hatches were open on arrival and suspect that the lamprey may have jumped out of the flume and landed on the walkway (Photo 1). However, the cause of this mortality is unknown. Bonneville Fisheries has mounted a trail camera to monitor potential predator activity and added netting to the flume to help prevent this mortality in the future (Photo 2).

- A. Species – Pacific Lamprey (*Entosphenus tridentatus*)
- B. Origin – Unknown.
- C. Length – unknown
- D. Marks and tags – Unknown
- E. Marks and Injuries found on carcass – None
- F. Cause and Time of Death – Desiccation, time: before the afternoon of 1 August.
- G. Future and Preventative Measures – BON Fisheries has added netting to the flume and will continue to monitor the area to identify any potential problems if any more mortalities occur near this location.

Photo 1: Adult lamprey mortality discovered on walkway near AFF Trap on 01 August.

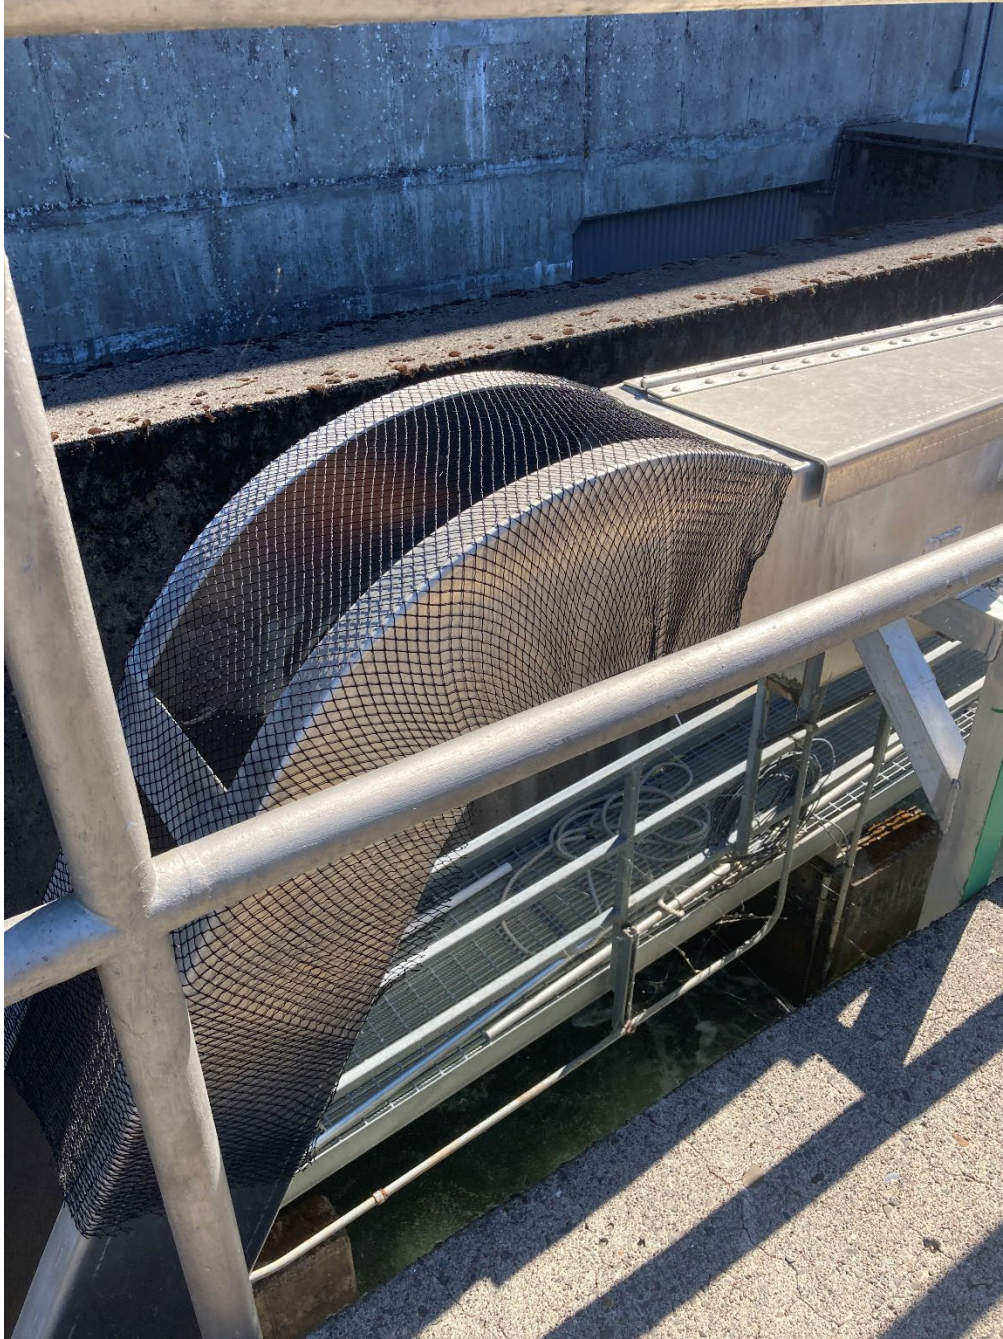
Photo 2: Netting was added to the flume portion of the AFF trap, adjacent to walkway.
