**MEMORANDUM FOR THE RECORD: 23 LGS 11 Second Adult Chinook Mortality****SUBJECT: Isolated Fish Ladder Incident – Single Adult Chinook Mortality**Background

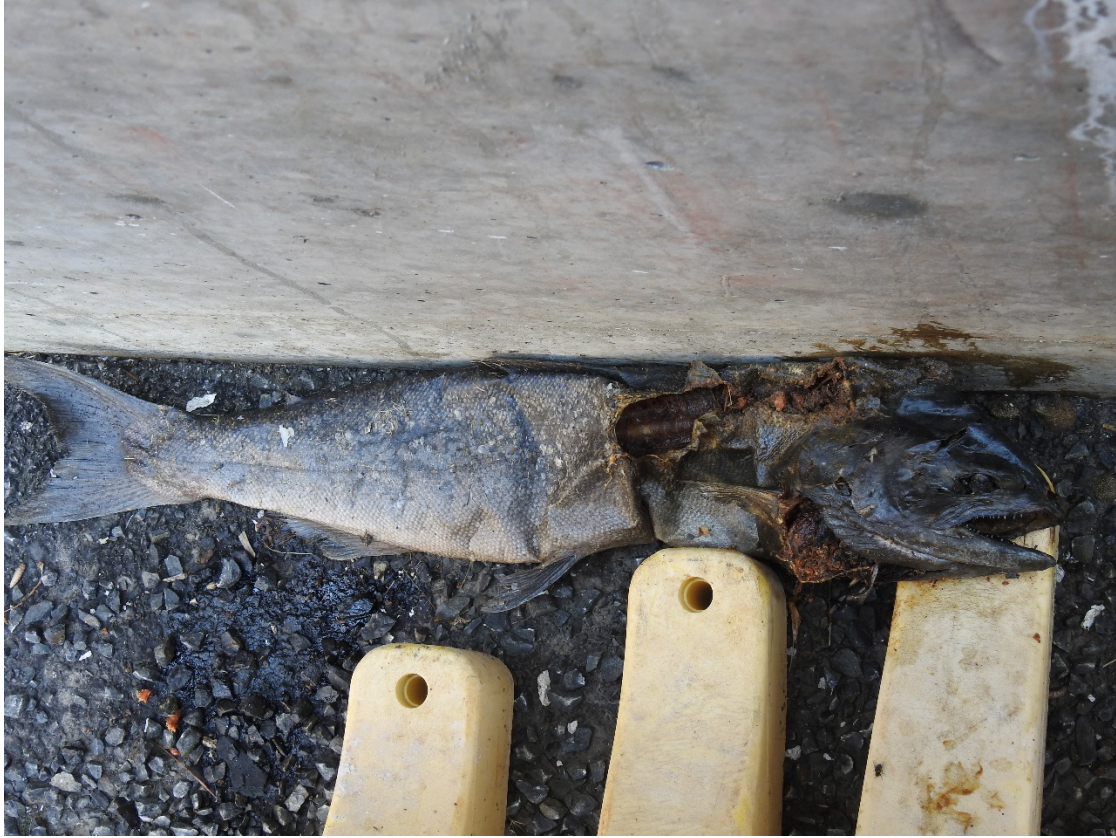
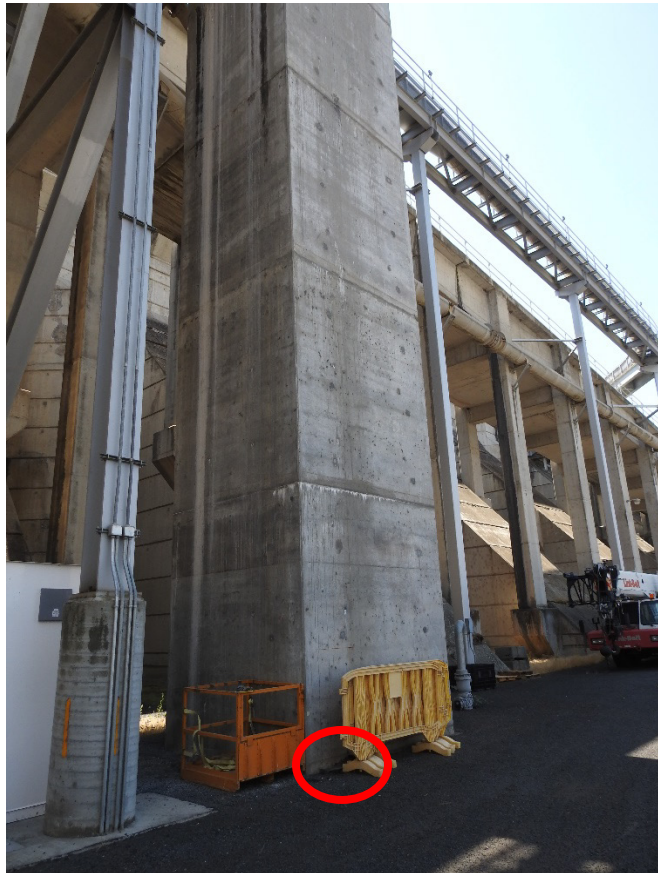
On the morning of July 20, USACE maintenance personnel informed LGS JFF staff of an adult fish mortality below the lower run fish ladder (see photos). The fish was found between a concrete column and plastic barricades. The abdominal and pericardial cavities were torn open and internal organs were gone. No sign of fish scales, etc. were found in the section of fish ladder walkway above where the salmon was found. We believed the fish jumped from the fishway and over the 56” railing, then fell to the ground where it was moved to the location where it was found by a scavenger.

- A. Species – Chinook salmon *Oncorhynchus tshawytscha*
- B. Origin – Wild
- C. Length – 30 inches
- D. Marks and tags – None, adipose intact
- E. Marks and Injuries found on carcass – Large wounds posterior to right pectoral fin exposing abdominal cavity and another immediately anterior to right pectoral fin exposing the pericardial cavity, skull apparently crushed, descale.

- F. Cause and Time of Death – Blunt force trauma, hypoxia. Estimated window for time of death early 7/14/23 based on first observation by USACE maintenance personnel.

- G. Future and Preventative Measures – LGS has experienced very few adult ladder “jumper” mortalities, with an occurrence rate of approximately 1 every 3 years. Serious consideration is being given to expand taller plastic mesh lining options at steeper ladder inclines, however addition of netting / mesh infrastructure presents major obstacles in regards to ladder access and fish rescue operations during annual unwatering activities in preparation for winter maintenance.
