MEMORANDUM FOR THE RECORD: 24 LGS 04: Potential Noise Above Fish Ladder Exit

SUBJECT: Mechanical crew modification to fish ladder cooling pump casing, new pump installation preparations

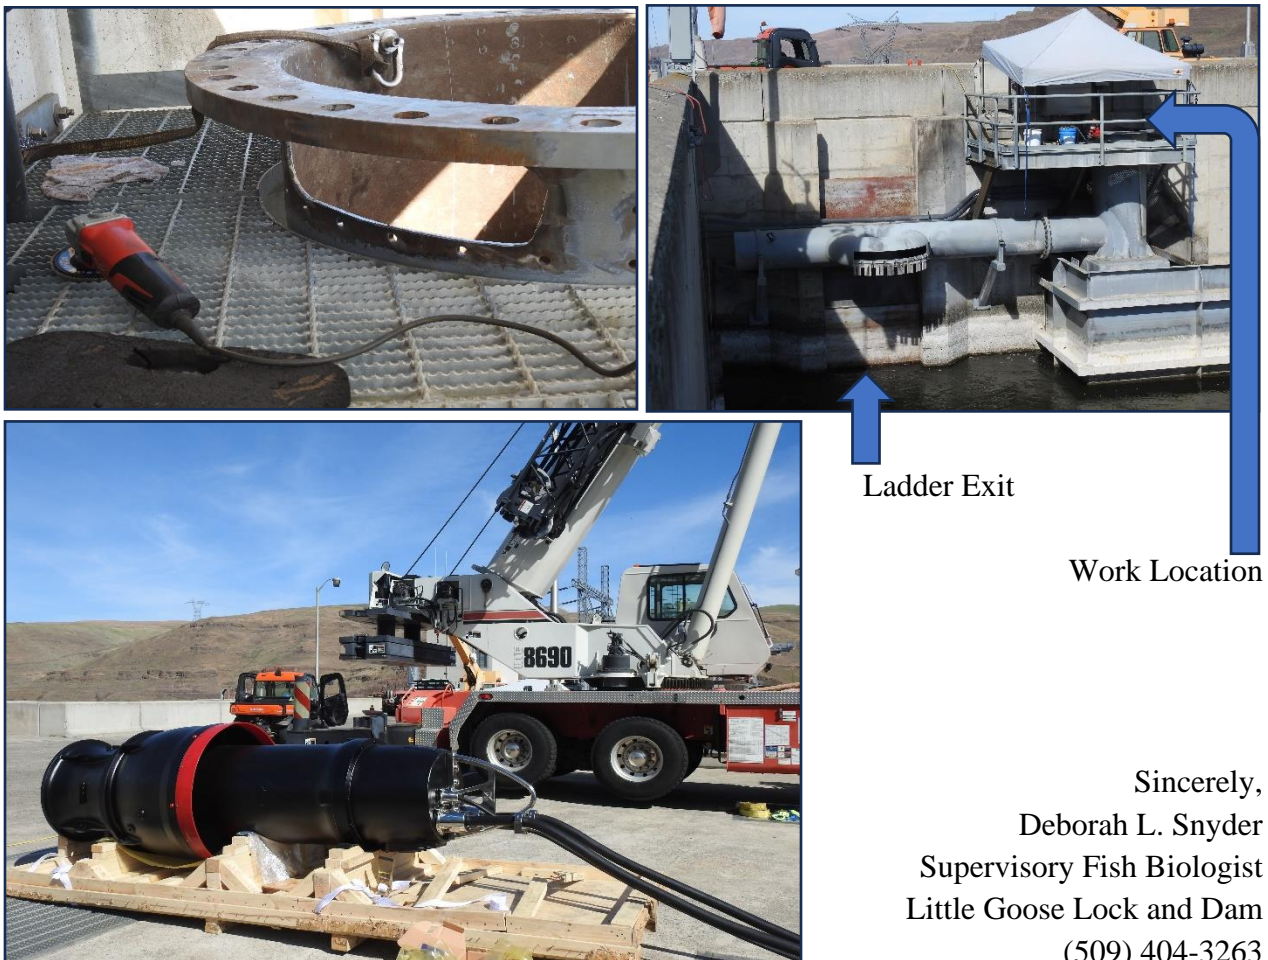
A small section of the Fish Ladder Cooling Pump (FLCP) column was cut out to allow for installation of an electrical harness support device to improve the mounting system. A portaband saw was chosen in lieu of angle grinder and drill, emitting the lesser amount of 75 – 80 dB at the source, and was utilized from 1200 to 1330 hours on May 23. Engineering Tech personnel estimate the maximum sound level at 80 dB at the point of generation, approximately 15 feet above the forebay surface. The sound may have traveled down the pump column about 15 ft below the surface near the upstream wall. It is surrounded by the cooling pump chimney which continues to 90 ft. in depth and is believed to have prevented most vibrations from reaching active fishways.
