SUMMARY OF MODIFICATIONS TO BONNEVILLE WA SHORE LAMPREY FLUME SYSTEM LPS

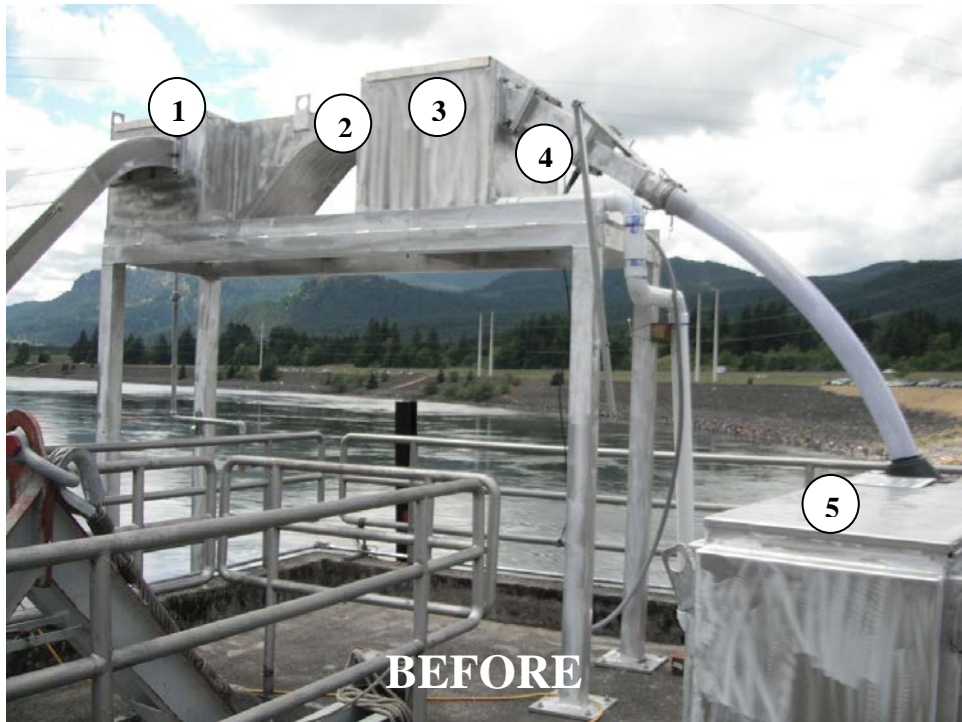
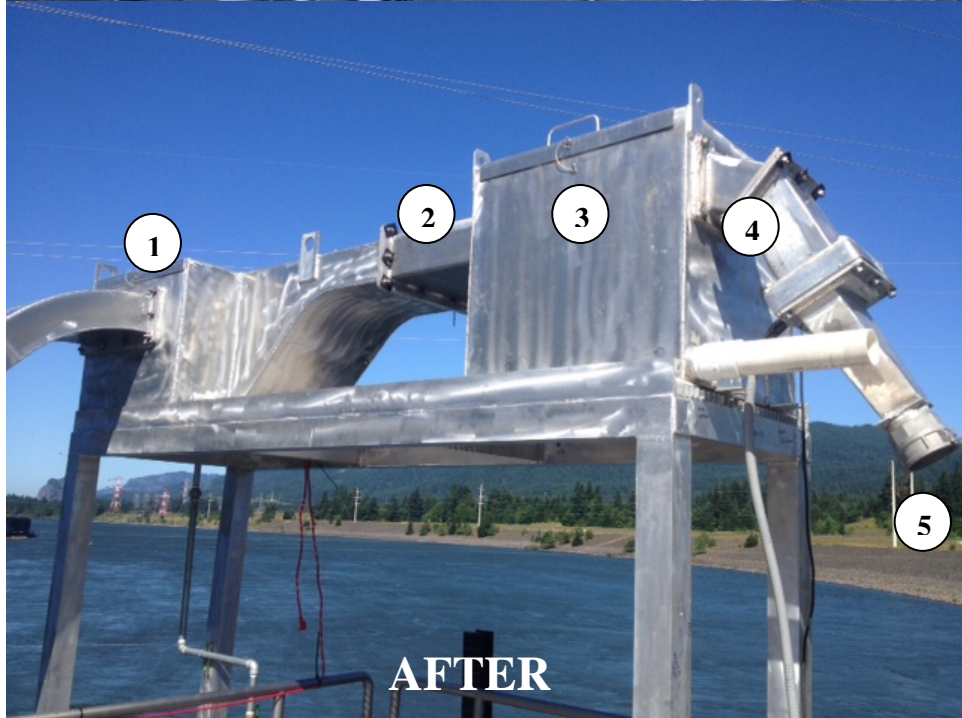
1. Removed plastic mesh from fyke inside Restbox #3, as this appeared to be blocking passage and causing a passage bottleneck at the top of the ramp immediately downstream.

2. Shifted Upwelling Box to the edge of the elevated platform to accommodate modifications to the exit chute. This shift required installation of the new transition piece connecting the Restbox #3 exit ramp to the Upwelling Box.

3. Removed plastic mesh from fyke inside Upwelling Box.
4. Exit chute modifications:
 - a. Lined interior with perforated plating to prevent lamprey attachment as they exit into collection tanks.

- b. Increased angle to approx. 60° to prevent lamprey resistance as they exit into collection tanks.
 - c. Removed Y-gate to simplify system and prevent lamprey impingement.

5. Collection tank modifications:
 - a. Added “quick connect” to exit hose and collection tank interface to allow simple switching between tanks.
 - b. Modified collection tank lid (not visible in ‘after’ photo) to allow easy retrieval of captured lamprey while system is operating.
