**CENWP-OD-B** 15 June 2016

## MEMORANDUM FOR THE RECORD

**SUBJECT: 16BON35 MFR** – Lamprey mortality at Bradford Island count station crowder.

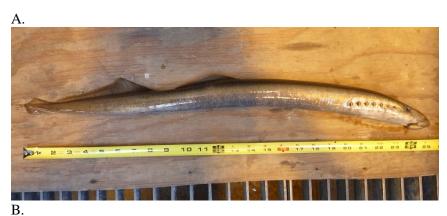
Between 13, 14 & 15 June, Project Biologists collected 11 Pacific Lamprey mortalities over the course of four inspections from the picket leads behind the Bradford Island count station crowder. Fish in good condition were frozen for researchers, the rest returned to river. Not all were photographed. One had markings, shown in pictures B and C on both sides of its body.

- A. Species Pacific Lamprey (*Entosphenus tridentatus*).
- B. Origin Unknown
- C. Length  $\sim 50-75$ cm
- D. Marks and tags None
- E. Marks and Injuries found on carcass The smaller fish in pictures B & C had visible marks on both sides. We believe that this might be caused by its tail end hanging through picket leads.
- F. Cause and Time of Death Unknown
- G. Future and Preventative Measures We are attempting to trap any possibly remaining fish for removal.
