CENWP-OD-B

09 June 2017

SUBJECT: 17BON16 MFR – Modifications to WA Shore AWS LPS Exit Chute.

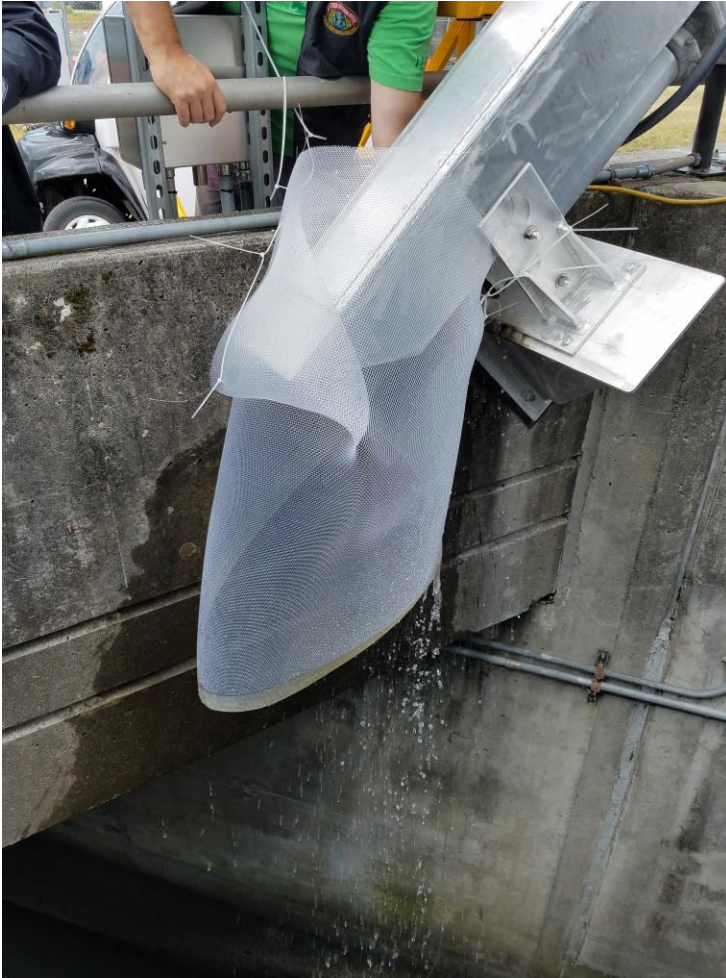
On 08 June 2017, FFU biologists informed Project Fisheries of recent video validation results from the new counter at the WA Shore AWS LPS exit chute. Upon reviewing of 6 hours of video, there were 47 passage events. Seventeen of them (36%) appear to have either splashed, grazed, or slightly impacted the concrete section of the bridge over the fishway; creating the possibility of removing some slime coat or worse.

On the morning of 09 June, Project Fisheries, FFU, and Portland District biologists observed fish making the same contact with not only the concrete on the bridge as observed in video but also along the opposite fishway wall nearest the water level of the ladder.

A plan was devised to minimize contact as observed in the video and prevent lamprey from making contact on the opposite wall altogether. Materials used on STSs (submergible traveling screens) were shaped to form a cone of sorts, gently guiding fish away from both walls. A more permanent solution will be investigated and installed.
