**MEMORANDUM FOR THE RECORD**

**SUBJECT: 17BON54 MFR - Pacific Lamprey mortality in Bonneville's DSM.**

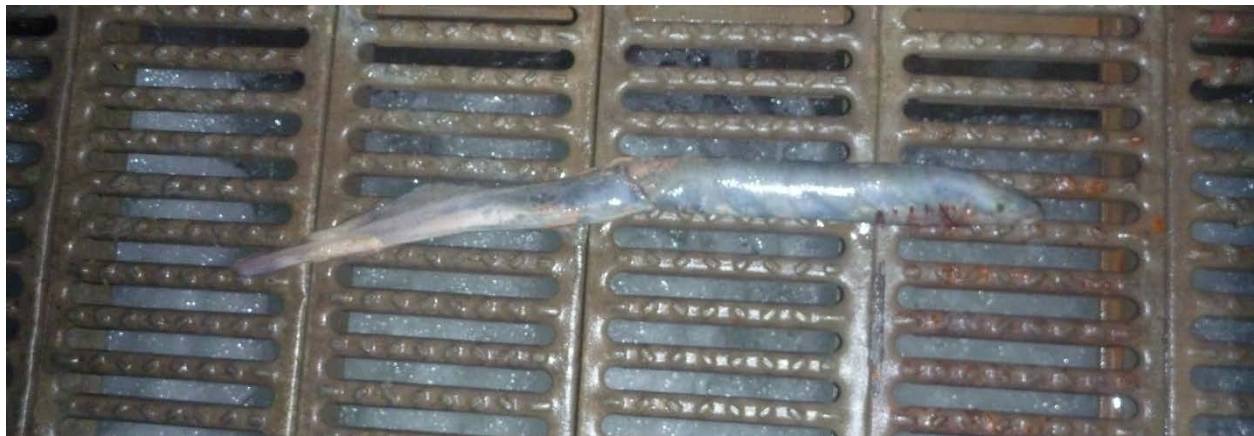
Figure 1.

On 24 July, project biologists found a Pacific Lamprey mortality on the grating in the DSM. The fish seems to have scaled the wall at the upstream end of the tunnel and wiggled its way over or past plastic fencing that had been placed to keep Lamprey out. Water from the end orifice sometimes boils up through the grating, attracting fish. Plywood had previously covered this area, but had rotted through, allowing water to again attract fish. In response, biologists covered the area with aluminum sheeting and cinder blocks. Attraction water will no longer come up through the grating and the wall with access is blocked by cinder blocks. The lamprey was returned to the river.

- A. Species – Pacific Lamprey
- B. Origin – Unknown
- C. Length – 55 cm
- D. Marks and tags – None
- E. Marks and Injuries found on carcass – The vertical mark on the middle of the fish is from its tail section hanging through the grating.
- F. Cause and Time of Death – Stranding.
- G. Future and Preventative Measures – Area closed off with aluminum sheeting and cinder blocks.
