MEMORANDUM FOR THE RECORD

SUBJECT: 20JDA09 John Day Spill bay #11 OOS

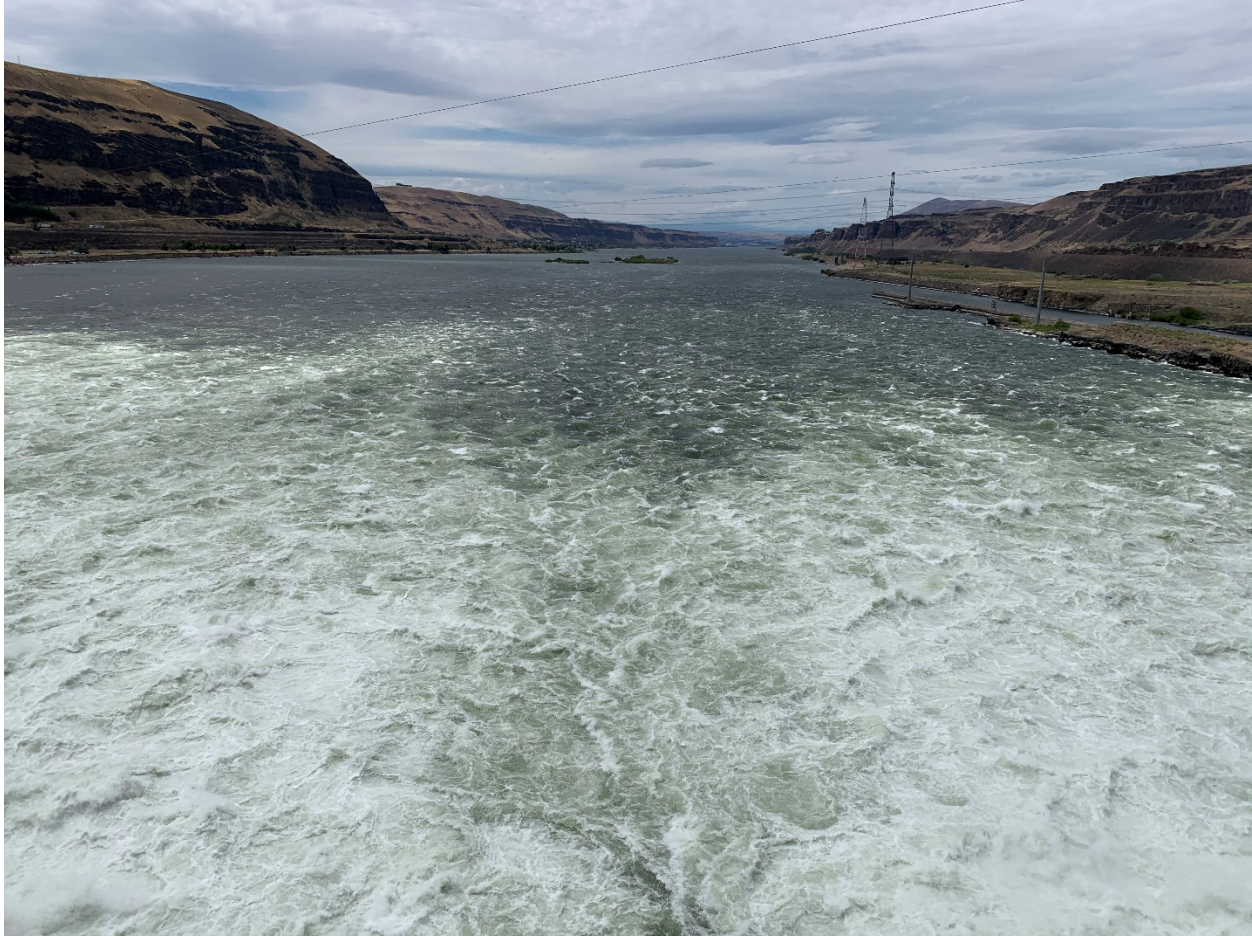
During the spill change at 0700, spill gate #11 went closed and will not operate remotely or manually. According to the FPP, SB#11 is opened at 2 stops for today's spill discharge and those two stops are now being distributed in different bays. A visual inspection of the egress conditions (photo) doesn't reveal any real concerns with water moving downstream of the spillway. The edge of the jets in spill bay 10 and 12 do show some slowing because of the lack of spill from bay 11 but overall the jets from 10 and 12 are moving downstream. The estimated return to service is yet to be determined and once SB#10 is RTS JD Fisheries will provide an update.

Photo taken from spill bay #11 looking downstream

UPDATE: Spill gate 11 returned to service on 7/14 at 1330.

Again I will ask, did anyone coordinate with hydraulics to see if they had any suggestions if this is going to continue on for an extended time. While bays 10 and 12 look ok, you now have a partial hole in the pattern at 11, which is not desired, there might not be anything we can do about this unless the spillbay can be dogged off at 2 stops or 1.5 since that is where it will be for most the rest of the season?

Erin informed me that you had a couple questions about the spill gate 11 outage at John Day. I have been emailing Askelson today and also shared the picture with him that was included in the MFR. He agreed that the pattern didn't look horrible considering we didn't have spill gate 11. I have also asked him to work with us (JD Fisheries) to look at what the best solutions may be during a spill gate outage. An example would be, spill gate 10 goes out of service on June 30th and we have 109 kcfs of spill. According to the FPP, spill gate 10 would be opened 3 stops (1.6 kcfs). We would then take those stops and distribute them either north or south of spill bay 10. The distribution could be in half stops (0.5) of full stops and this would provide 109 total kcfs of spill as listed in the FPP.

The question about dogging off spill gate 11 at a given stop, that is a no since the gate can't be operated manually or remotely. JD maintenance will be taking a closer look at the issue today or tomorrow and we will provide an update of the issue and an estimated RTS.
