MEMORANDUM FOR THE RECORD**SUBJECT: 22JDA13 STS camera train lubricant leak**

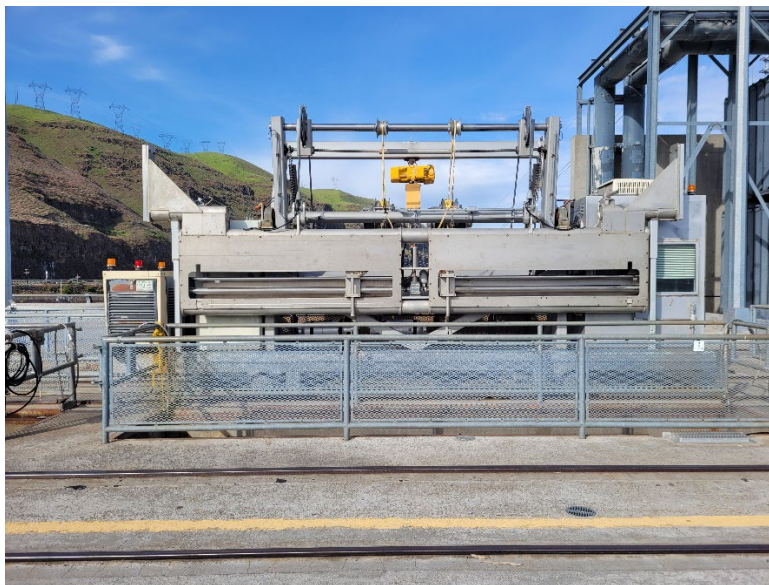
At approximately 1400 on Monday September 26th John Day Mechanical personnel reported seeing several small rainbow sheens in STS slots 12A, 13A, 13C, 14A, 14C, 15C. Investigation determined the gearbox seal on the STS camera train seeped less than one (1) teaspoon of gearbox oil to slots. An attempt to recover sheen was made using absorbents. Reports were promptly called in to NRC WA/OR.

Figure 1: STS camera train

- A. Species- N/A
- B. Origin – N/A
- C. Length – N/A
- D. Marks and tags – N/A
- E. Marks and Injuries found on carcass – N/A
- F. Cause and Time of Death – N/A
- G. Future and Preventative Measures – Gatewells are inspected daily by fisheries personnel. STS screens will be manually pulled until the leak is repaired.
