## **MEMORANDUM FOR THE RECORD**

## SUBJECT: 22JDA19 MU 16 VBS Panel

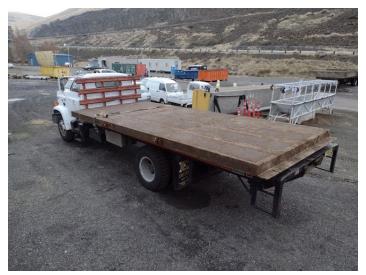
On the morning of 12 December, during the planned removal of the submersible traveling screens (STS) for Winter maintenance, the JDA maintenance crew started removing screens from MU 16 when they noticed a vertical barrier screen (VBS) panel had fallen off blocking the intake bulkhead slot preventing the removal of the STS. JDA maintenance was able to remove the 5' x 20' panel (fig 1) from the slot on the afternoon of 13 December. Work is currently underway to dewater the unit to reattach the panel and inspect all other panels for deficiencies.

Fig 1 VBS panel from MU16 gatewell A slot.

- A. Species estimated 200 juvenile shad morts were recovered, no salmonids or lamprey.
- B. Future and Preventative Measures Hardware will be inspected for any degradation.
