MEMORANDUM FOR THE RECORD**SUBJECT: 23JDA08 Submersible Traveling Screen (STS) Oil Leak in Gatewell Slot 10B**

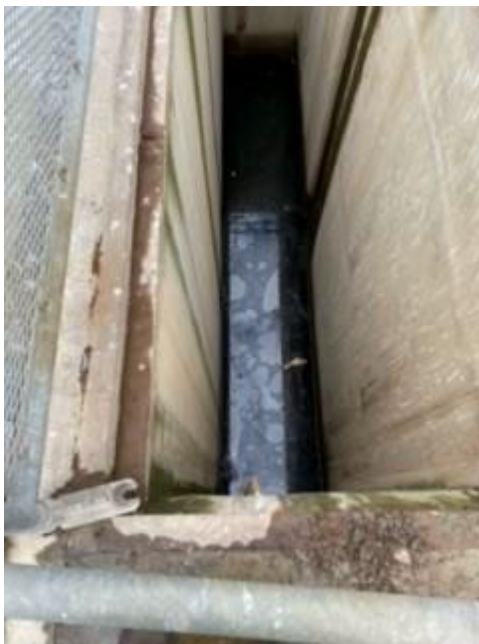
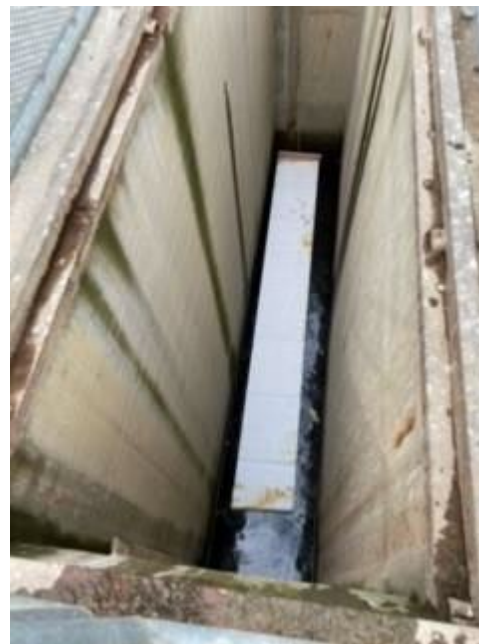
The leaking STS screen was removed from service and taken to STS pit for repair. It is estimated that 2 quarts of SHC 634 oil leaked from the screen. JDM personnel discovered that the piping leading from the accumulator tank failed, causing the release. JDM personnel are currently draining the screen to achieve a more accurate amount of oil lost.

- A. Species – NA
- B. Origin – NA
- C. Length – NA
- D. Marks and tags – NA
- E. Marks and Injuries found on carcass – NA
- F. Cause and Time of Death – NA
- G. Future and Preventative Measures – Monitor during winter maintenance periods
