**MEMORANDUM FOR THE RECORD – 17 TDA 11 AWS Parking Lot Backfill****SUBJECT: AWS Parking Lot Backfill**

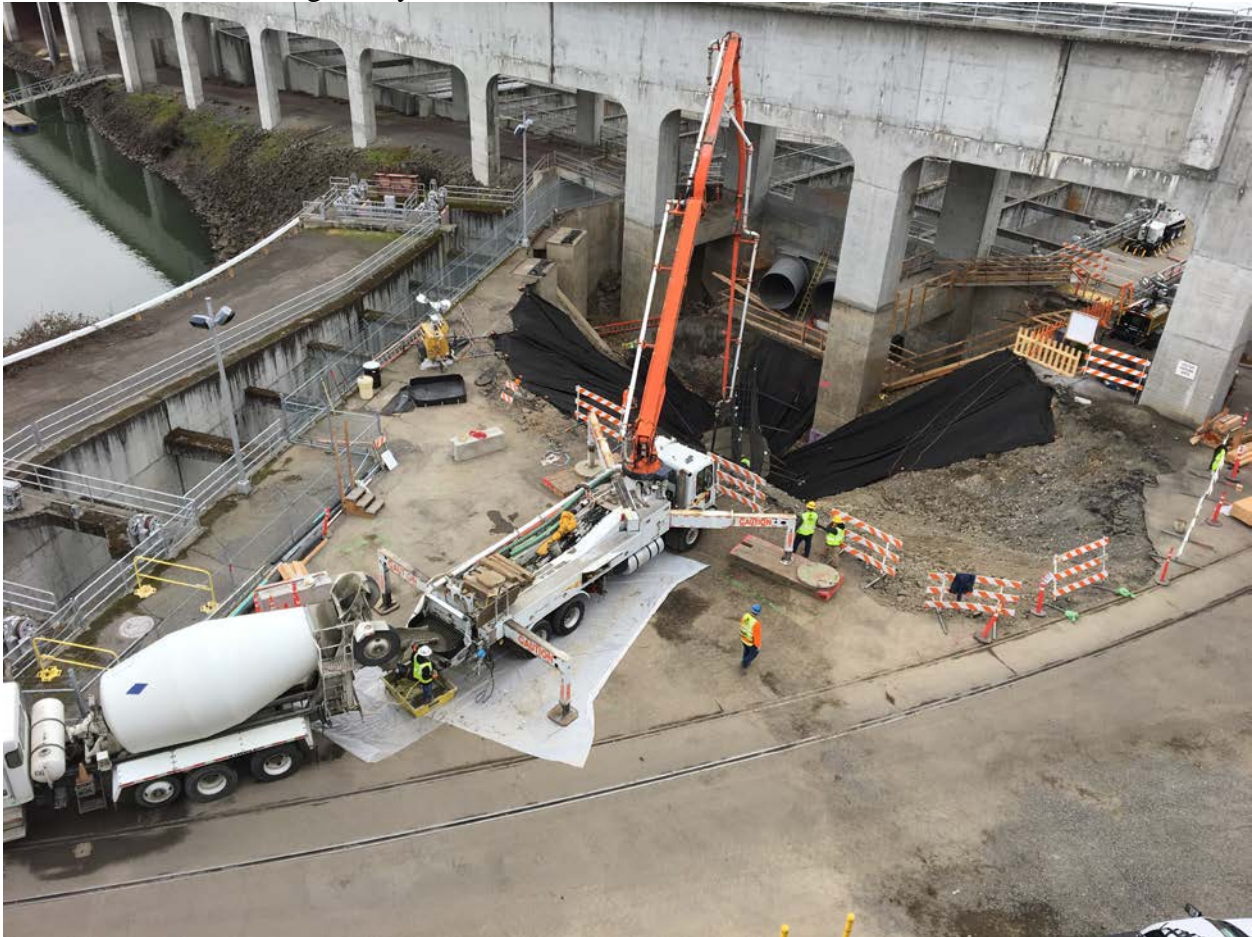
The AWS backup contract work has encountered numerous delays jeopardizing the schedule milestones, including inclement weather and unanticipated obstacles. As specified in 17TDA5 MOC, work was scheduled through March to complete season 1 milestones. The final step of this work involves backfilling the hole where 7' valves are located. This work cannot be completed in March and must be done the first week of April. Equipment list includes; John Deere 350 Excavator, Dump Trucks, Cat 14G Grader, Cat CS 563 Roller, Cat 416 Backhoe, walk behind plate compactor, Wacker type jumping jack compactor, concrete pump and rough terrain crane. This work will be within 50' of the fish ladder. Equipment size will be minimized. Work will be done at night only.
