**MEMORANDUM FOR THE RECORD****SUBJECT: 16TDA26 - Lamprey mortalities at E2 & E3 weirs**

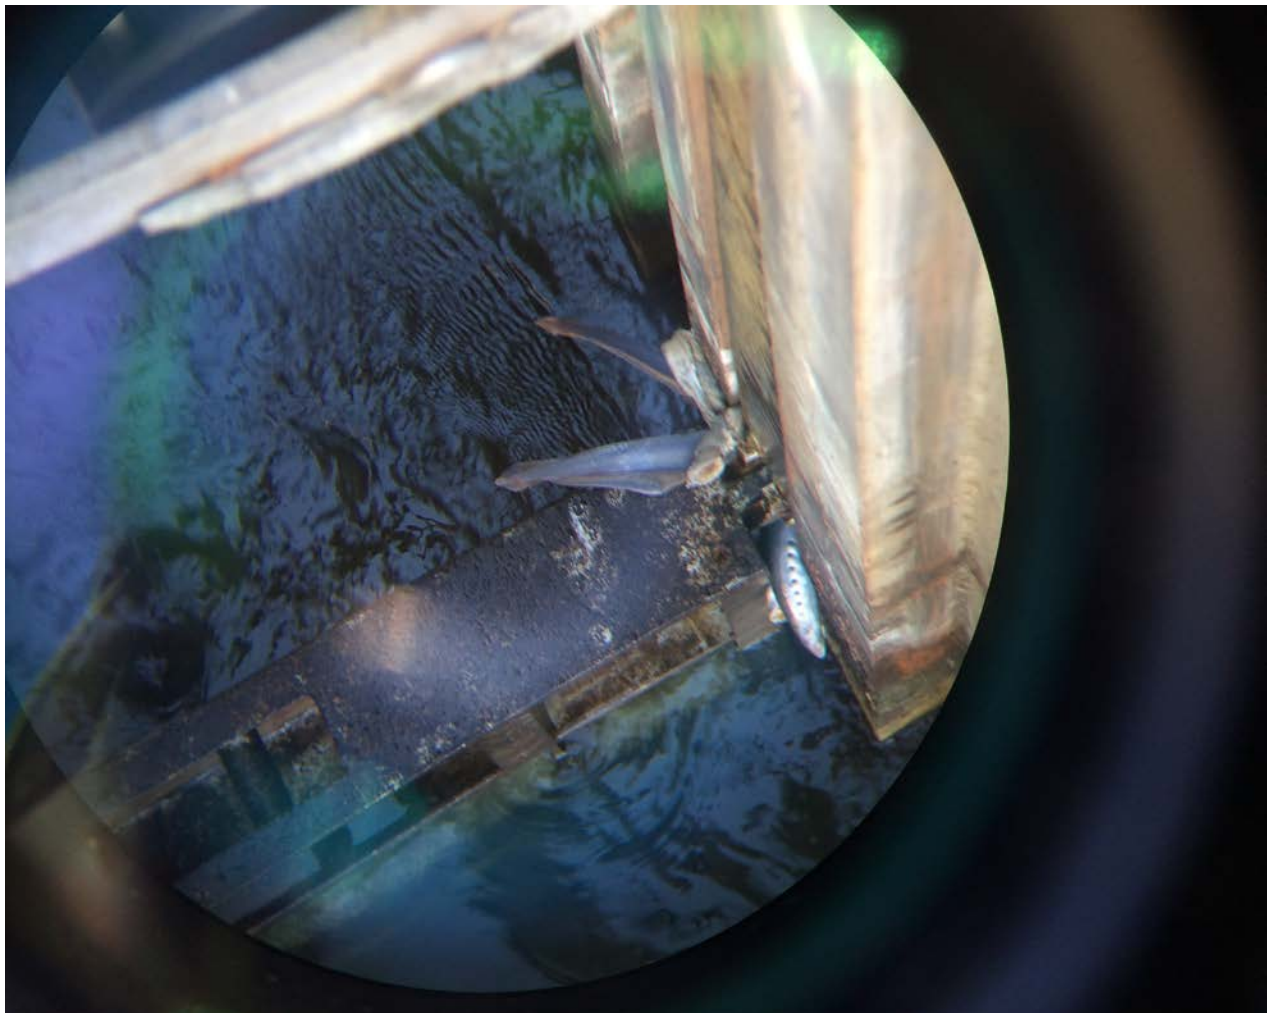
Similar to last year, on 8 August, Fisheries technician conducting grating inspection via ROV raised the east entrance weirs above tail water. Adult lamprey mortalities were observed pinched between the weir and guide. E3 had 4 new and 1 old mortalities. E2 had 2 new mortalities. This MFR is late due to an oversight. It was thought to be completed and on record.

- A. Species – Pacific Lamprey (*Entosphenus tridentatus*).
- B. Origin – Unknown.
- C. Length – Unknown.
- D. Marks and tags – No marks and/or tags.
- E. Marks and Injuries found on carcass – See photo
- F. Cause and Time of Death – The lamprey were pinched between the weir and guide.
- G. Future and Preventative Measures – The project will be installing the weir caps this winter and will consult lamprey minor modification Product Development Team for other suggestions.
