MEMORANDUM FOR THE RECORD (22TDA02 MFR Wasco PUD mortality)

SUBJECT: *fry and lamprey mortality in Northern Wasco County PUD dewatering structure on the north shore of The Dalles Dam.*

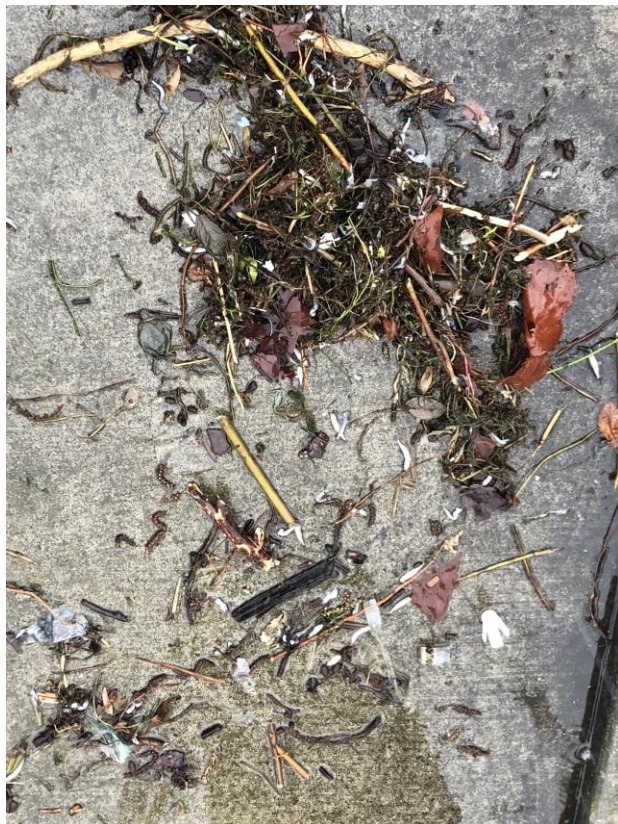
Fry mixed with debris
