MEMORANDUM FOR THE RECORD 19-IH-16

SUBJECT: Jack Chinook salmon mortality

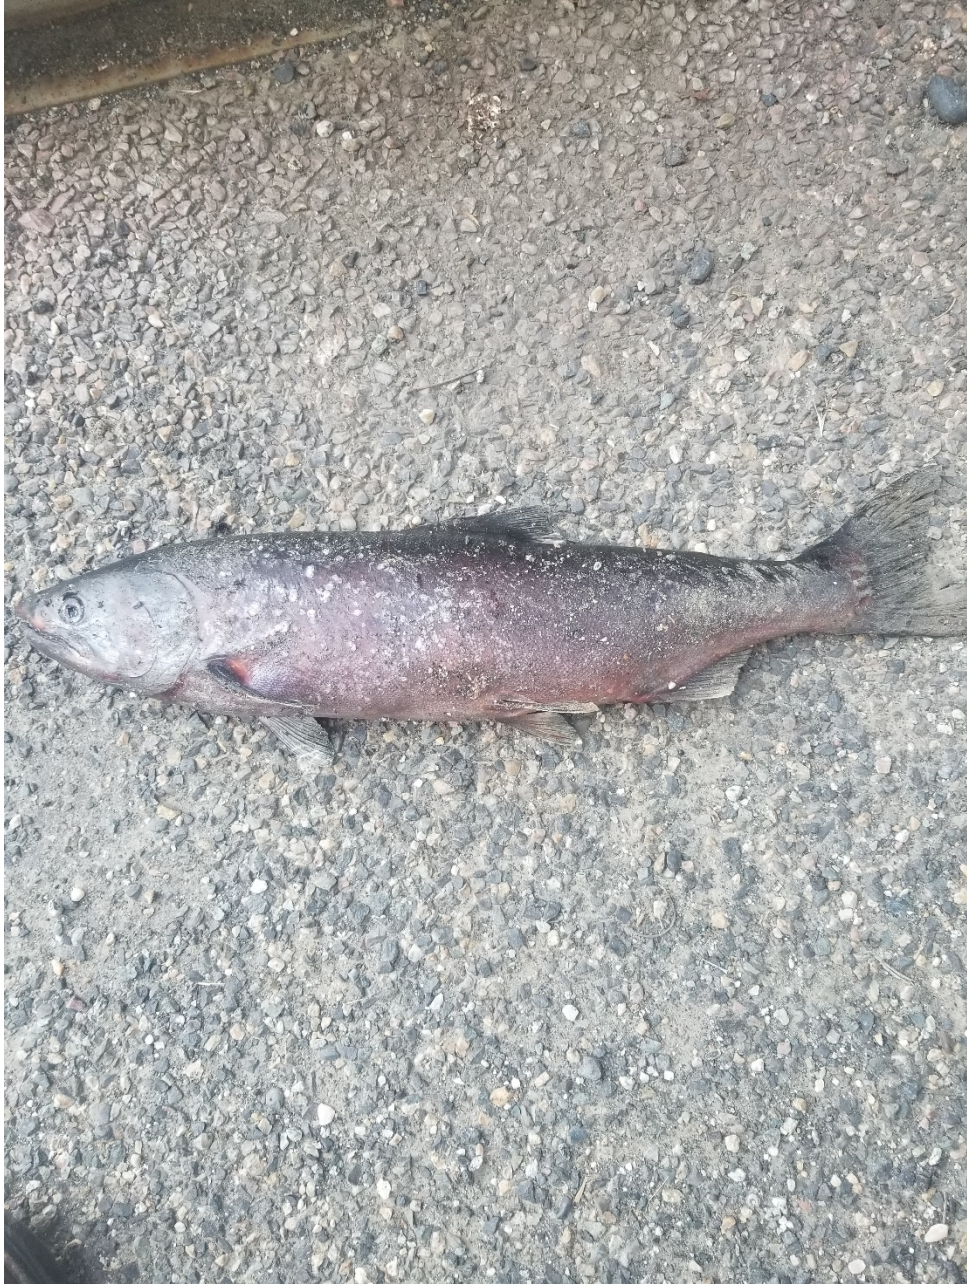
- I. Pictures included – see below

A jack Chinook salmon mortality found on the morning of August 8, 2019, below the east end of the south fish ladder.

- A. Species – *Oncorhynchus tshawytscha*.
- B. Origin – Unknown.
- C. Length – 20.5”
- D. Marks and tags – clipped
- E. Marks and injuries found on carcass – descaling from rubbing against the pavement, blood pooling at base of pectoral fins.

- F. Location – The fish was on the ground at the base of the stairs that lead up to the south shore picketed leads.
- G. Cause and time of death – The fish most likely jumped over the fence at the turning pool just upstream from the fish counting station. It probably did not jump from the upper diffuser area, based on the lack of impact marks on the fish. The fish was dead for less than one day, as it was not there at the end of the previous work day.

- H. Future and preventative measures – Project staff will attach netting or some other type of jump barrier to the top of the fence, as feasible, at the turning pool upstream from the count station.
