MEMORANDUM FOR THE RECORD 20 LGS 07 Unit Priority to Clear Debris**SUBJECT: Little Goose Unit Priority to Clear Debris**Background

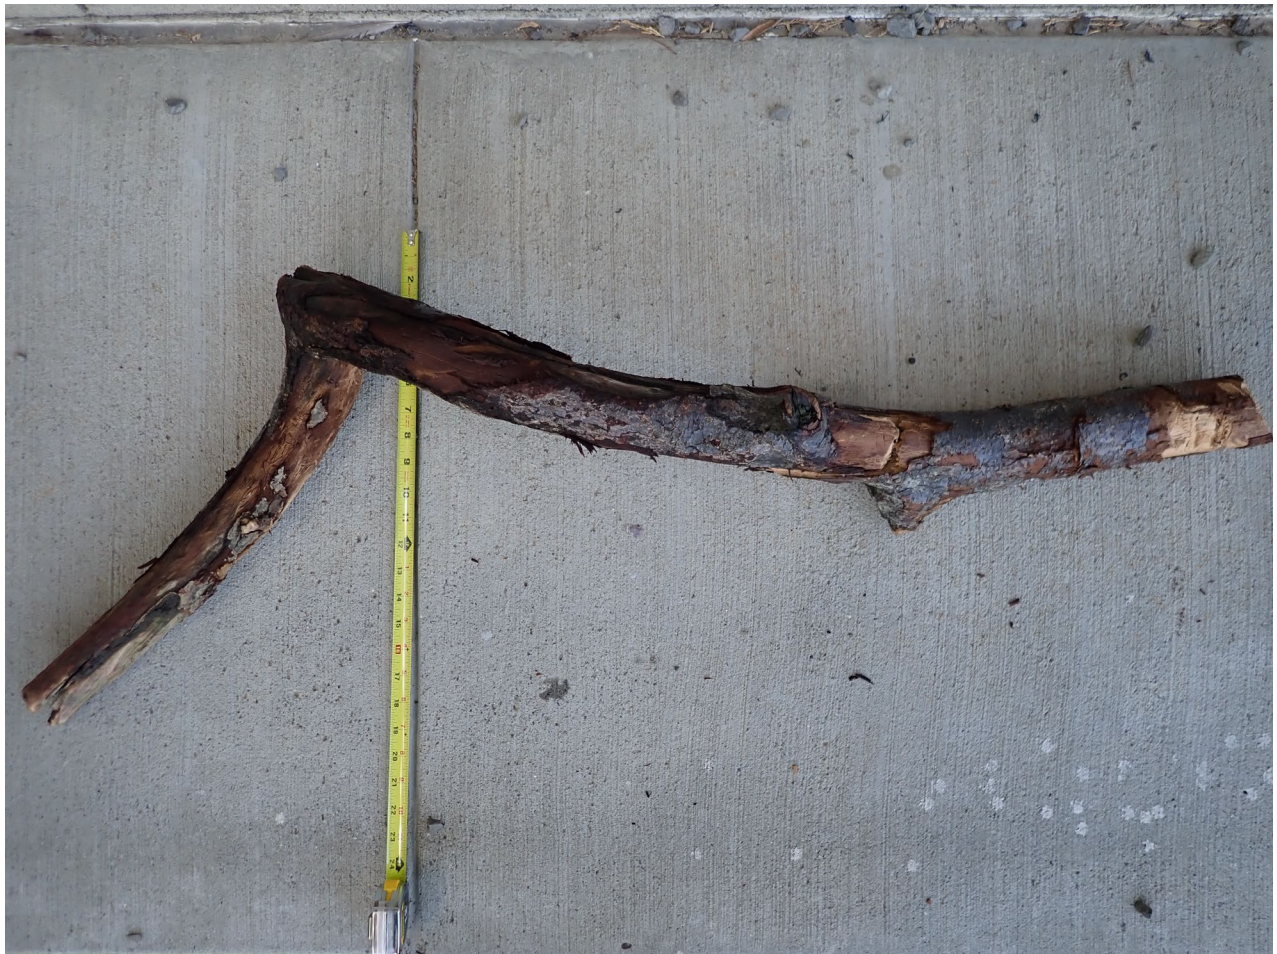
JFF staff removed a long piece of woody debris that was caught in the orifice (Picture 1) utilized grappling hooks and a saw. The debris in the orifice was found early enough that no mortalities were observed. Additionally, the accumulation of floating woody debris in the immediate forebay is very low and is monitored daily.

Picture 1: Debris removed from orifice 1A1.

Little Goose will continue to conduct routine inspections and utilize all necessary tools to ensure safe passage of juvenile fish through the collection and bypass system. Staff will also continue to monitor debris in the immediate forebay.
