MEMORANDUM FOR THE RECORD: 22 LGS 11 Adult Steelhead Mortality**SUBJECT: One adult steelhead mortality**

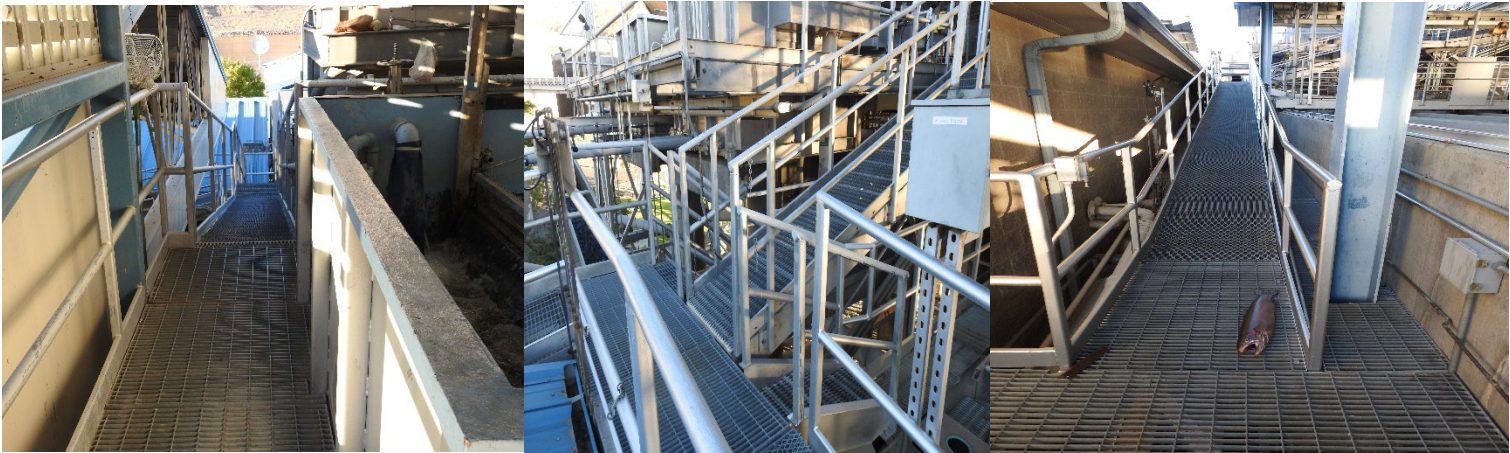
Separator location and potential pathway

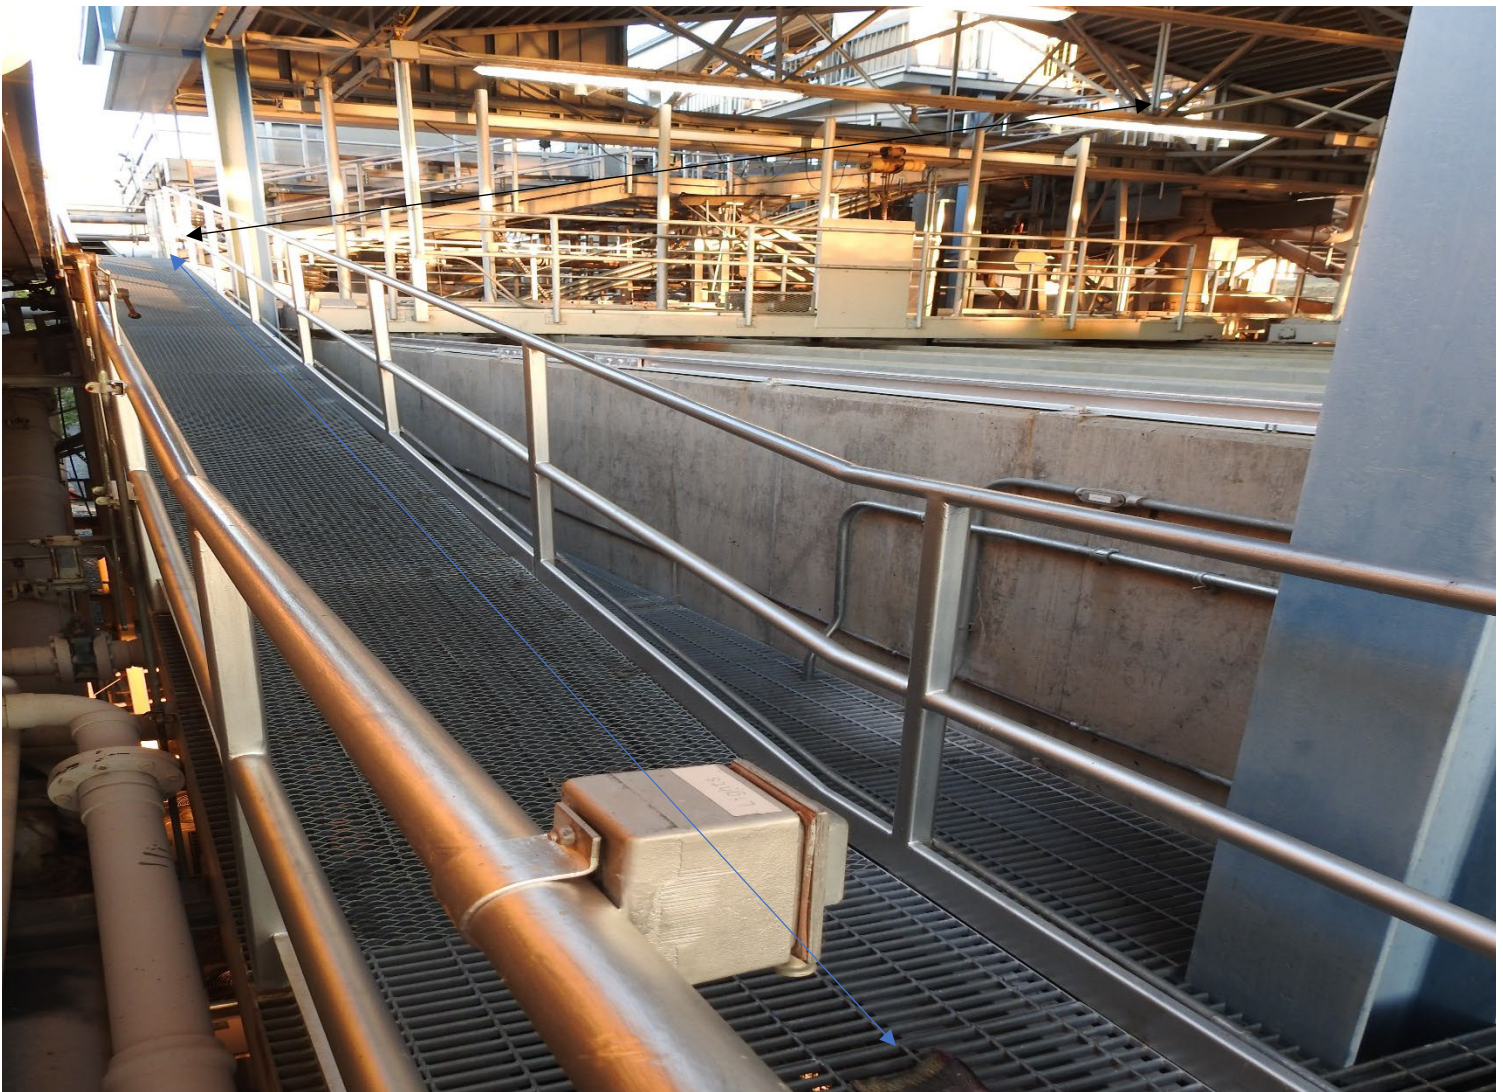
Potential pathway overview
