MEMORANDUM FOR RECORD: 17 LWG 13 Emergency Debris Spill Subject:

Emergency Spill Operation

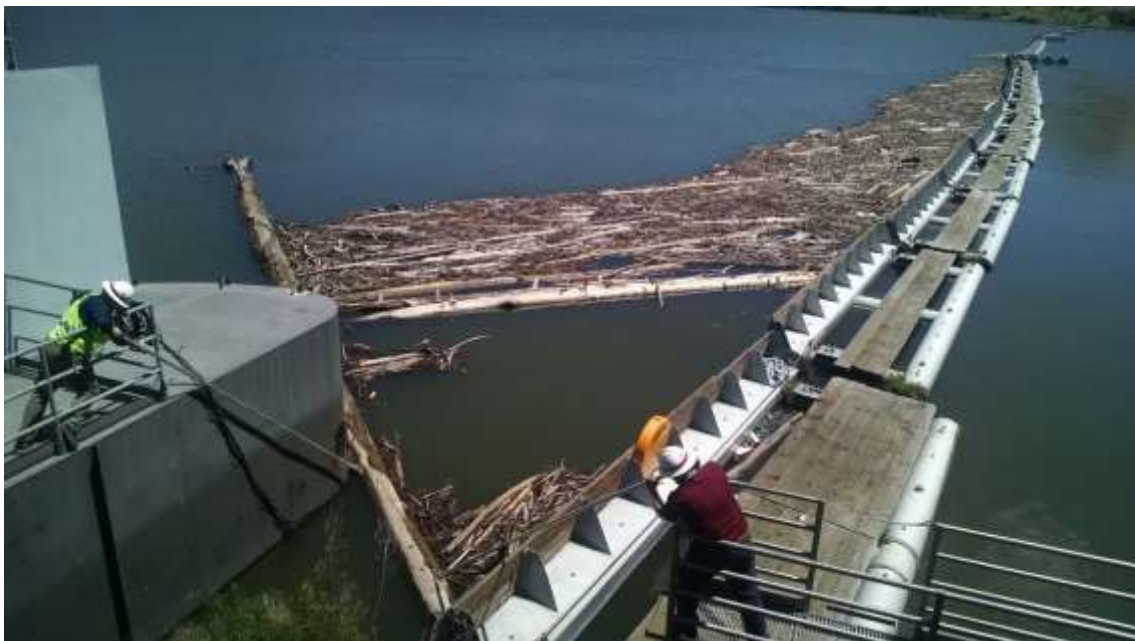
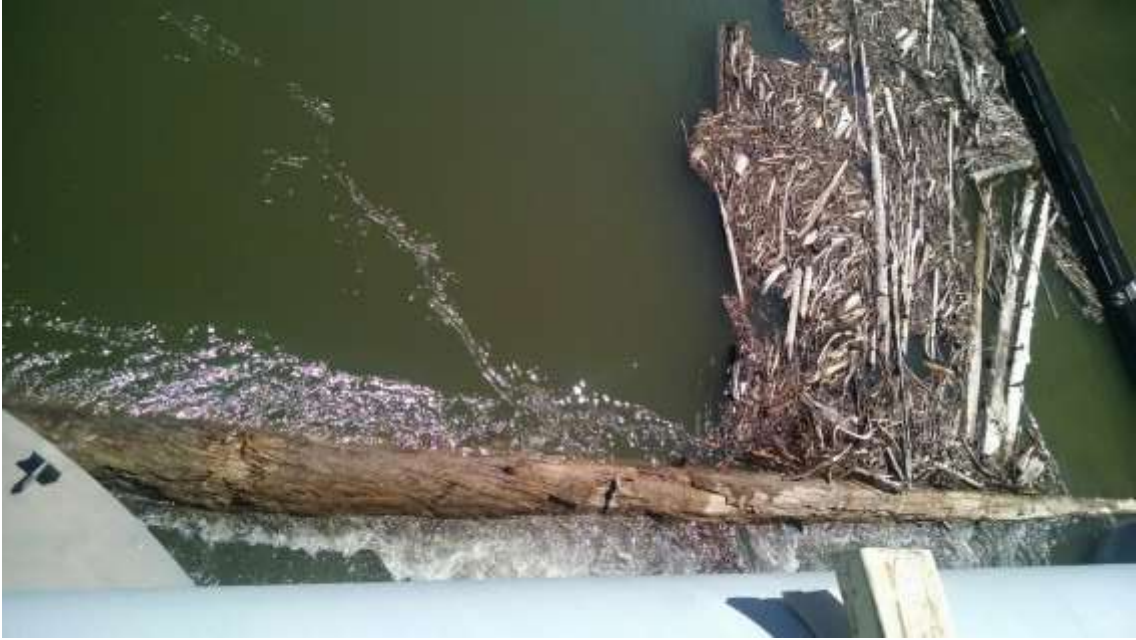
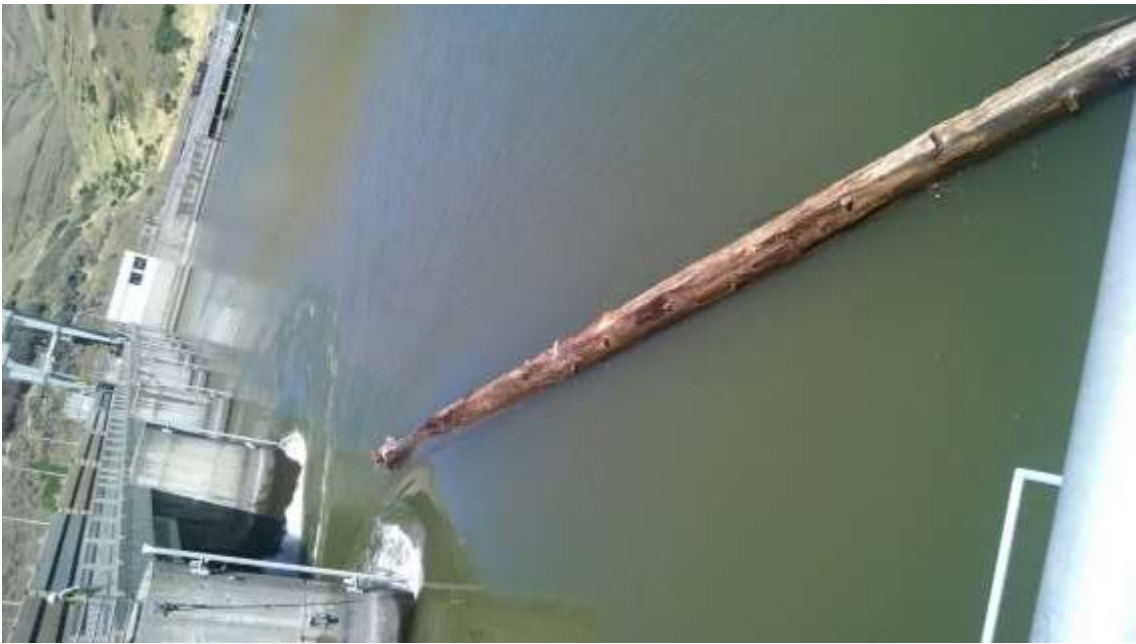
A large log became wedged between the RSW and forebay debris boom. The log blocked debris from passing through the RSW and formed a mat blocking about 1/3 of the surface flow. Logs wedged in this location are a reoccurring problem this season. June 22 from about 1300-1415 hours the Project closed the RSW and opened spillway 3 to remove the wedged log and debris in front of the RSW. Operations deviated from the Fish Passage Plan (FPP) spill pattern during this operation. Spill volume remained unchanged during the debris spills.

- A. Species – N/A
- B. Origin – N/A
- C. Length – N/A
- D. Marks and tags – N/A
- E. Marks and Injuries found on carcass – NA
- F. Cause and Time of Death – N/A
- G. Future and Preventative Measures – The Project will continue to implement emergency debris spills when debris or logs accumulate in front of the RSW as described in FPP (LWG-31 5.2. Emergency Debris Spills) to prevent obstructions to fish passage. A boom is being designed for installation during winter outage to divert debris away from the area.
- H. Photos – see photo below.
