U.S. Army Corps of Engineers
Portland District

Effects of Dam Passage on Juvenile Pacific Lamprey (*Lampetra tridentata*)

FINAL REPORT

January 2001

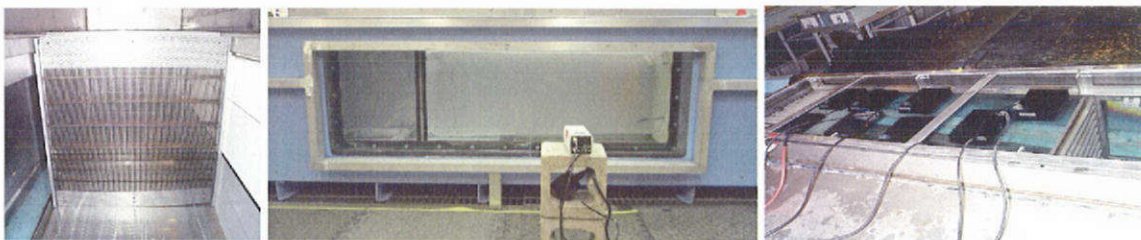
A 17 in. × 17 in. section of 1/8-in. spaced, wedge-wire bar screen was deployed in a 600-gal Brett-type flow respirometer (Brett 1964); the screen was placed perpendicular to the flow within the swim chamber (Figure 1). In three replicate trials, separate groups of 10 lamprey were exposed to velocities of 2.0, 2.5, 3.0, or 3.5 ft/s, for a duration of 20-min followed by a 10-min period at zero flow to observe whether impinged lamprey would be able to free themselves from the screen material. Two additional trials were conducted for a 10-min duration, and one for a 5-min duration, at velocities of 2.0, 3.0, and 4.0 ft/s, again followed by a 10-min observation period. Initially, replicates were conducted in the order 2.5, 3.0, and 3.5 ft/s. After an initial analysis of the data additional trials were then conducted at 2.0 and 4.0 ft/s. These and all subsequent laboratory tests were conducted from 2000-2400 hr, in the dark, using infrared illuminators. Appendix A describes the testing schedule and replicate order used for screen impingement laboratory tests.

Figure 1. Bar Screen in Position, Side View of the Swim Chamber, and Infrared Illuminators Positioned Above the Viewing Window

A custom-built 600-gal Brett-type respirometer was constructed of stainless steel and contained a working section with removable cover, impeller, flow straightener, and viewing window. The observation section measured 5.9-ft long, 1.7-ft wide, and 1.7-ft high. A 25-hp variable speed alternating-current (AC) motor drove the impeller that provided velocities that ranged from 0 to 5 ft/s. The respirometer was immersed in a fiberglass cooling tank that measured 14.7-ft x 5.5-ft.

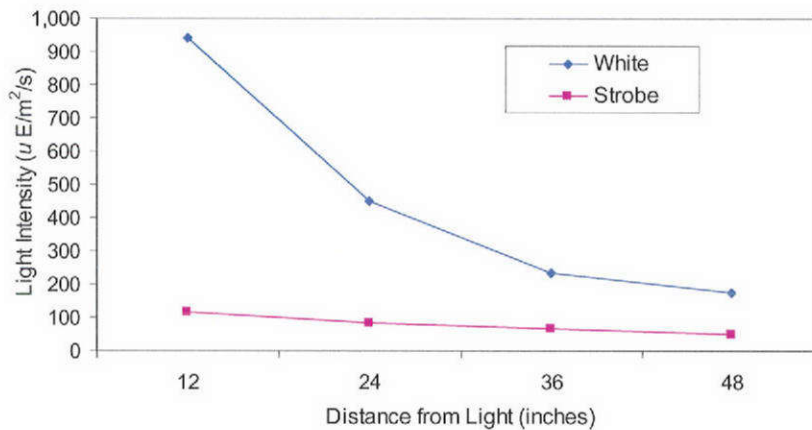
Light intensity measurements made within the cage were averaged over three depth ranges. The measured intensity of white halogen light was far greater than the strobe light. The true intensity of the strobe is assumed to be greater as the meter measured the average intensity at 300 fpm. The intensity measured ranged from 177-942 $\mu\text{E}/\text{m}^2/\text{s}$ for the white light and 51-115 $\mu\text{E}/\text{m}^2/\text{s}$ for the strobe light (300 fpm) depending on distance from the source (Figure 5).

Figure 5. Strobe and White Light Intensities Measured at 12-in. Intervals Within the Swim Chamber

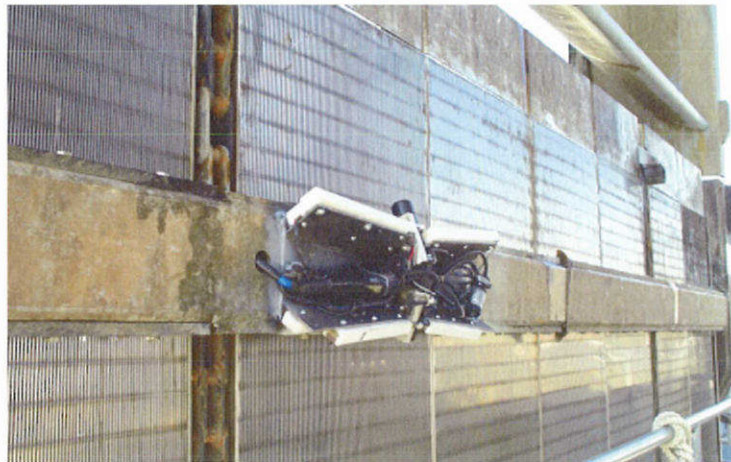
Two low-light monochrome cameras were fastened to a steel bracket welded to the top of the ESBS brush bar. One camera was positioned to look downward, and the other was positioned to look upward. In association with each camera four IR light bar arrays were mounted to the bracket on either side of the cameras to provide illumination (Figure 8).

The bracket was mounted in turbine unit 4 on screen 4B near the center portion of the screen. A single cable with a 5/8-in. wire rope support was used to supply power to the light arrays and cameras. The cable was routed up the face of the screen, around the flow vane, and up to the forebay deck. The cable was manually deployed during brush operation using a large pulley fastened to the hand railing. The brush bar was operated with a portable manual controller and operated at 20-min cycles during the study period. Video was recorded on digital camcorders using 8-mm tape. Recordings were made continuously starting at 1440 hr on May 31 and ending at 0644 hr on June 2, 2000.

Figure 8. Underwater Cameras and Infrared Lighting Mounted on Brush Bar

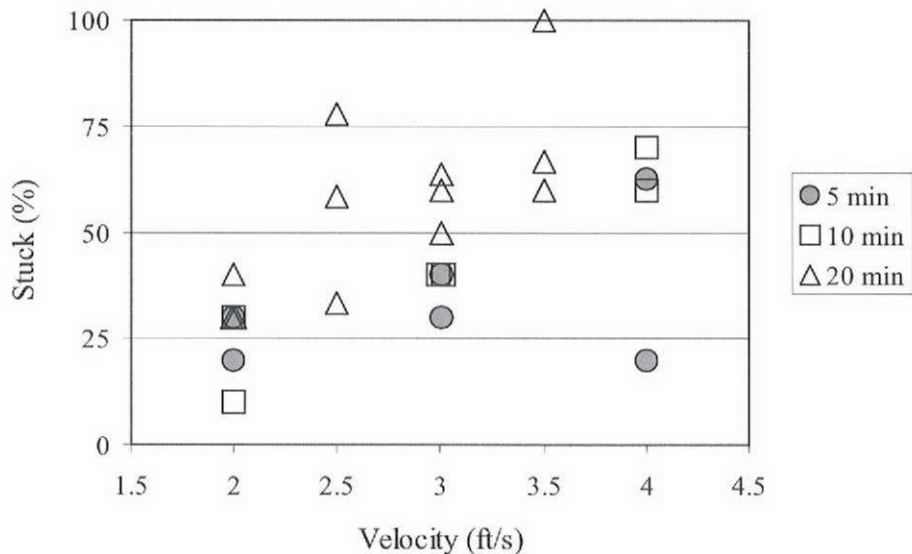
Time-velocity tests showed there was a “dose-dependent” relationship between impingement rate of juvenile lamprey and the amount of time they spent in contact with the 1/8-in. ESBS. We found that juvenile lamprey were more likely to become stuck¹ on the test screens as velocities increased from 2 to 4 ft/s and as their exposure duration increased from 5 to 20 min (Figure 9). The stuck behavior occurred when a fish wedged its tail between the 1/8-in. bar spacing. Depending on velocity, the percent of stuck lamprey ranged from 20 to 30%, 15 to 60%, and 30 to 75% for exposure durations of 5, 10, and 20 min, respectively.

Figure 9. Percent of Lamprey Stuck Versus Exposure Duration for Velocities Ranging from 2 to 4 ft/s (screen perpendicular to flow, n=10)

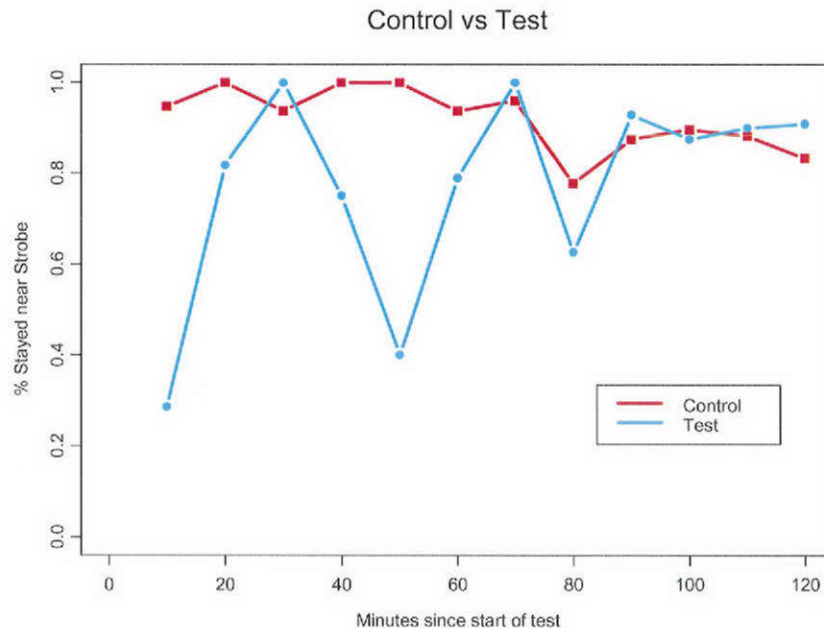
Test replicates were pooled to obtain responses for test and controls. Analysis of variance was used to test the differences in response to the light between test fish and control fish. Factors included in the analysis were: *test* (six test events vs. six control events), *strobe position* (left vs. right), *groups* (four different groups of fish were tested), *runs* (two runs were made for each group), and *time* (12 total events at 10-min intervals). Overall, there was no significant difference between the test and control responses for the duration of a 2-hr test ($P=0.579$); however, there was a significant time effect ($P=0.028$). Analysis of the data from the first 80-min of the test showed there was a significant difference between the test and control ($P=0.041$). This trend suggests that juvenile lamprey became habituated to the stimulus (Figure 12). Lamprey that stayed near the strobe did not vacate the illuminated half of the net pen during the 40-s “strobe on” period.

Figure 12. Movement Patterns of Lamprey when Subjected to Strobe Light Under a Static Environment (mean response for 8 test replicates, $n=10$)

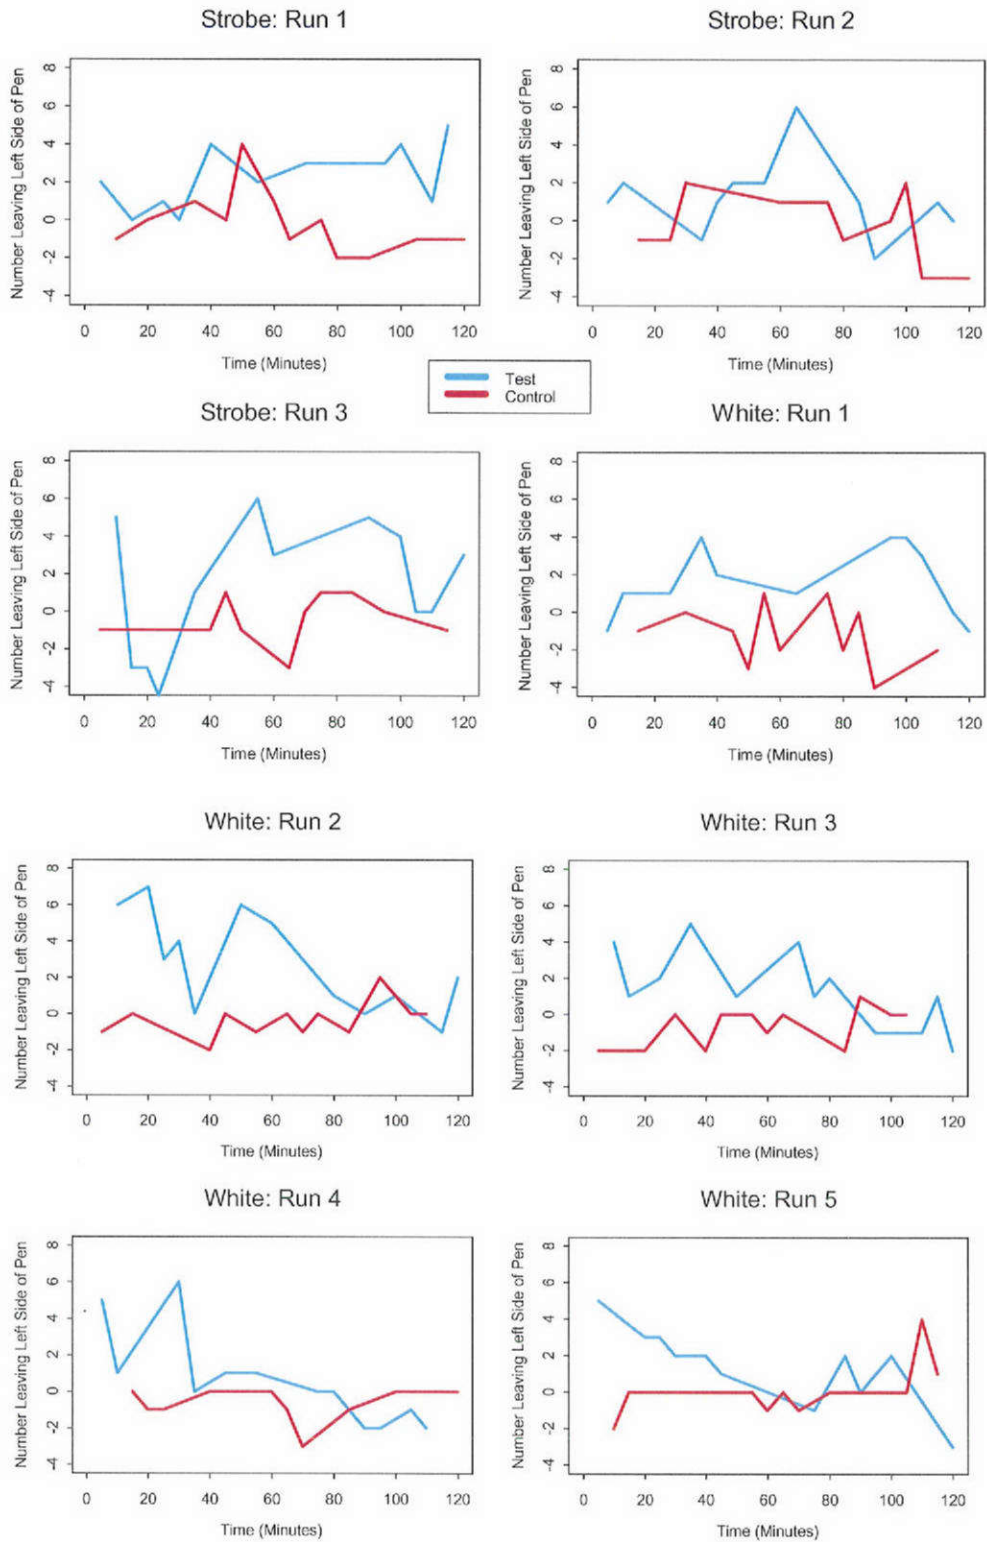
An analysis of variance was performed using the same factors used with the flight response analysis. The response variable analyzed was the proportion of fish that displayed an avoidance response. The test periods had significantly more movement from the left side of the pen to the right (avoidance of the stimulus) than the controls ($P < 0.001$). The analysis showed no significant differences in avoidance responses between the strobe tests and the white light tests ($P = 0.496$).

Regression analyses were performed to examine the effect of lamprey moving from the left side (source end) during the 2-hr testing period. There was no significant change over time during the strobe tests during this testing period ($P = 0.085$). But, there was a trend in decreasing avoidance ($P = 0.0016$) over time based on the number of lamprey moving from the left side of the cage during the white light tests (Figure 14).

Figure 14. Plots of Lamprey Avoidance Responses During Strobe and White Light Tests Conducted in Swim Chamber (n=10 for each run)

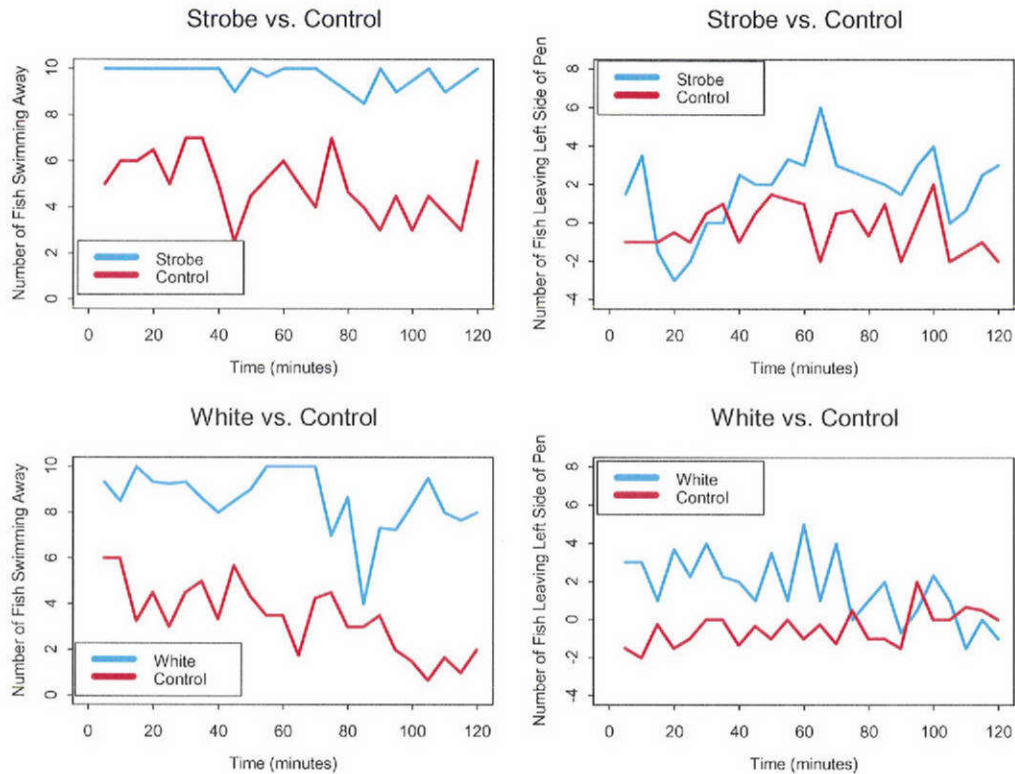
Figure 15. Relative Number of Lamprey Moving from Light Sources (combined test results) During a 2-hr Test

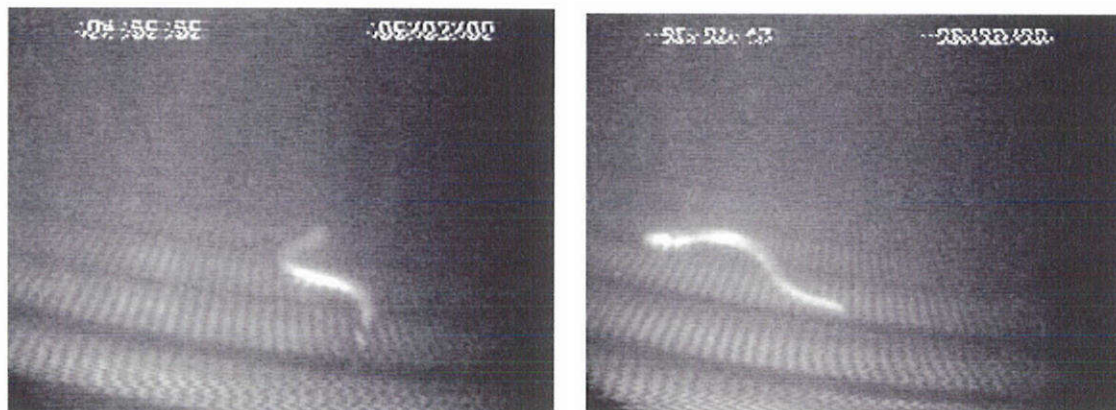
Lamprey were seen in early stages of becoming stuck, i.e., they were in contact with and unable to swim away from the screen face. We observed no lamprey stuck as we have defined it for our laboratory experiments. However, some lamprey exhibited signs of tail-first penetration behavior. The observed lamprey were still able to free themselves by volitionally extracting their tail from between and the bar spacing. We also noted that sweeping velocities along the screen and appeared to push the lamprey up the screen toward the gatewell. It is speculated that this sliding activity would be interrupted by a horizontal bar configuration.

Figure 16. Still Images From Digital Video Footage Taken at McNary Dam on June 2, 2000, at 4:55 AM. The image on the left shows the tail of a lamprey through the bar spacing; the image on the right is the same lamprey a moment later after the tail was extracted volitionally.
