# Hydroacoustic Evaluation of Adult Steelhead Fallback and Kelt Passage at McNary Dam, Winter 2010-2011

Final Report

Battelle  
Pacific Northwest Division  
Richland, Washington 99352

Prepared for  
U.S. Army Corps of Engineers, Walla Walla District,  
Walla Walla, Washington  
Under Biological Services Contract W912EF-08-D-0004  
Delivery Order 0002

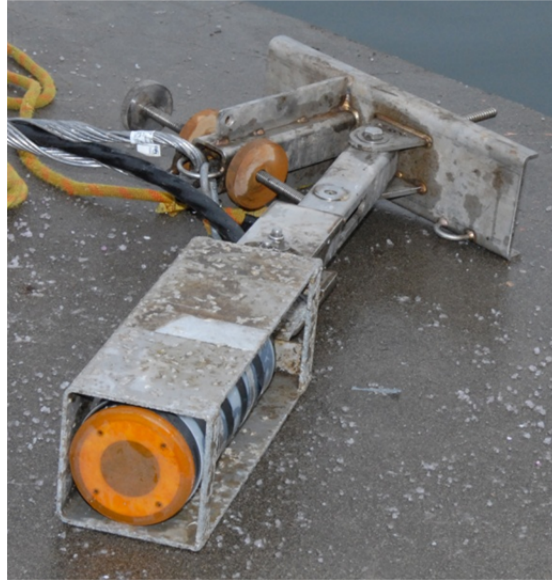
**Figure 2.1.** Transducer Installed in an Adjustable Mount and Prepared for Installation

Eight Precision Acoustic Systems, Inc. (PAS) 420-kHz split-beam transducers with a nominal beam angle of 6 degrees were used to sample adult fish passing downstream through the A slot of units 3, 4, 5, 6, 8, 9, 11, and 13 (Figure 2.1). One split-beam system (System C) sampled intakes 3A and 4A, a second system (System L) sampled intakes 5A, 6A, 8A, and 9A, and the third system (System K) sampled intakes 11A and 13A. Transducers were attached to the center of the trash rack horizontal member at an

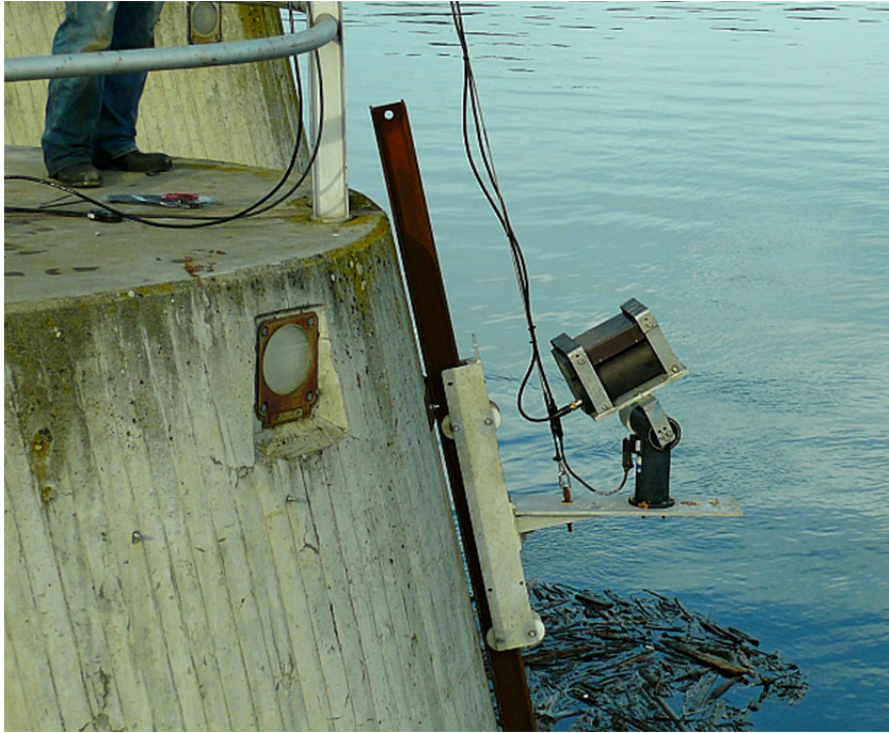
**Figure 2.3.** DIDSON Mounted to Rotator and Trolley Prior to Being Deployed at Unit 5/6 Main Pier Nose

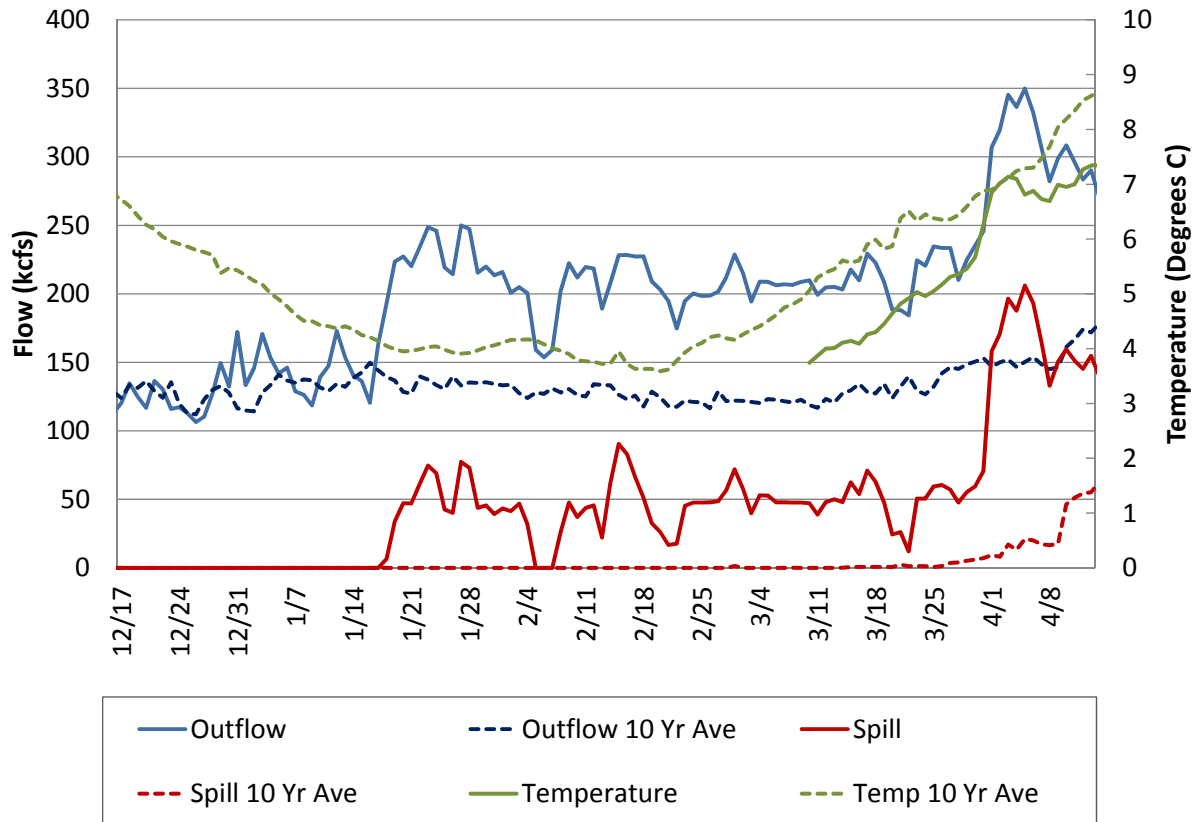
**Figure 3.1.** Daily Total Discharge, Spill Discharge, and Temperature for The Study Period (solid lines) and 10-Year Averages (dashed lines). Source: [www.cbr.washington.edu/dart/dart.html](http://www.cbr.washington.edu/dart/dart.html).

This study monitored passage of adult fish through turbine units at the powerhouse of McNary Dam from December 18, 2010 to April 13, 2011. River discharge during that period was near the 10-year average until mid-January, after which it was well above average through the remainder of the study period (Figure 3.1). Starting in mid-January, the river discharge often exceeded powerhouse capacity, resulting in unplanned spill. The 10-year average spill for this period of the year was essentially 0% until the start of the juvenile fish passage season in April, so the amount of spill during the study period was very atypical. Temperature records were unavailable until mid-March, and temperatures after that date were below the 10-year average. To address the influence of unplanned spill on passage of adult steelhead at the powerhouse, we formed ad hoc analysis groups according to whether there was spill or not on a given day.

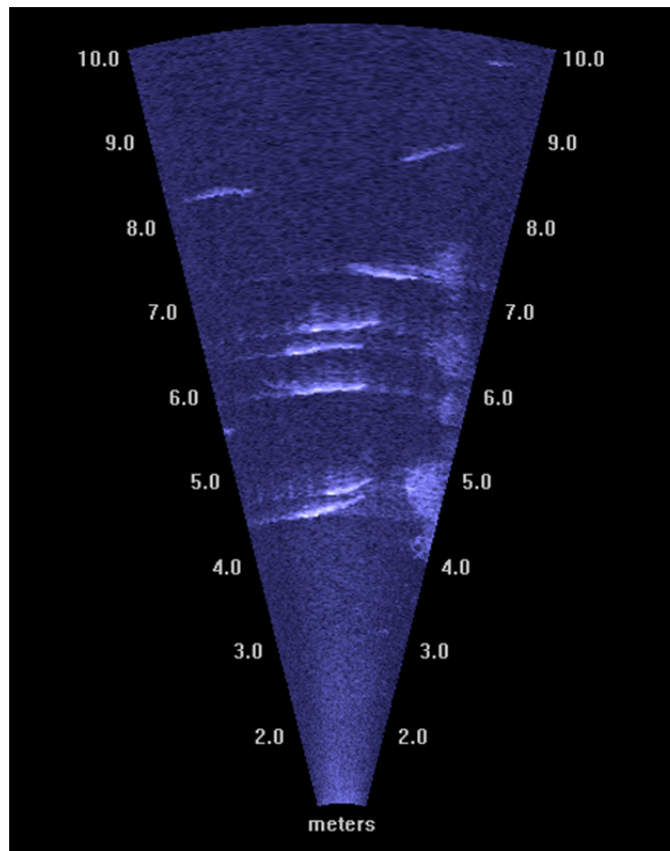
**Figure 3.8.** DIDSON Image of Several Adult Steelhead Milling Upstream of Intake 5C. Objects to right are tumbleweeds on trash rack.

Adult steelhead were observed milling and slowly swimming just upstream of the intake and trash racks, with much less movement across the powerhouse than shad. Darting behavior was also observed on occasion. During brief periods, up to 20 steelhead adults could be observed milling within the region of a particular intake bay (Figure 3.8). It was not possible to determine with certainty that a steelhead or other fish passed downstream of the trash racks because a fish could exit the volume sampled by the DIDSON in more than one direction. The bulk of adult steelhead observed in the DIDSON samples were moving and behaving in ways that were not suggestive of turbine passage. In contrast to shad, they moved less across the upstream face of the powerhouse and were often closer to trash racks. Behavioral observations suggest that fish are holding upstream of the powerhouse, and the presence of fish in the forebay is not a reliable indicator of the number of fish passing downstream.
