Use of Adult Pacific Lamprey Passage Structures at Bonneville Dam  
*2021 Letter Report*

U.S. Army Corps of Engineers  
Portland District, Fisheries Field Unit  
Cascade Locks, OR 97014  
March 31, 2022

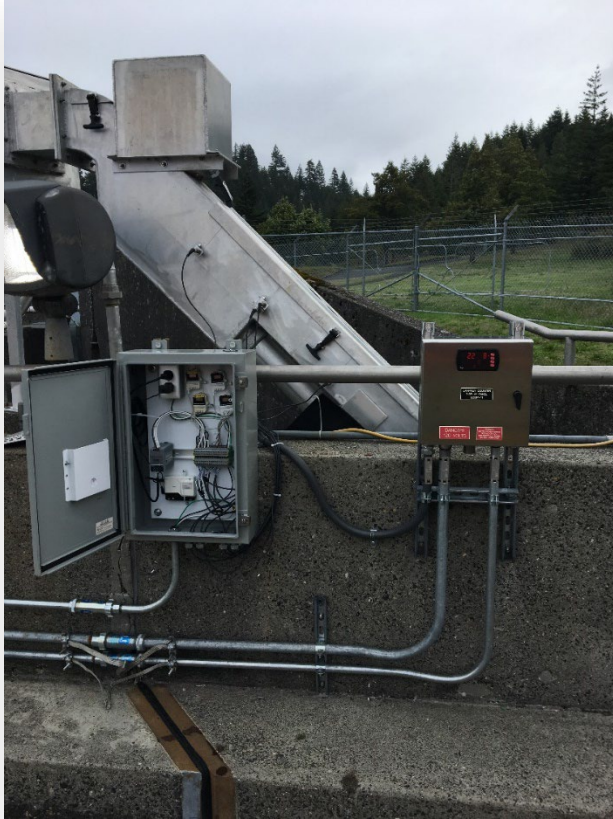
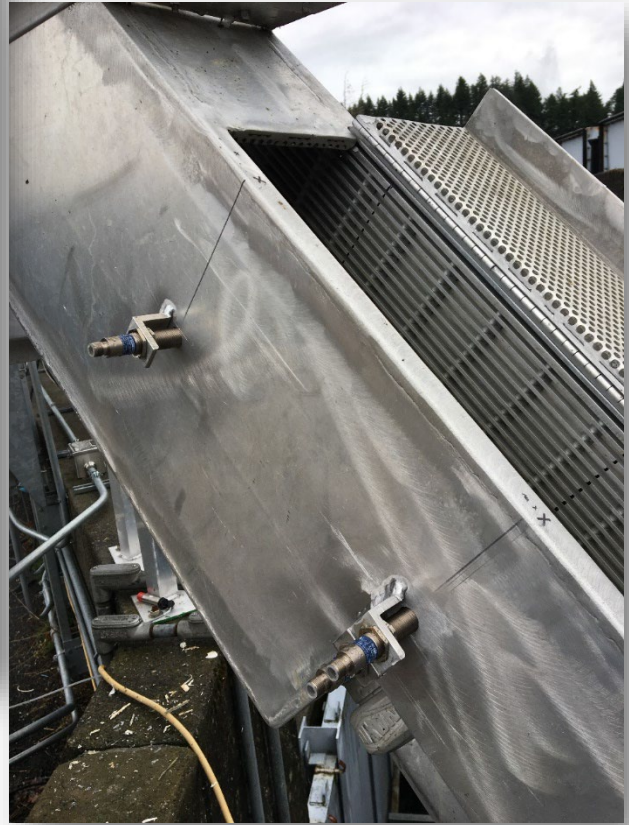
***On the cover:*** Washington Shore-AWS LPS exit slide with optical sensors.

For the 2020 lamprey passage season, three optical counters were installed at WA-AWS exit. The optical sensors sample at a rate of 3,500 Hz or 3,500 times each second. This can result in a single fish being counted multiple times if the light beam is broken, re-connects, and is broken again by a single passing lamprey. To alleviate this issue, one-shot timers were attached to each optical counter and set to three different time delays in seconds: 0.1, 0.5, 1.0 to increase count accuracy. When compared to the video counts in 2020 preliminary results indicated overcounting of all optical sensors as well as the mechanical paddle counter. We found that as the one-shot timer period was increased, overcounting decreased. To find the optimum setting for the one-shot timers, during the 2021 passage season we used delays of 1, 2, and 3 seconds. Results of the 2021 WA-AWS paddle and optical sensor comparisons to the video counts (Table 1) indicate that the accuracy of all three timer settings is well within the 15% precision goal.
