## MEMORANDUM FOR Biologist, Operations Division (CENWP-OD)

SUBJECT: Bonneville Project, Fishway and Fish Activities for **Week 25** of 2019, which covers the period from **16-22 June**.

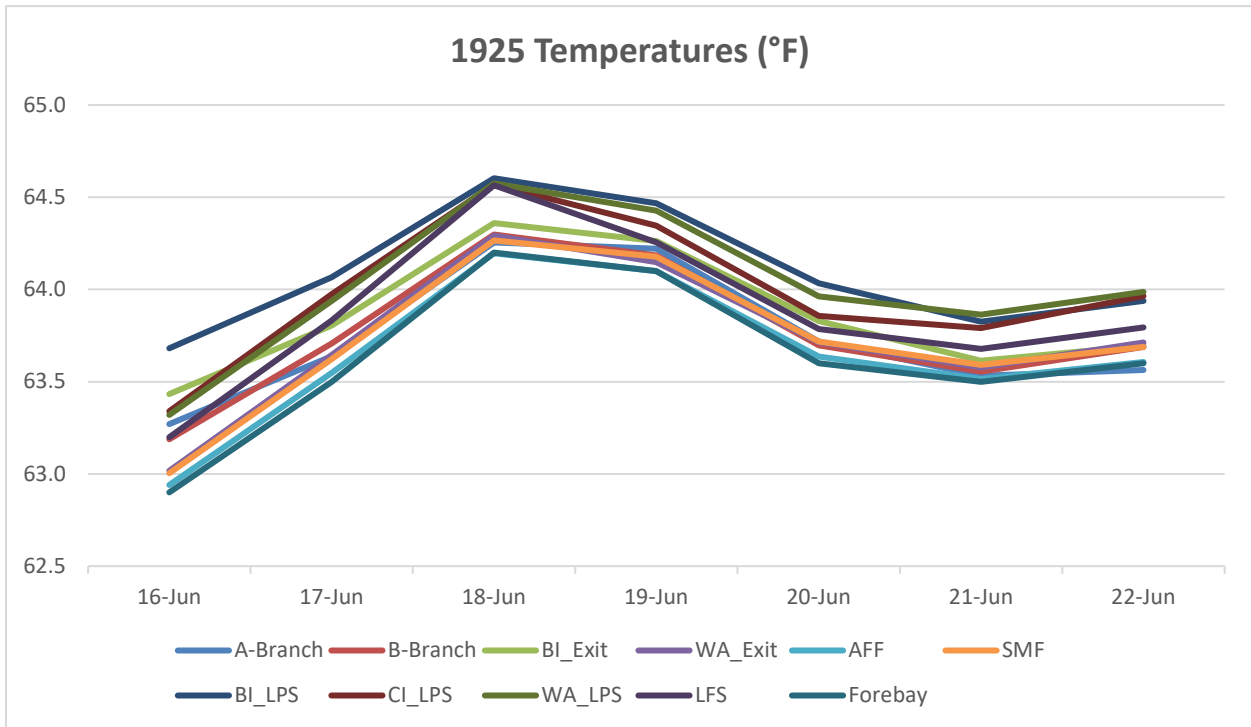
a. Fishway Temperatures. Temperatures are taken from 01 March through 30 November.

Date	A-Branch	B-Branch	BI_Exit	WA_Exit	AFF	SMF	BI_LPS	CI_LPS	WA_LPS	LFS	Forebay
16-Jun	63.3	63.2	63.4	63.0	62.9	63.0	63.7	63.3	63.3	63.2	62.9
17-Jun	63.6	63.7	63.8	63.6	63.5	63.6	64.1	64.0	63.9	63.8	63.5
18-Jun	64.3	64.3	64.4	64.3	64.2	64.3	64.6	64.6	64.6	64.6	64.2
19-Jun	64.2	64.2	64.3	64.1	64.1	64.2	64.5	64.3	64.4	64.3	64.1
20-Jun	63.7	63.7	63.8	63.7	63.6	63.7	64.0	63.9	64.0	63.8	63.6
21-Jun	63.5	63.6	63.6	63.6	63.5	63.6	63.8	63.8	63.9	63.7	63.5
22-Jun	63.6	63.7	63.7	63.7	63.6	63.7	63.9	64.0	64.0	63.8	63.6
