MEMORANDUM FOR Biologist, Operations Division (CENWP-OD)

SUBJECT: Bonneville Lock & Dam, Fishway and Fish Activities for Week 24 of 2023, which covers the period from 11 June to 17 June 2023.

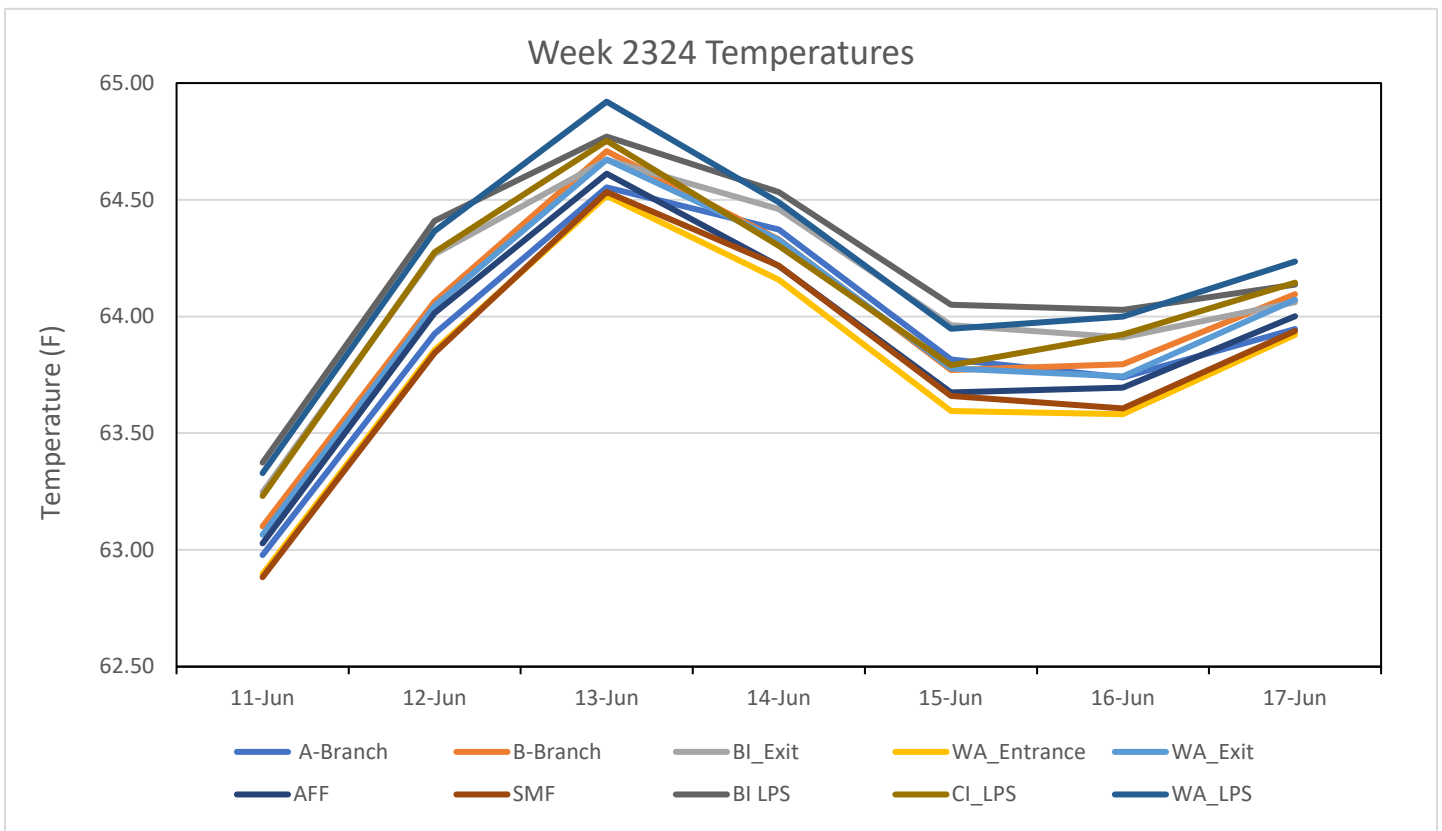
Figure 1. Average Fishway Temperatures for 11 June to 17 June at Bonneville Lock & Dam

a. Fishway Temperatures: Fishway temperature monitoring is currently underway.
