FISHWAY STATUS REPORT

Date: 11/9/2013 **Inspection Period:** 11/2 thru 11/9/13

JOHN DAY DAM

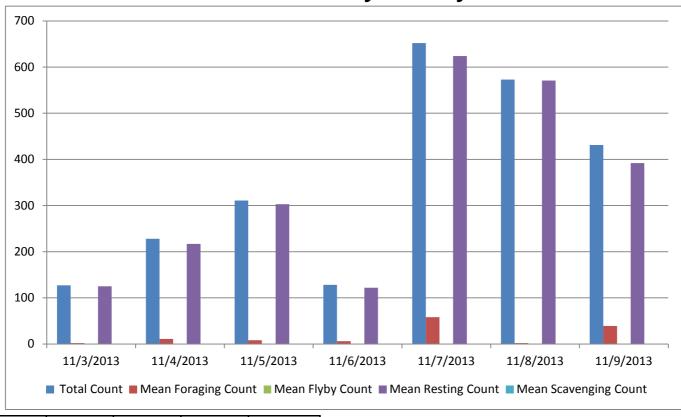
Bird Count by Activity

Mean		Mean	Mean
	Total	Foraging	Mean Flyby	Resting	Scavenging
Date	Count	Count	Count	Count	Count
11/3/2013	127	2		125	
11/4/2013	228	11		217	
11/5/2013	311	8		303	
11/6/2013	128	6		122	
11/7/2013	652	58		624	
11/8/2013	573	2		571	·
11/9/2013	431	39		392

Seasonal High numbers of GULLS in the Forebay and on the WING WALL.
