The Dalles Dam Fishway Status Report

11/19/2017

Inspection Period: 11/12/2017-11/18/2017

THE DALLES DAM

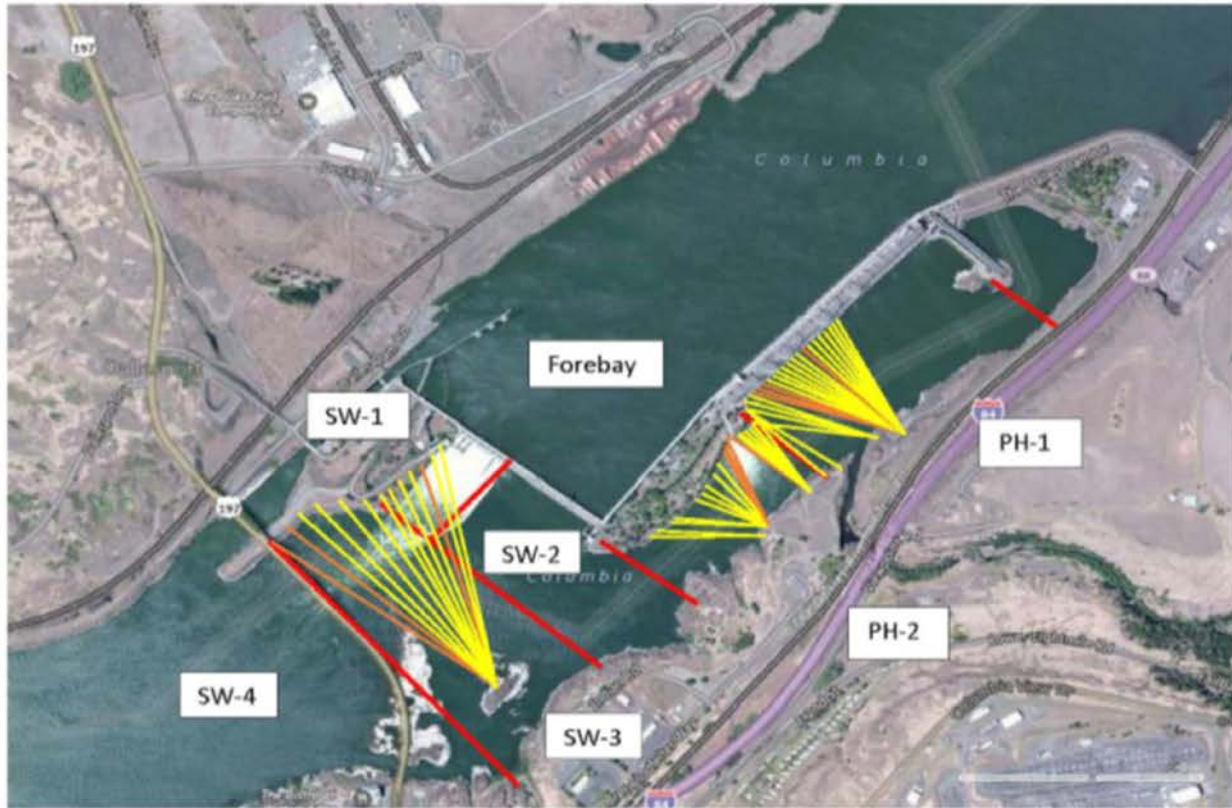
Red lines = avian zones

Yellow lines = current wires

Orange lines = down or missing wires

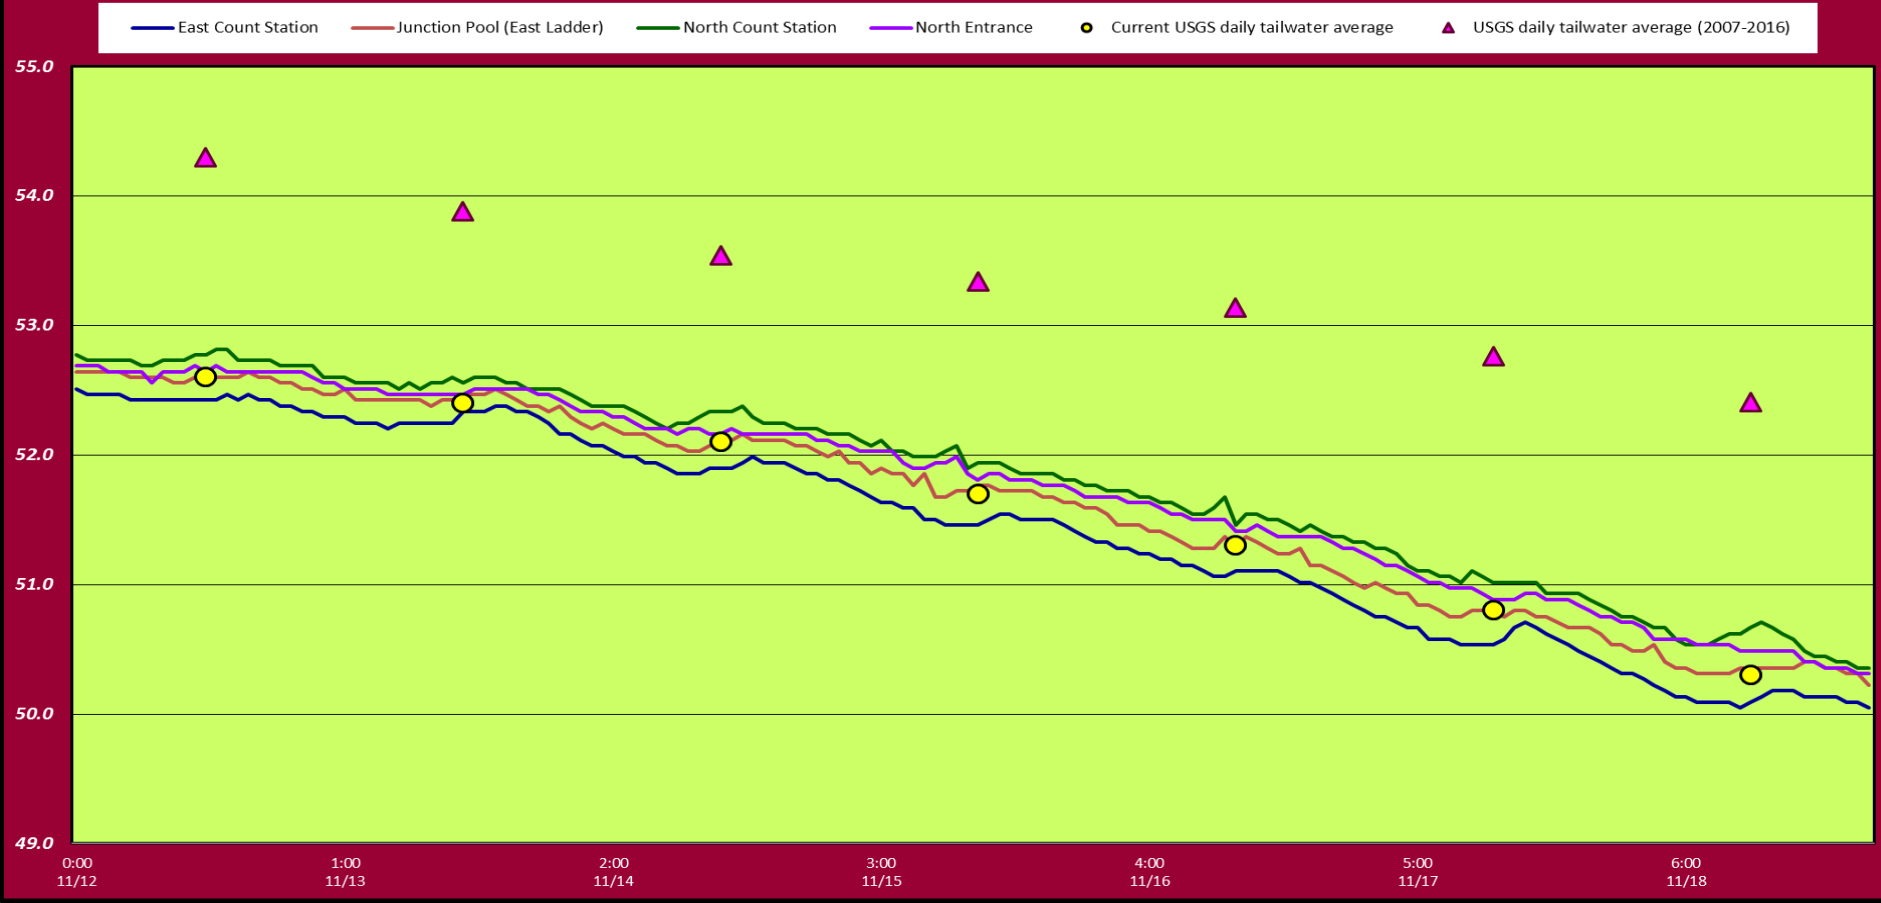
The Dalles Dam Adult Fish Ladder(s) River/Water Temperature

USGS: <http://pweb.crohms.org/tmt/documents/ops/temp/201711icol.html>

Secchi:		Temperatures
5.0	Sun	52.6
5.0	Mon	52.4
5.0	Tue	52.1
5.0	Wed	51.7
5.0	Thurs	51.3
5.0	Fri	50.8
5.0	Sat	50.3
5.0	AVG	51.6
